**HISTORIC STRUCTURE SURVEY
AND LIMITED ARCHAEOLOGICAL TESTING
SANIBEL LIGHTHOUSE AND KEEPERS' QUARTERS
(8LL00097)
LEE COUNTY, FLORIDA**

**City of Sanibel
Planning Department
2475 Library Way
Sanibel, FL 33957**

**Archaeological Consultants, Inc.
8110 Blaikie Court, Suite A
Sarasota, Florida 34240
(941) 379-6206**

May 2024

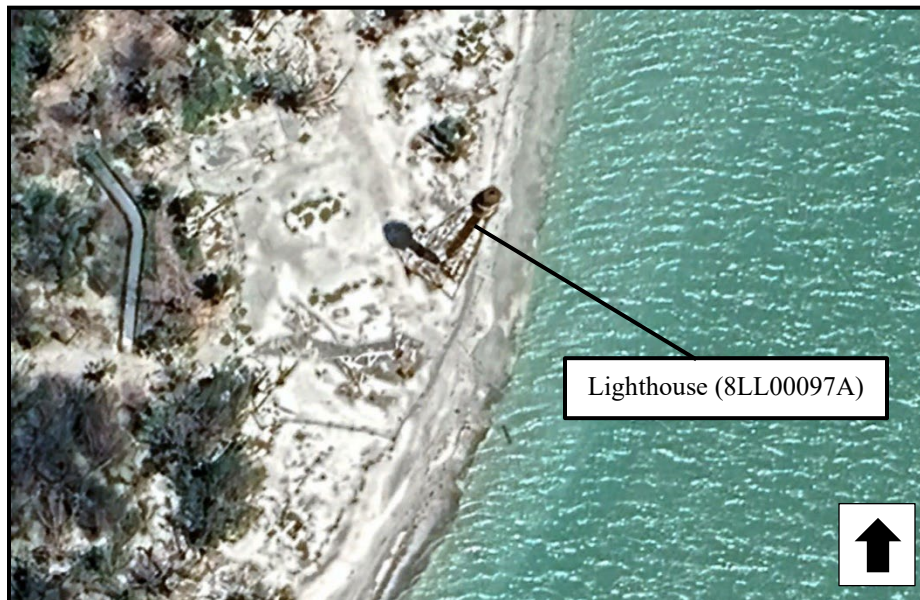
Figure 4. A Google Earth aerial photograph taken in May 2023 following Hurricane Ian (Google Earth 2024). Note the drastically altered shoreline and absence of supporting buildings, including the two Keepers' Quarters buildings and the oil house.

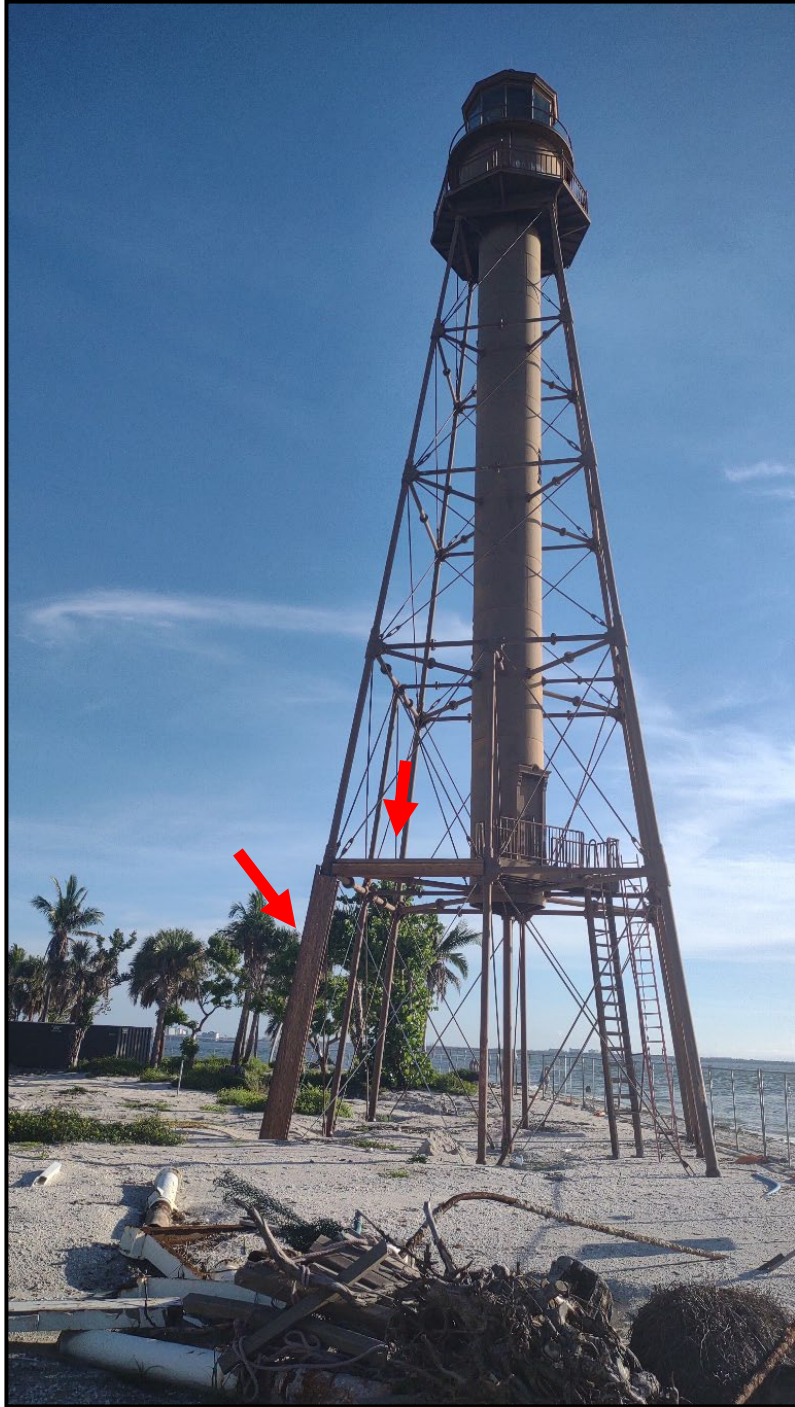
Photo 3. A photograph of the Sanibel Lighthouse following Hurricane Ian and prior to restoration work. Temporary wooden supports were installed and are indicated by the red arrows. Photo taken by Kim Ruiz, City of Sanibel Principal Planner, in August 2023.

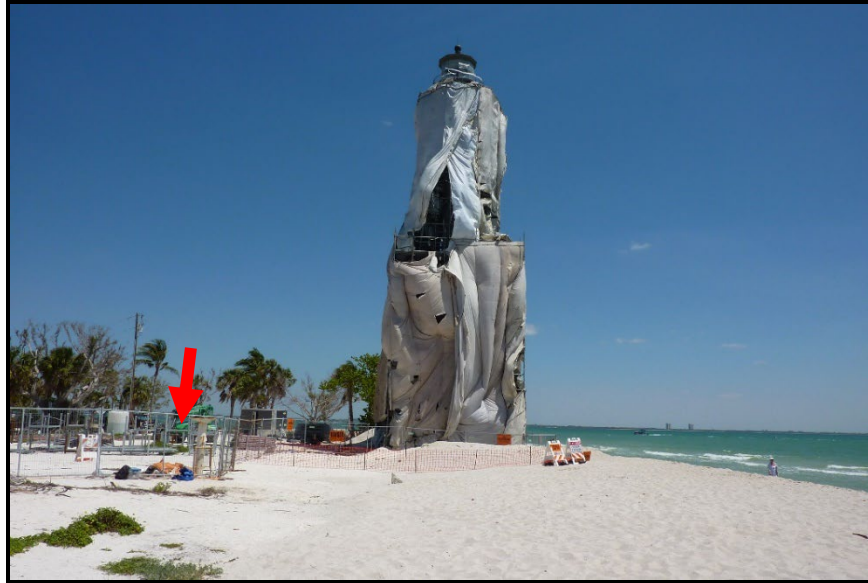
Photo 4. The Sanibel Lighthouse during restoration, looking north. The location of an in-situ support pier from the Keepers' Quarters is indicated by the red arrow. The second Keepers' Quarters building was located to the right of the lighthouse. Remnants of the associated support piers were identified within the water due to the eroded shoreline.

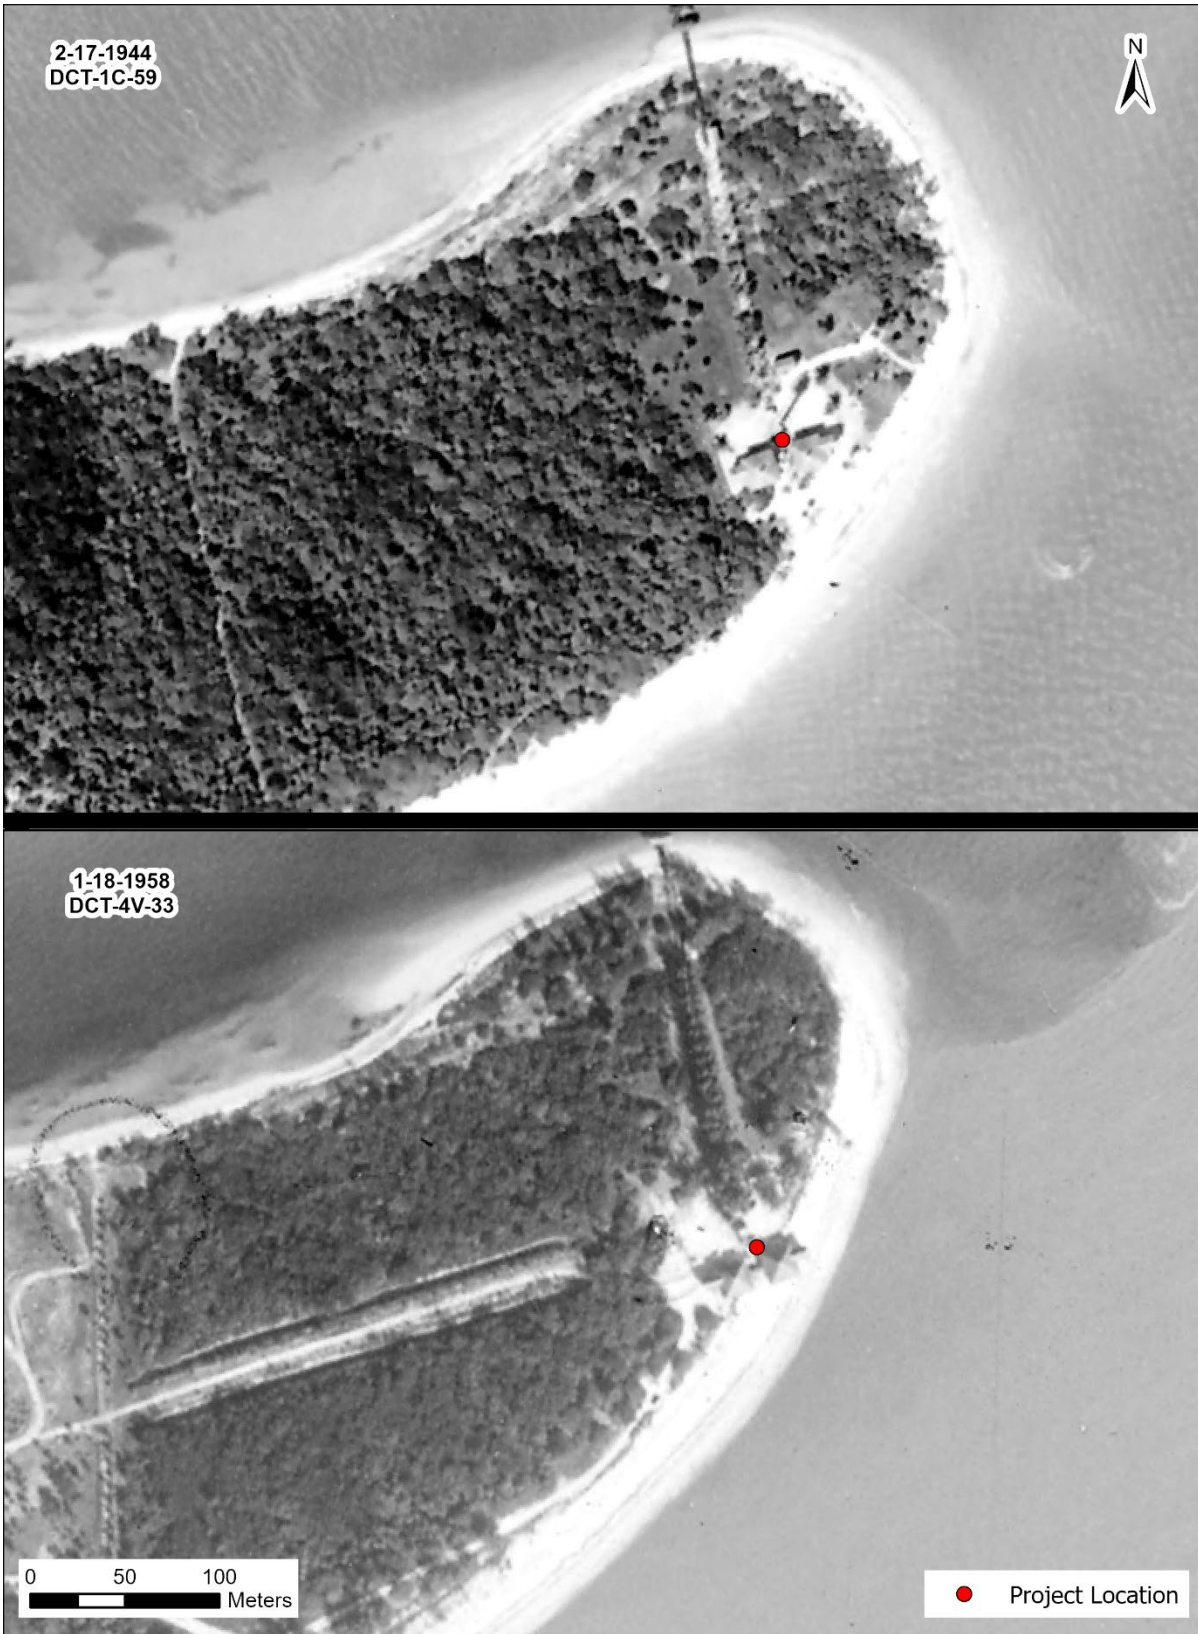
Figure 6. Historic aerial photographs showing significant beach erosion between 1944 and 1958.

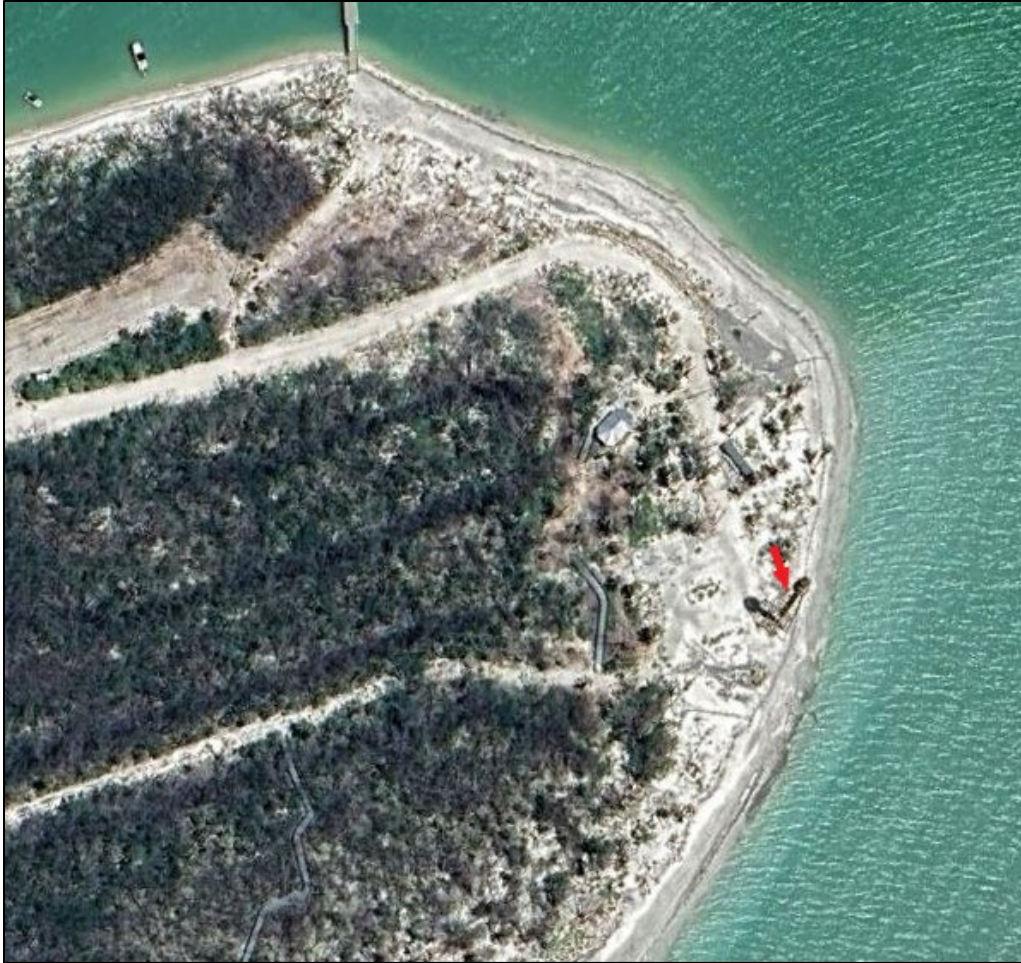
Archaeological field survey included surface reconnaissance and the excavation of six shovel tests throughout the property, none of which produced intact cultural materials or evidence of subsurface features (**Figure 5**). Testing followed the planned methodology with no significant shifts. The majority of identified cultural materials were on the surface. The surface scatter consisted of materials related to the lighthouse including large chunks of concrete, metal, footer posts, and wood beams. These results are consistent with the previous monitoring projects discussed above. Three shovel tests did evidence historic materials; however, they appeared to be in storm deposit and not in situ. Shovel test 1 did find part of the foundation related to one of the Keeper's Quarters supports (**Photo 5**). While this informative, it is not new or unexpected. The lack of material artifacts is likely due to hurricane and storm erosion of the coastline, past development and soil removal projects, and possible past deposition practices designed to keep pests away from the light keeper's quarters. Historic aerials show significant change in the coastline over time. **Figure 6** shows significant erosion in the years between 1944 and 1958 (USDA 1944, 1958). The lighthouse, marked by a red dot, is closer to shore with structures extremely close to the water line. The current Google Earth imagery shows a higher degree of beach erosion following Hurricanes Ian and Irma. In this image the lighthouse is sitting at the edge of the high tide line (**Figure 7**) (Google Earth 2024). Joel Caouette (2024), a conservation officer with the city in charge of beach renourishment efforts, confirmed that Hurricane Ian removed several feet of coastline (2024), a change visible in **Figure 7**.

Figure 7. Present Google Earth imagery showing the proximity of the lighthouse to the waterline following Hurricanes Ian and Irene. The red arrow points to the lighthouse.

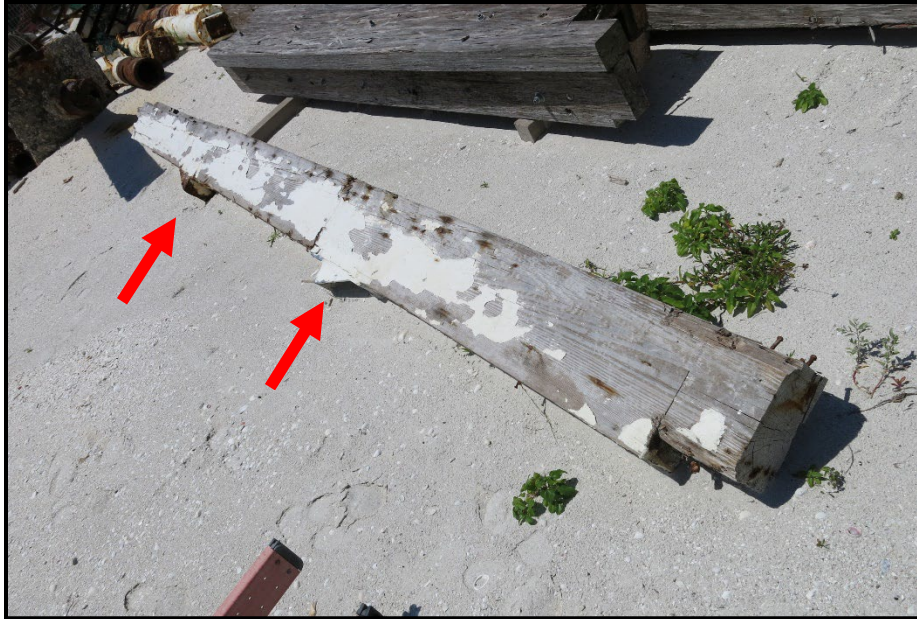
The dimensions of the wooden girder are approximately 16' x 11 7/8" x 5 3/4". One end of the girder (left end in **Photo 17**) was broken during the destruction of the Keepers' Quarters and as such, the original length of the girder is unknown. The elements of Group No. 3 are an example of the structural building techniques utilized to construct the Keepers' Quarters in the coastal environment, similar to Group No. 1; however, this wooden girder has intact mortises with wooden pegs and remnants of wooden tenons within the joints. In addition, two metal brackets are on the bottom side of the girder and likely would have attached to wooden structural brackets similar to those found on Group No. 1.

Photo 18. The wooden girder with intact mortise and tenon joints. The right end of the girder is intact; however, the left end of the girder in the photograph has been broken. The red arrows indicate the location of the metal brackets on the bottom of the girder. The mortise and tenon joints are located along the top of the girder.

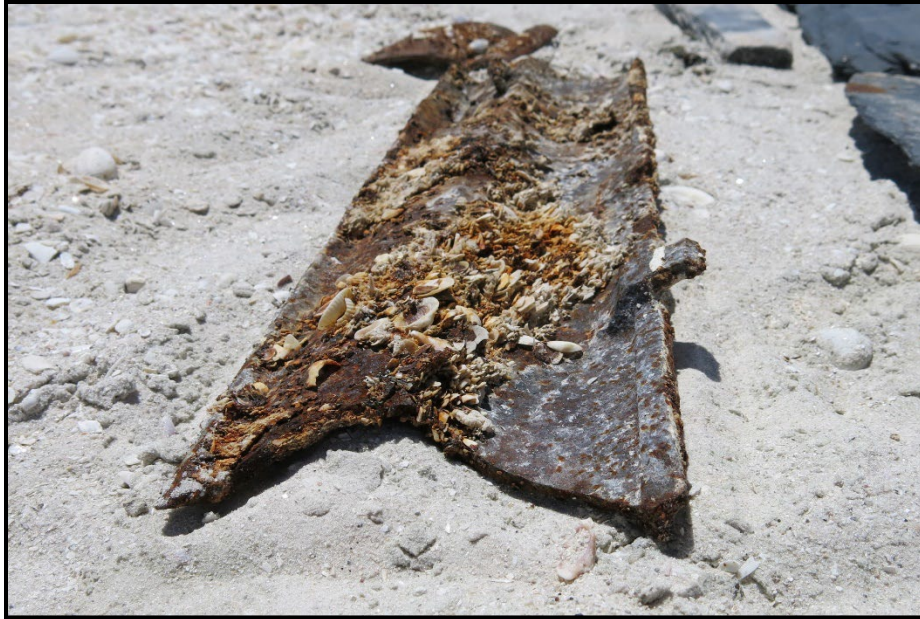
Photo 23. The back side of the cast iron coal burning fireplace surround segment. This side of the segment is covered with shell and rust due to marine exposure.

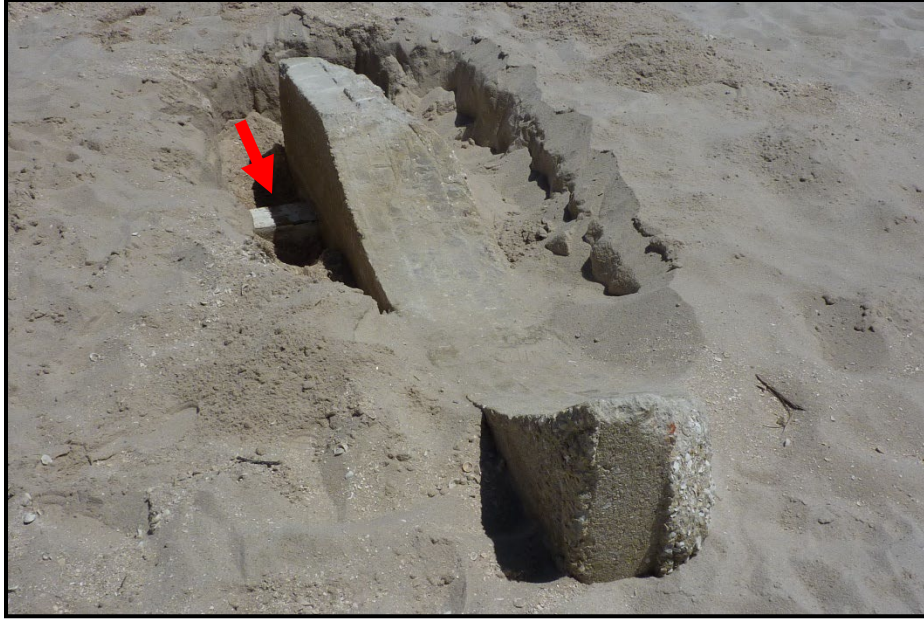
During the site visit, ACI architectural historians and archaeologists identified a large concrete object protruding from the sand southwest of the lighthouse. The object was partially excavated and photographed. A review of historic photographs, as well as photographs taken pre-Hurricane Ian, revealed that the object was a concrete footer that had been displaced by stormwaters. A segment of the squared wooden foundational support post was visible beneath the sand as indicated in **Photo 28** by the red arrow. The footer was rotated onto its side, exposing the curved edge which was poured immediately adjacent to the brick cistern behind the Keepers' Quarters (**Photo 29**). As such, the concrete footer follows a partial contour of the brick cistern and is lined with impressions of the brick. The dimensions of the contour, combined with the extant segments of the cistern walls in Group No. 2, may provide an estimate of the cistern's original dimensions.

Photo 28. The concrete footer, partially buried beneath the sand and rotated onto its side by stormwaters. The squared wooden support post for which the footer was laid is indicated by the red arrow. The curved surface is lined with brick impressions from the brick cistern.

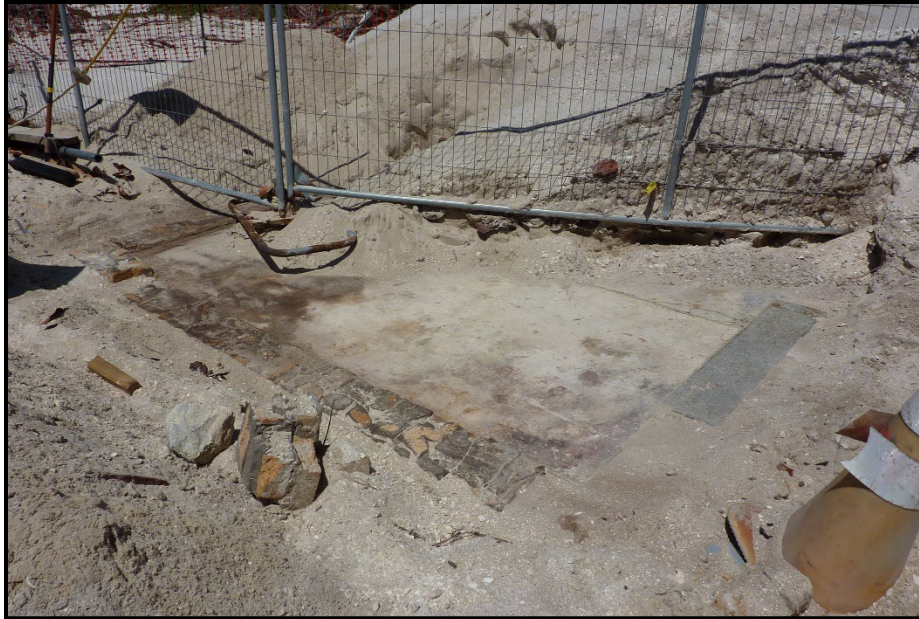
Photo 31. The partially excavated oil house foundation, looking northeast.

- a) Small debris/artifacts could be put on display within the museum setting.
 - b) The excavation and maintenance of the oil house foundation as a part of the historic property would provide visitors the opportunity to visualize where supporting buildings and structures were located prior to Hurricane Ian.

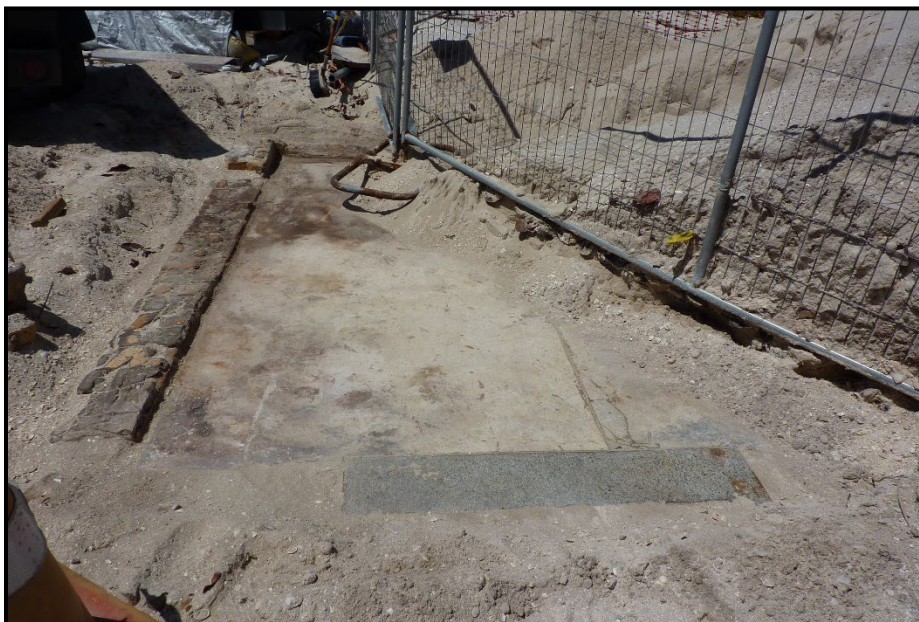
Photo 32. The partially excavated oil house foundation, looking north. Note the granite threshold in the foreground, concrete slab, and continuous brick wall around the perimeter of the slab. The right corner and wall are covered with piled sand being utilized for erosion control/shore reconstruction and the temporary metal fencing separating Lighthouse Beach Park from the construction site.
