HISTORIC STRUCTURE SURVEY AND LIMITED ARCHAEOLOGICAL TESTING SANIBEL LIGHTHOUSE AND KEEPERS' QUARTERS (8LL00097) LEE COUNTY, FLORIDA

May 2024

HISTORIC STRUCTURE SURVEY SANIBEL LIGHTHOUSE AND KEEPERS' QUARTERS (8LL00097) LEE COUNTY, FLORIDA

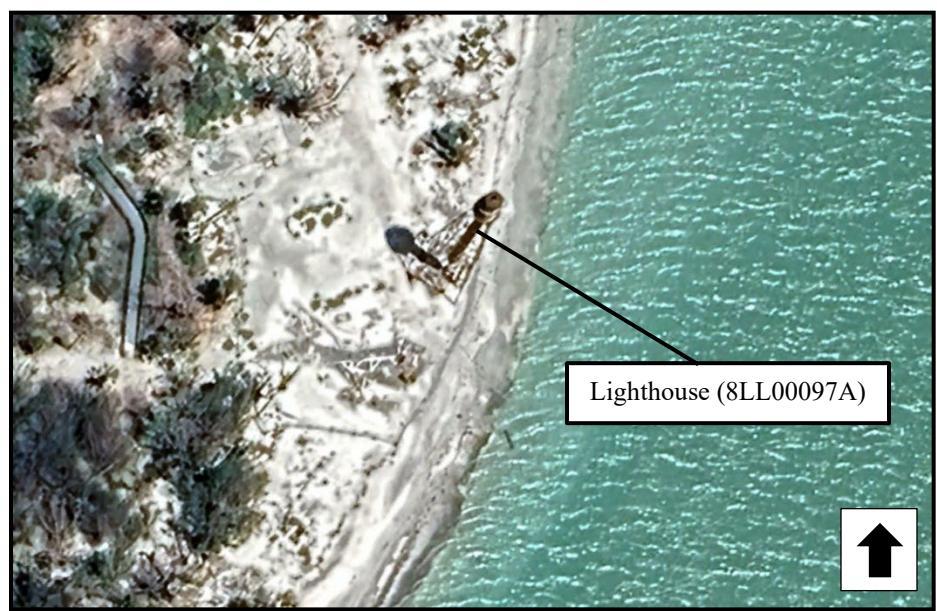
Figure 4. A Google Earth aerial photograph taken in May 2023 following Hurricane Ian (Google Earth 2024). Note the drastically altered shoreline and absence of supporting buildings, including the two Keepers' Quarters buildings and the oil house.

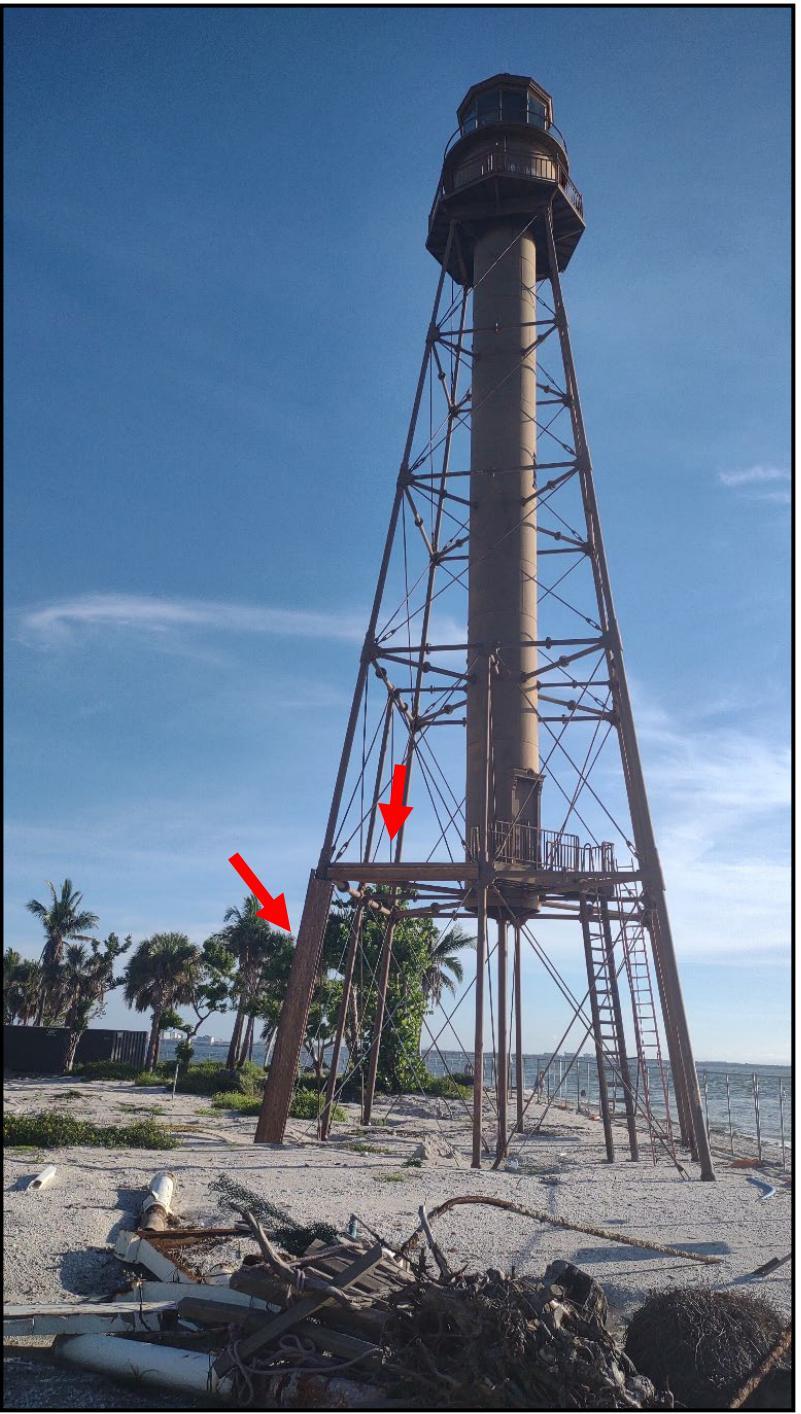
Photo 3. A photograph of the Sanibel Lighthouse following Hurricane Ian and prior to restoration work. Temporary wooden supports were installed and are indicated by the red arrows. Photo taken by Kim Ruiz, City of Sanibel Principal Planner, in August 2023.

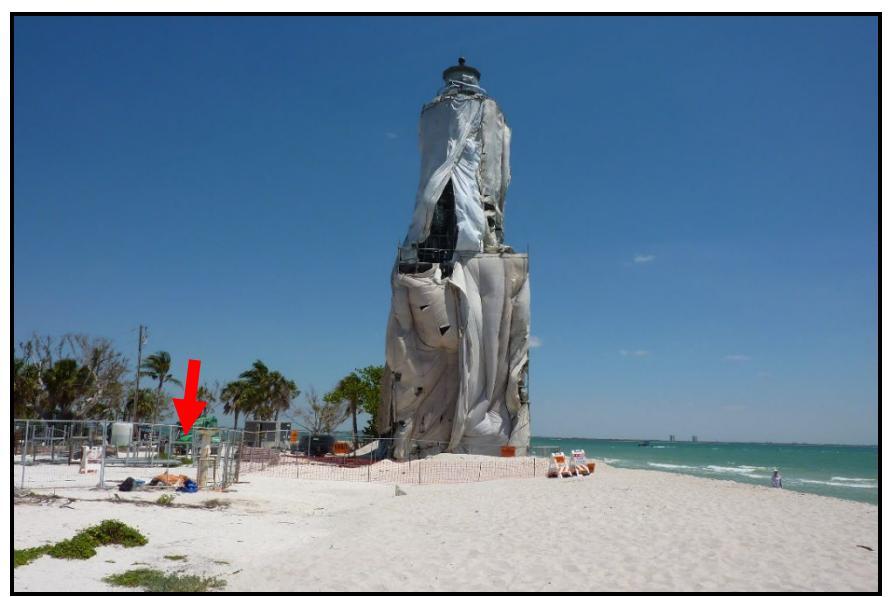
Photo 4. The Sanibel Lighthouse during restoration, looking north. The location of an in-situ support pier from the Keepers' Quarters is indicated by the red arrow. The second Keepers' Quarters building was located to the right of the lighthouse. Remnants of the associated support piers were identified within the water due to the eroded shoreline.

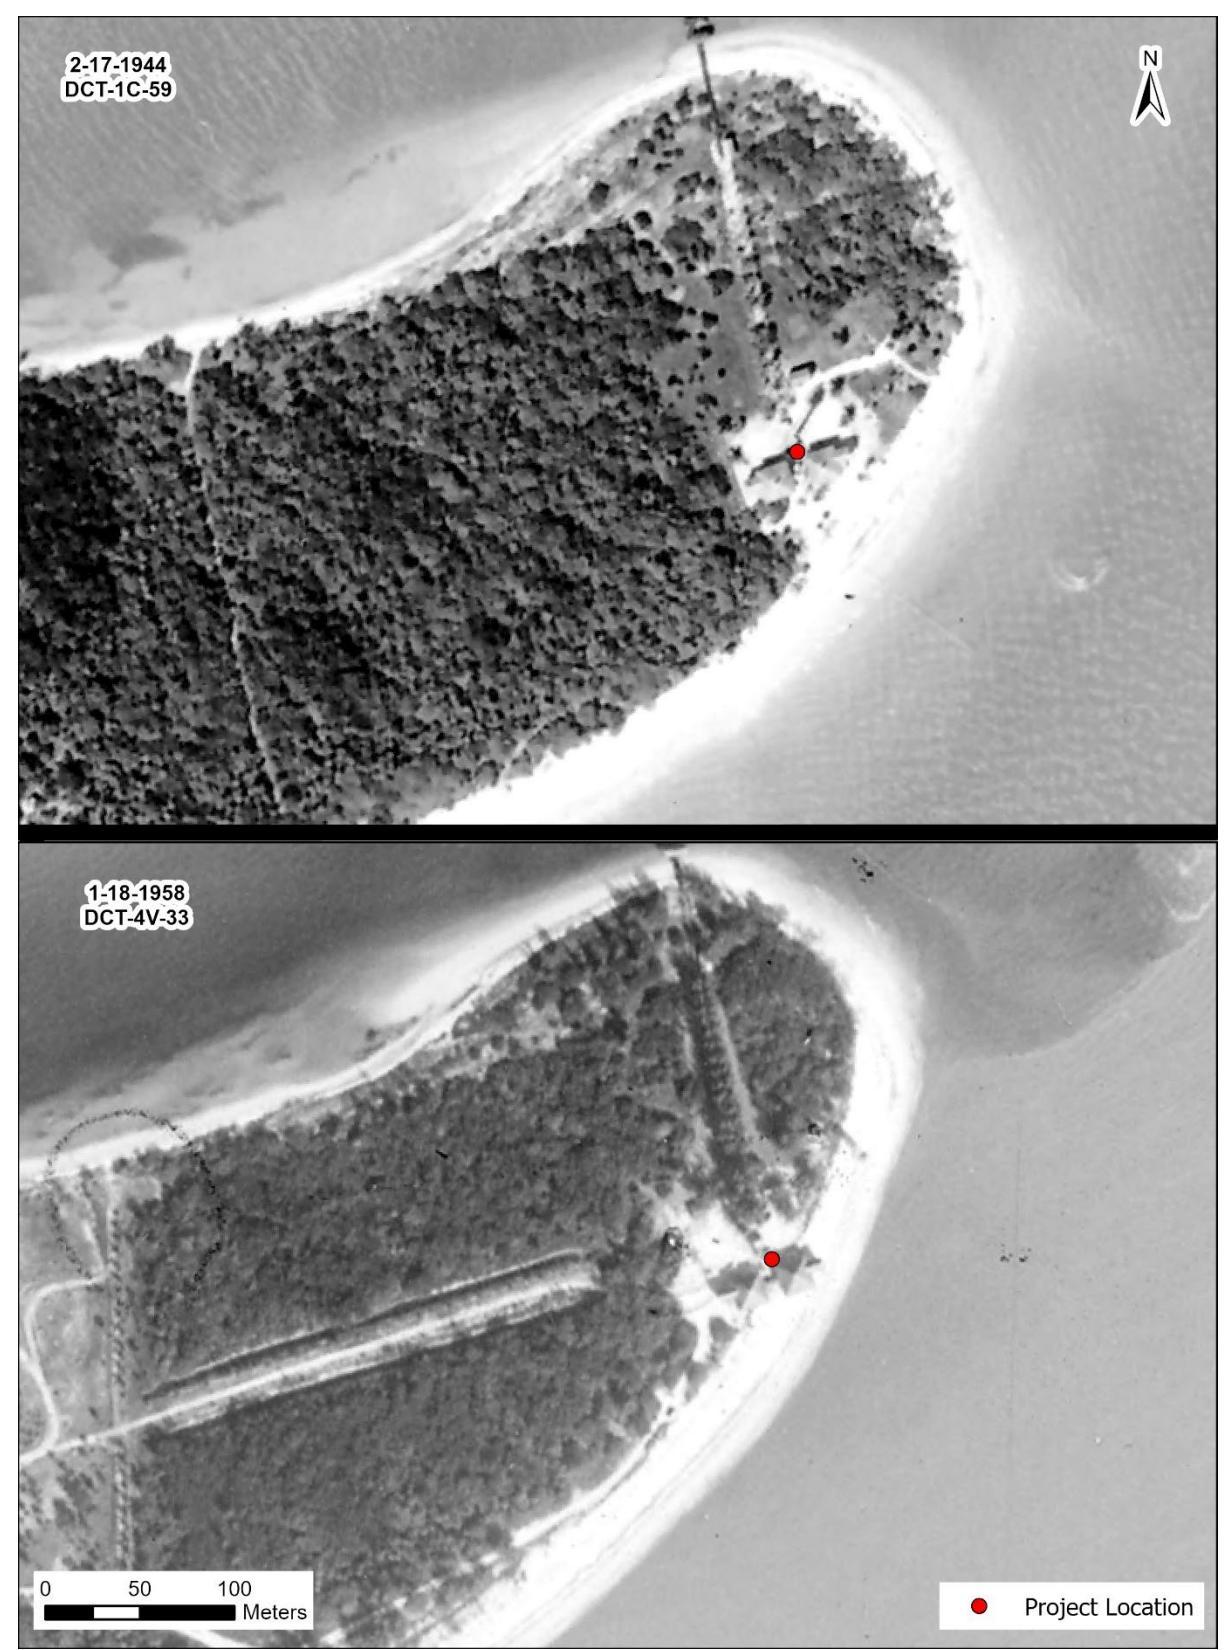
significant erosion in the years between 1944 and 1958 (USDA 1944, 1958). The lighthouse, marked by a red dot, is closer to shore with structures extremely close to the water line. The current Google Earth imagery shows a higher degree of beach erosion following Hurricanes Ian and Irma. In this image the lighthouse is sitting at the edge of the high tide line (**Figure 7**) (Google Earth 2024). Joel Caouette (2024), a conservation officer with the city in charge of beach renourishment efforts, confirmed that Hurricane Ian removed several feet of coastline (2024), a change visible in **Figure 7**.

Figure 6. Historic aerial photographs showing significant beach erosion between 1944 and 1958.

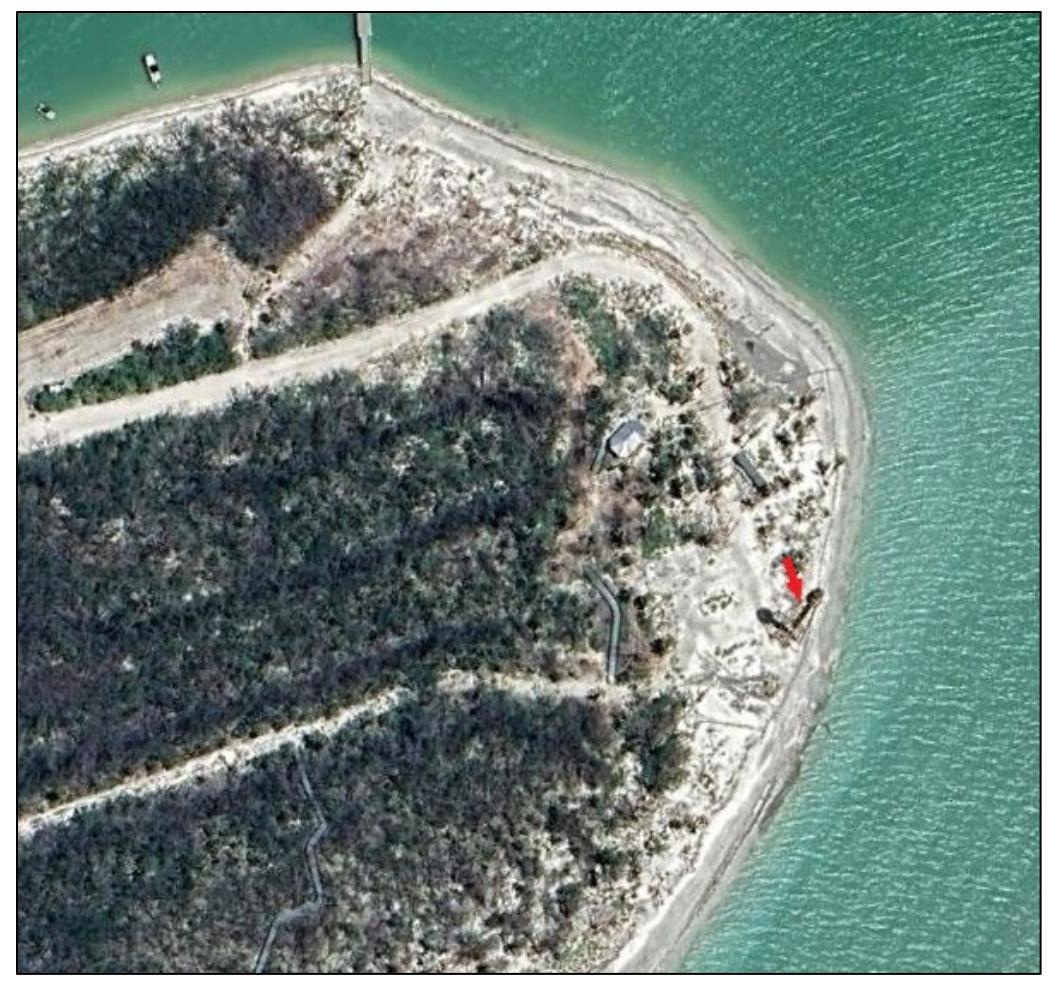
Figure 7. Present Google Earth imagery showing the proximity of the lighthouse to the waterline following Hurricanes Ian and Irene. The red arrow points to the lighthouse.

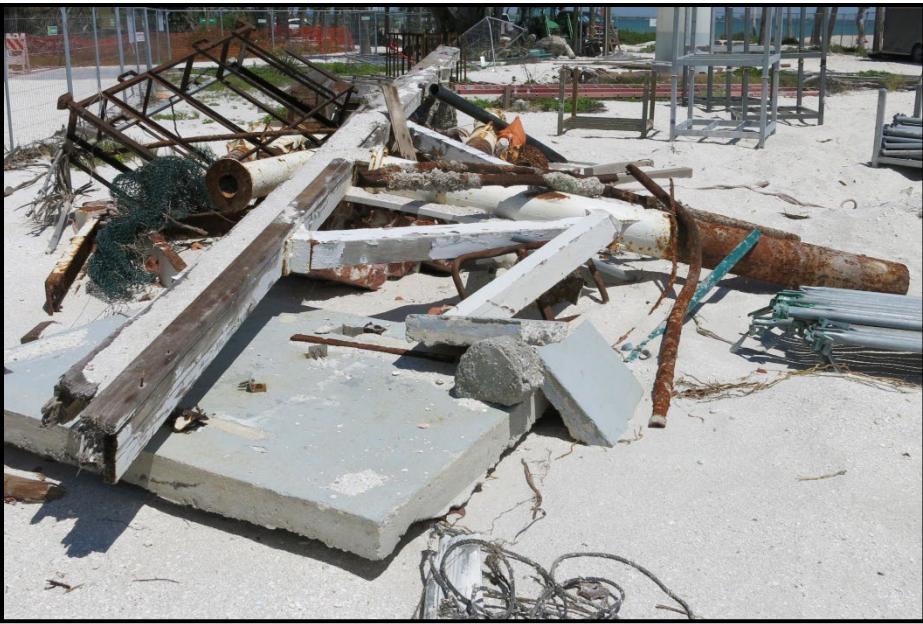
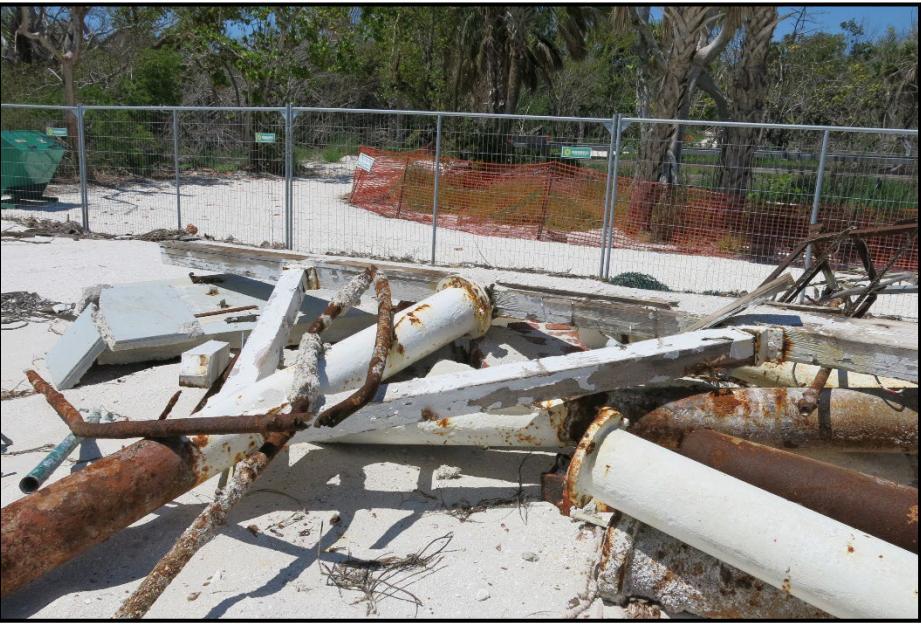
The dimensions of the wooden girder are approximately 36' x 11 ¼" x 5 ½". The ends of the girder were broken during the destruction of the Keepers' Quarters and as such, the original length of the girder is unknown. The elements of Group No. 1 are an example of the structural building techniques utilized to construct the Keepers' Quarters in the coastal environment. Supporting buildings and structures found at light stations were typically raised three to five feet above the ground by continuous brick or brick pier foundations due to the proximity to water (Johnston and Jones 2002). The Keepers' Quarters at the Sanibel Lighthouse, however, rested on cylindrical metal support posts rather than brick. The wooden girder with intact metal support post and wooden brackets also utilized mortise and tenon joints; however, the joints were destroyed during the destruction of the Keepers' Quarters. An example of relatively intact mortise and tenon joints and a description of the construction method can be found in Group No. 3 below.

Photo 14. Wooden girder with intact metal support post and wooden brackets.

Photo 15. Wooden girder with intact metal support post and wooden brackets.

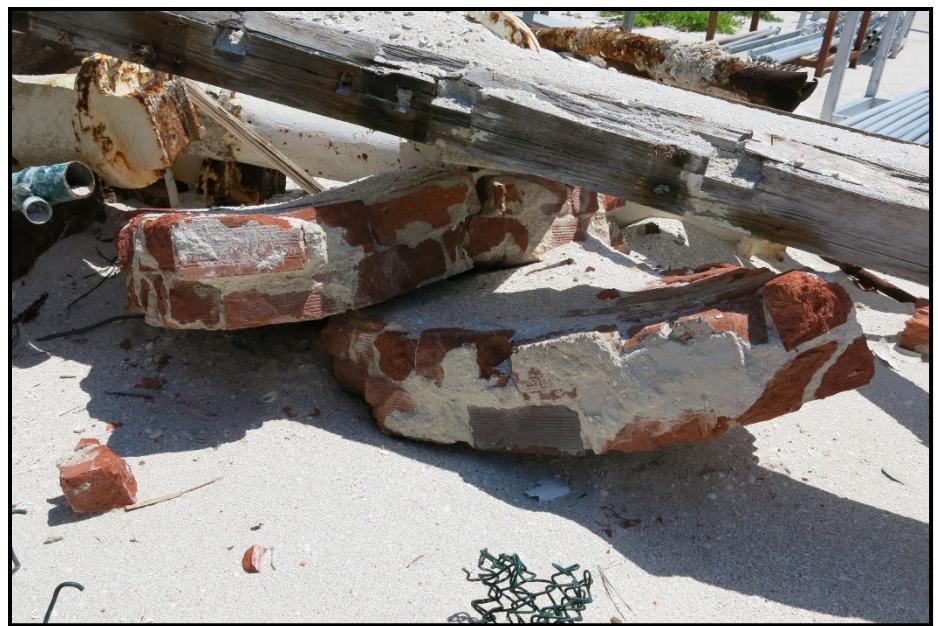
Group No. 2 – Intact segments of the brick cistern (Photo 16)

Two curved segments of the former brick cistern were identified within the debris pile. These segments are constructed with striated brick laid two wythes thick and held together with mortar. In addition to keepers' quarters, oil houses, and privies, light stations were commonly equipped with cisterns to hold freshwater, which was not easily accessible in remote, seaside locations such as Sanibel Island (Johnston and Jones 2002). This cistern was located behind the Keepers' Quarters at the Sanibel Lighthouse (**Photo 16**).

Photo 16. Two curved segments of the cistern walls comprised of striated face brick constructed two wythes thick with intact mortar.

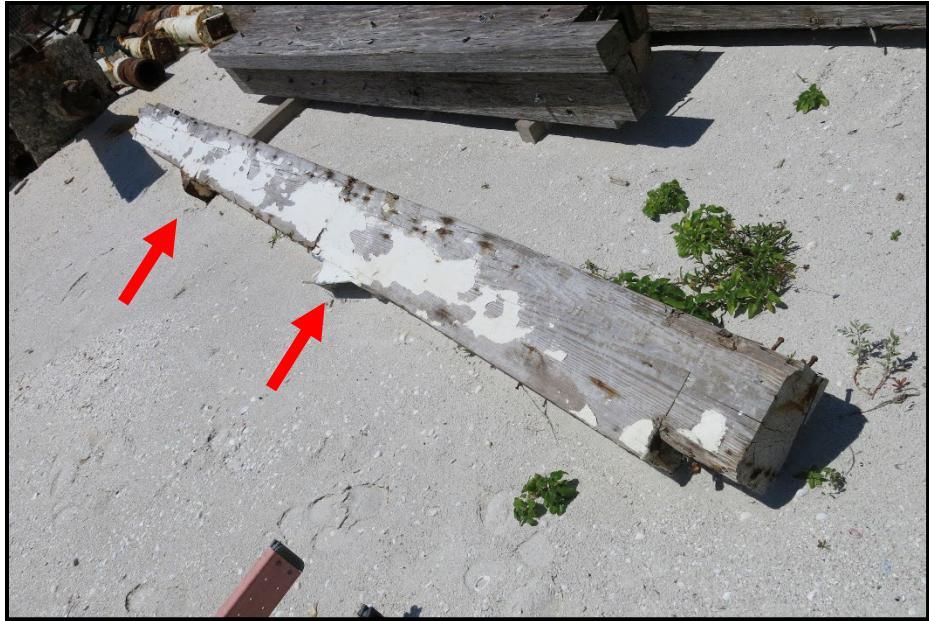
The dimensions of the wooden girder are approximately 16' x $11 \frac{7}{8}$ " x $5 \frac{3}{4}$ ". One end of the girder (left end in **Photo 17**) was broken during the destruction of the Keepers' Quarters and as such, the original length of the girder is unknown. The elements of Group No. 3 are an example of the structural building techniques utilized to construct the Keepers' Quarters in the coastal environment, similar to Group No. 1; however, this wooden girder has intact mortises with wooden pegs and remnants of wooden tenons within the joints. In addition, two metal brackets are on the bottom side of the girder and likely would have attached to wooden structural brackets similar to those found on Group No. 1.

Photo 18. The wooden girder with intact mortise and tenon joints. The right end of the girder is intact; however, the left end of the girder in the photograph has been broken. The red arrows indicate the location of the metal brackets on the bottom of the girder. The mortise and tenon joints are located along the top of the girder.

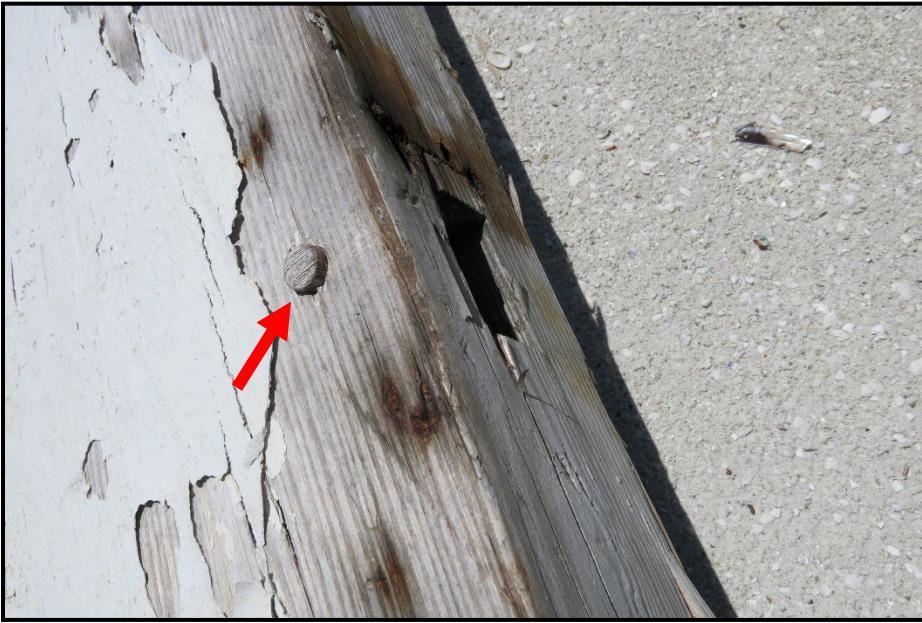
Photo 19. An example of a partially intact mortise and tenon joint along the top of the wooden girder. The rectangular cavity to the right is the mortise and the cylindrical wooden peg to secure the tenon (broken off) is visible to the left and indicated by the red arrow.

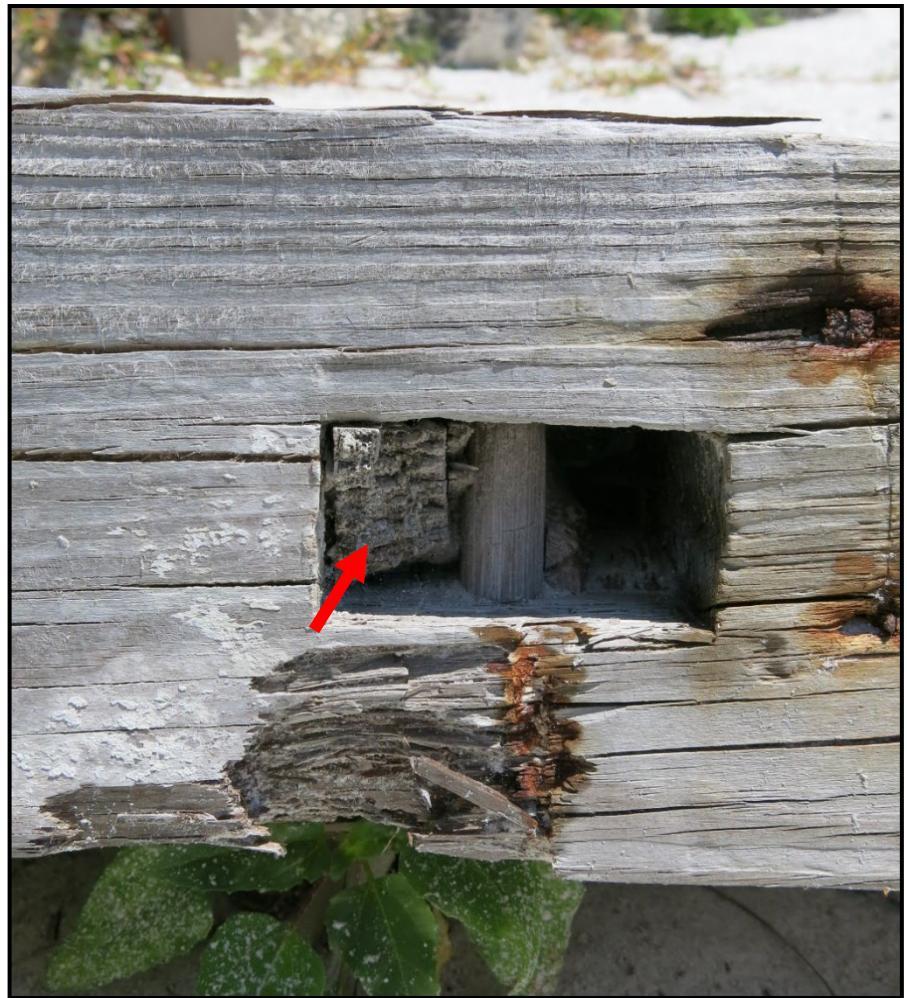
Photo 20. An example of a partially intact mortise and tenon joint along the top of the wooden girder. The rectangular cavity is the mortise, and it is bisected by a cylindrical wooden peg to secure the tenon. The tenon has broken off and only a small segment remains within the mortise (red arrow).

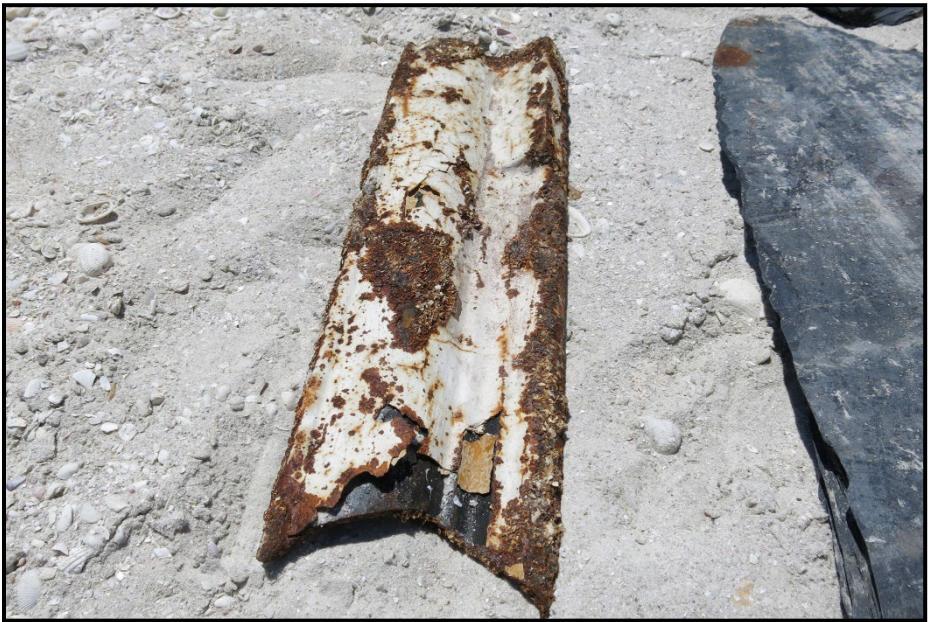
Photo 22. The larger of the two segments of the cast iron coal burning fireplace surround. Note the decorative curved detailing and the paint is peeling, revealing the bare cast iron.

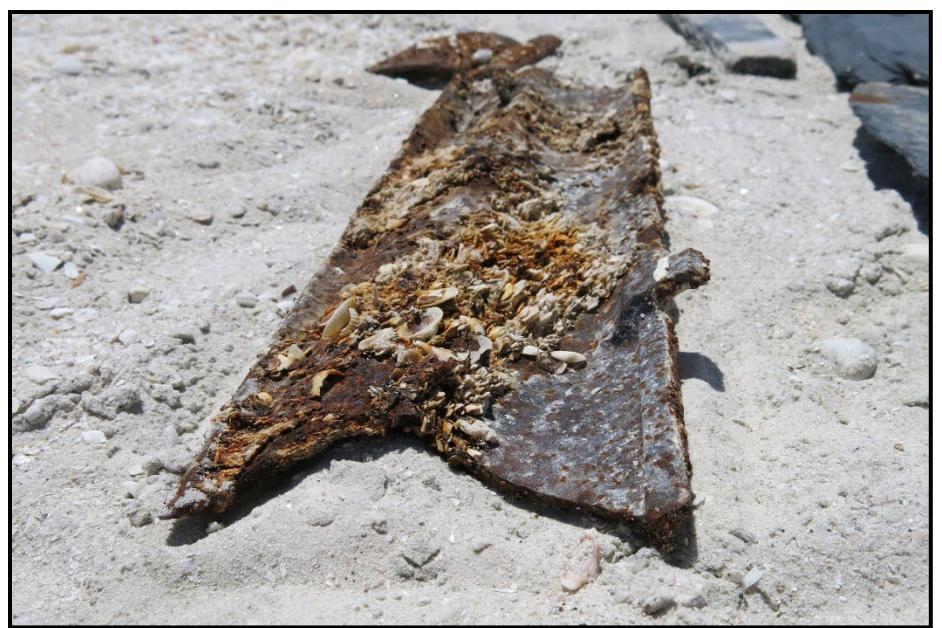
Photo 23. The back side of the cast iron coal burning fireplace surround segment. This side of the segment is covered with shell and rust due to marine exposure.

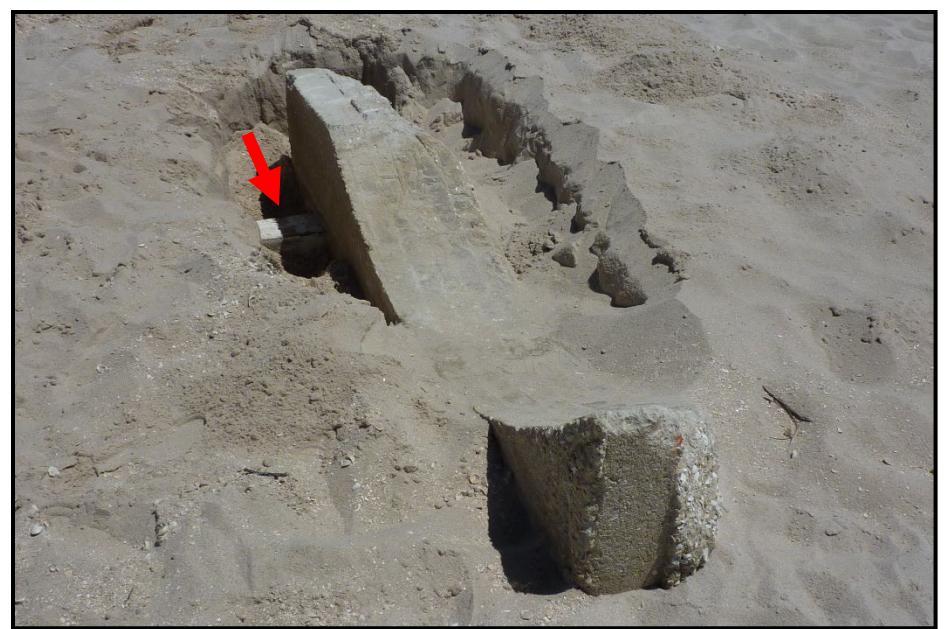
During the site visit, ACI architectural historians and archaeologists identified a large concrete object protruding from the sand southwest of the lighthouse. The object was partially excavated and photographed. A review of historic photographs, as well as photographs taken pre-Hurricane Ian, revealed that the object was a concrete footer that had been displaced by stormwaters. A segment of the squared wooden foundational support post was visible beneath the sand as indicated in **Photo 28** by the red arrow. The footer was rotated onto its side, exposing the curved edge which was poured immediately adjacent to the brick cistern behind the Keepers' Quarters (**Photo 29**). As such, the concrete footer follows a partial contour of the brick cistern and is lined with impressions of the brick. The dimensions of the contour, combined with the extant segments of the cistern walls in Group No. 2, may provide an estimate of the cistern's original dimensions.

Photo 28. The concrete footer, partially buried beneath the sand and rotated onto its side by stormwaters. The squared wooden support post for which the footer was laid is indicated by the red arrow. The curved surface is lined with brick impressions from the brick cistern.

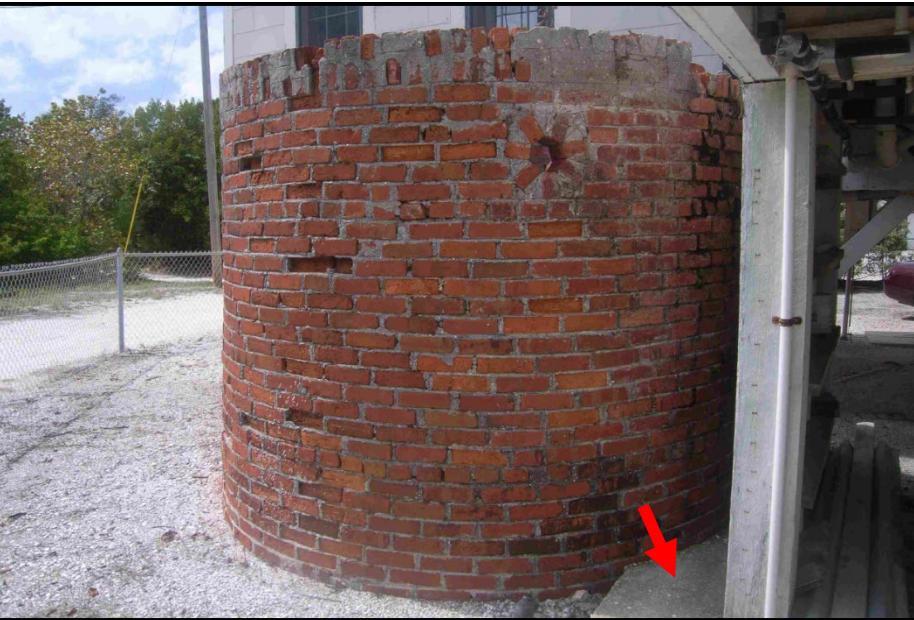
Photo 29. The concrete footer and attached squared wooden support post were installed immediately adjacent to the brick cistern to the rear of the Keepers' Quarters as seen in the above photograph (FMSF n.d.). As such, the concrete footer follows the contour of the cistern, and the curved edge is lined with visible brick impressions.

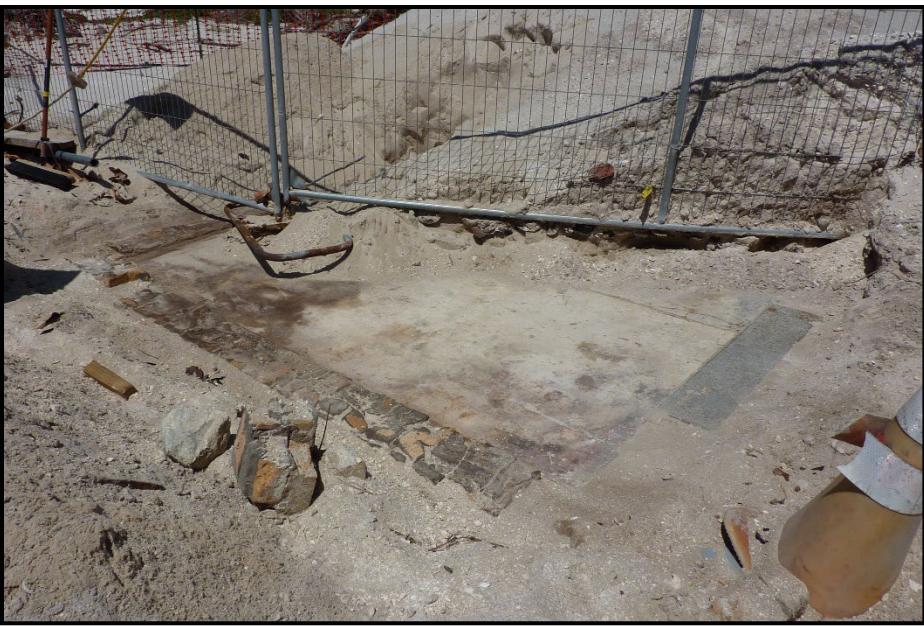
Photo 31. The partially excavated oil house foundation, looking northeast.

- a) Small debris/artifacts could be put on display within the museum setting.
 - b) The excavation and maintenance of the oil house foundation as a part of the historic property would provide visitors the opportunity to visualize where supporting buildings and structures were located prior to Hurricane Ian.

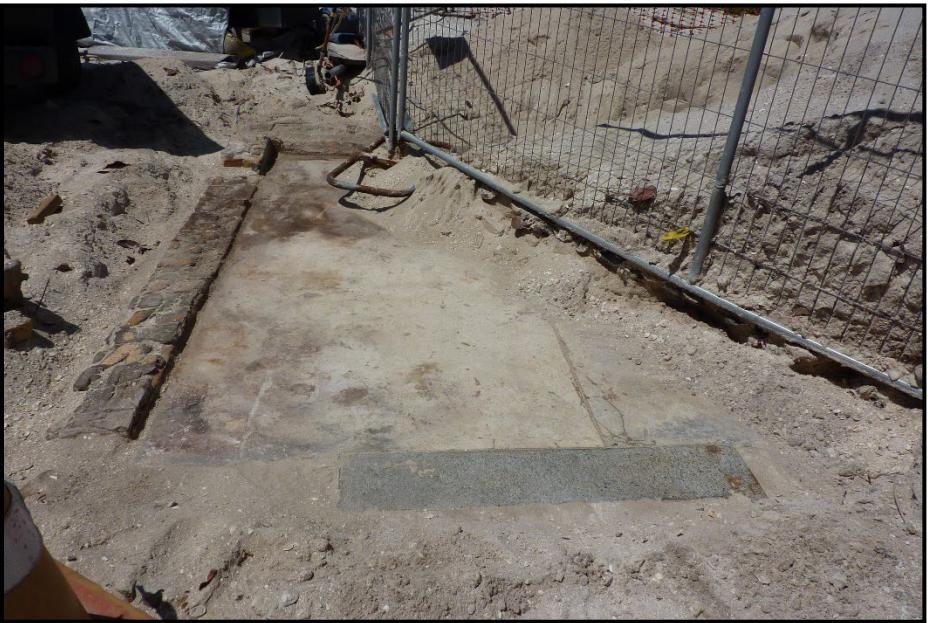
Photo 32. The partially excavated oil house foundation, looking north. Note the granite threshold in the foreground, concrete slab, and continuous brick wall around the perimeter of the slab. The right corner and wall are covered with piled sand being utilized for erosion control/shore reconstruction and the temporary metal fencing separating Lighthouse Beach Park from the construction site.
