# **Surface Water Management Master Plan Update Following Hurricane Ian (2022)**

**September 2025**

**JOHNSON**  
ENGINEERING

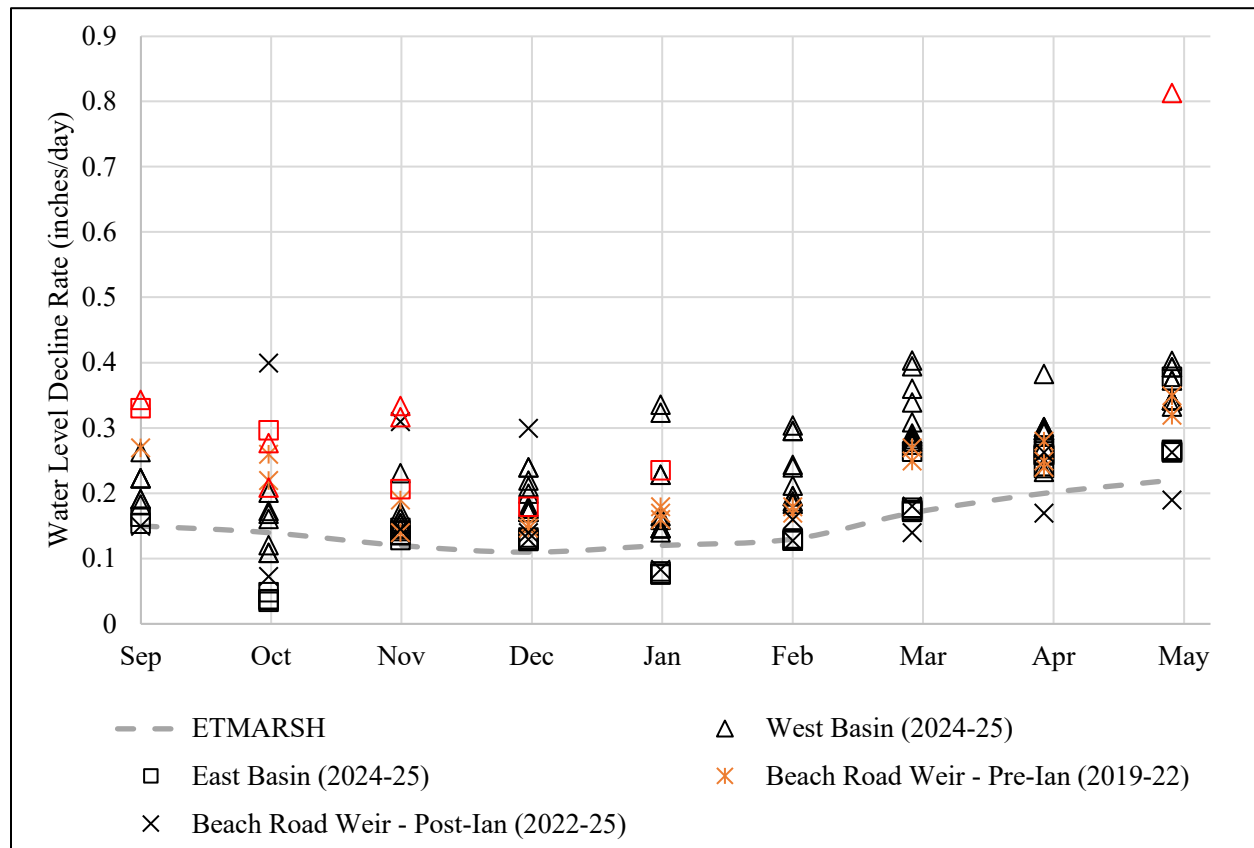
**Figure 8. Water level decline rates at locations across Sanibel. Red markers indicate unusually high post-Ian decline rates.**

JE-2127's rapid rate of decline is likely due to its location in a retention area that is adjacent to a drainage ditch. The rapid recovery seen is caused by percolation into the adjacent ditch. Another unusual observation was the rapid decline rate found at sensor JE-2123 in May 2025. Something abnormal is clearly occurring since the sensor drops below the low tide elevation and below all other sensors in the west basin, at twice the rate of other sensors in the basin.

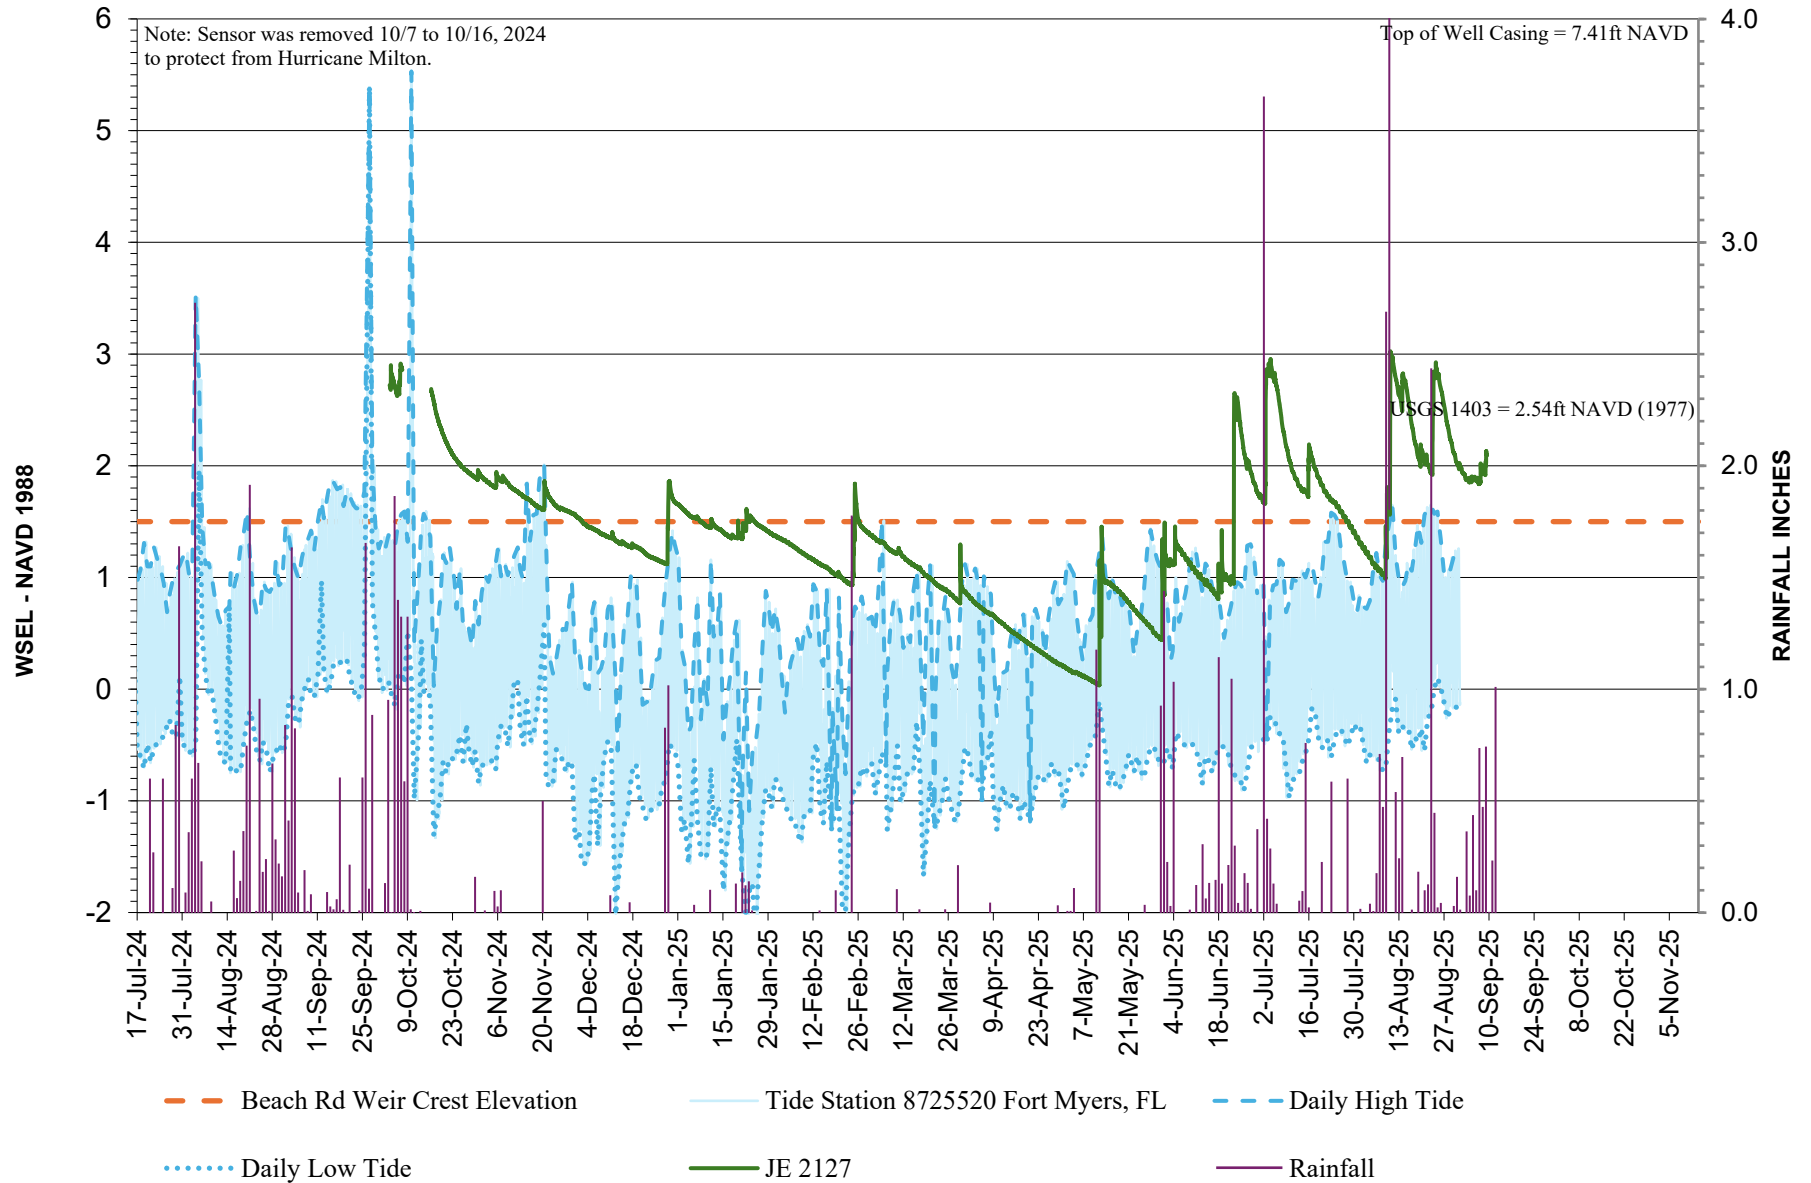
# Sanibel Island Water Levels- JE 2127

**Casa Ybel Road and Algiers Lane:** Monitoring well location JE 2127 in Basin 5a was installed in a roadside retention swale that is immediately adjacent to a drainage ditch. The graph for this well shows that it has a slower rate of recovery than the downstream monitoring locations, which is typical for retention areas. Analyzing the graph during a dry period in October shows it recovering at a rate of 7.2 inches per week, far exceeding the recovery rates observed at JE 2124 and JE 2125. Removing the estimated evapotranspiration rate of 1.4 inches per week shows that the retention area recovered at a rate of 5.8 inches per week. This indicates that when retention areas on Sanibel are adjacent to a receiving ditch, the areas are recovering (and functioning) as designed following rainfall events.

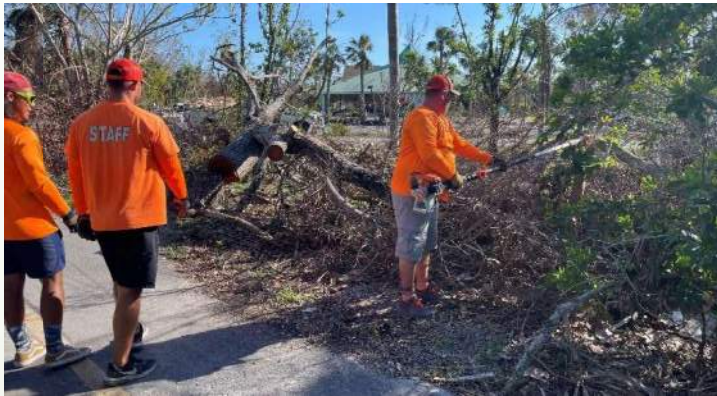
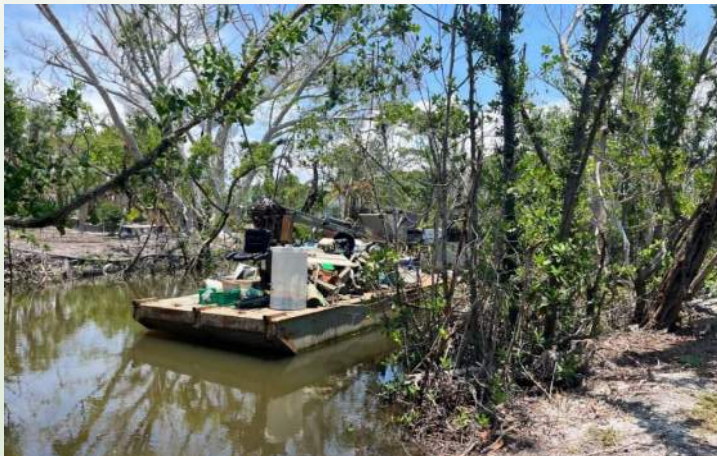
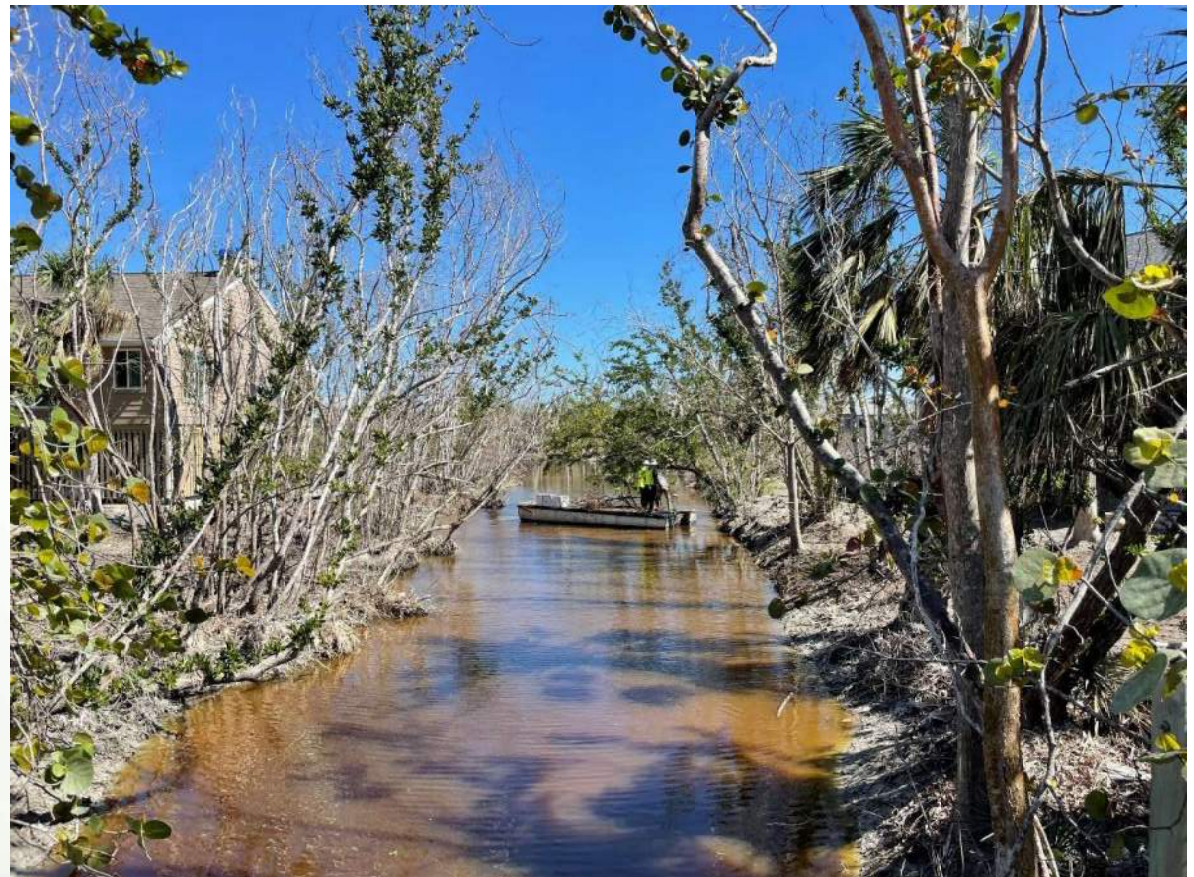
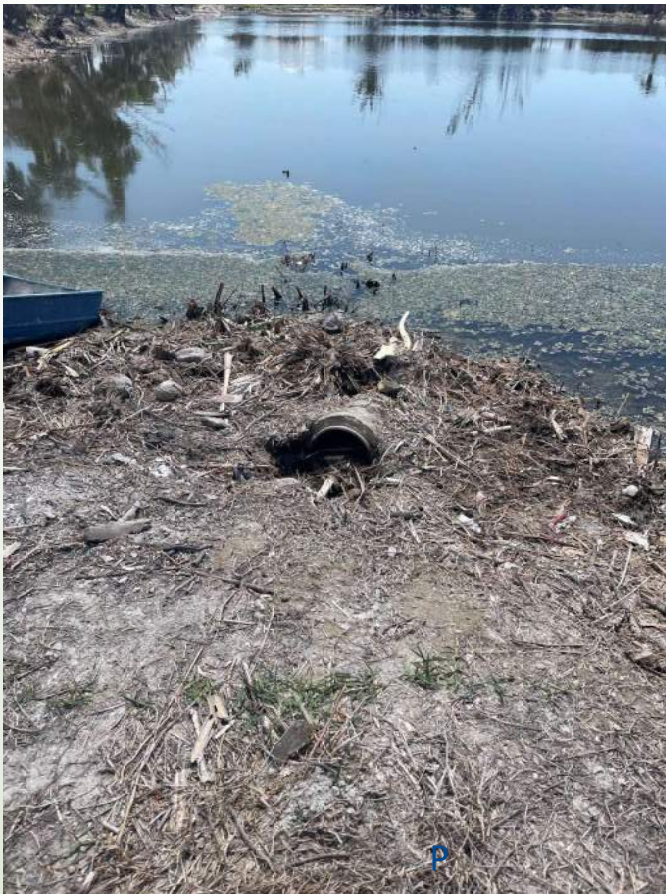
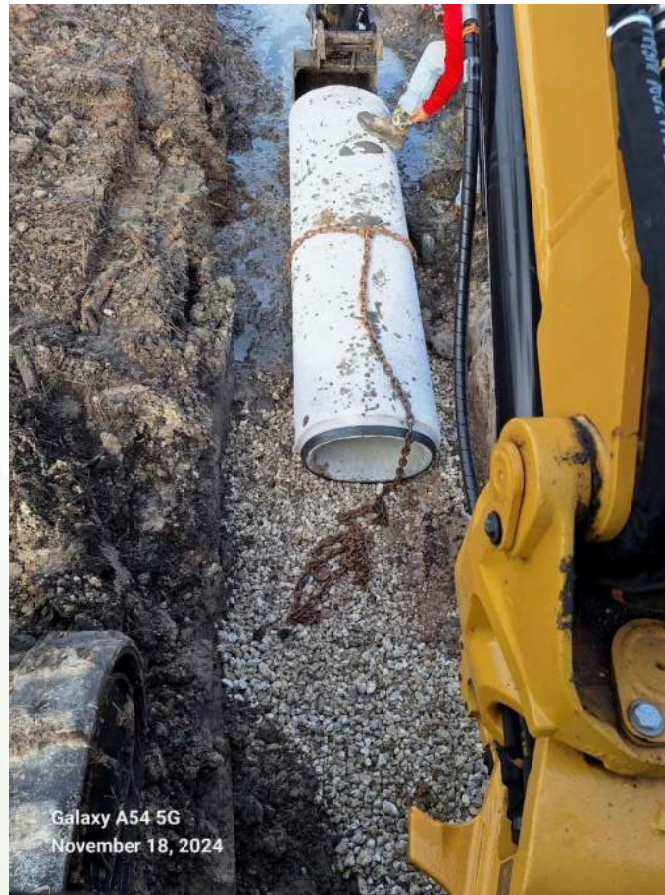
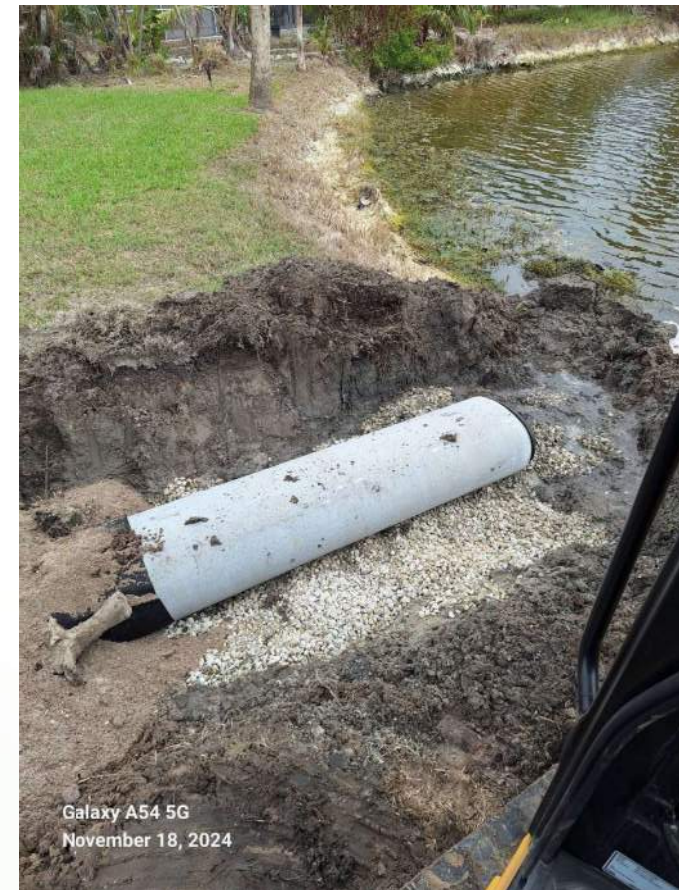
# IMMEDIATE REPAIRS POST-STORM

- Cleaned major blockages & urgent issues.
- Annual Sanibel River clearing.

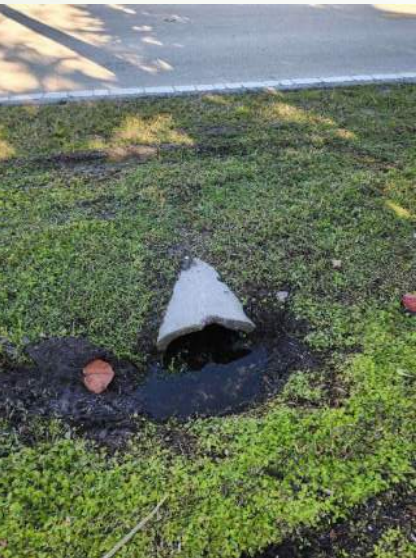
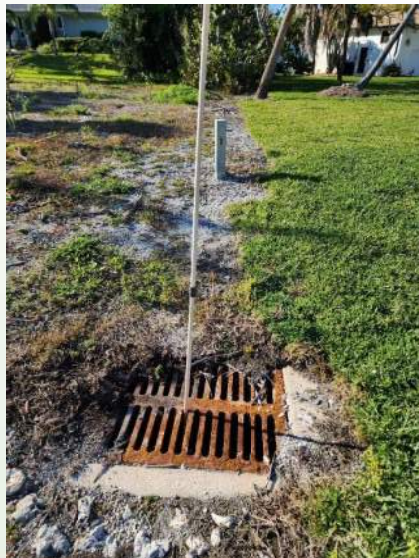
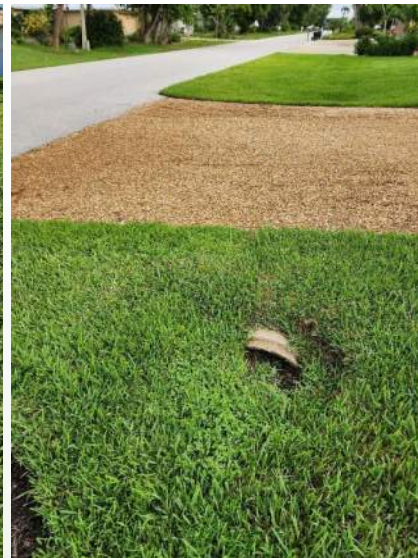
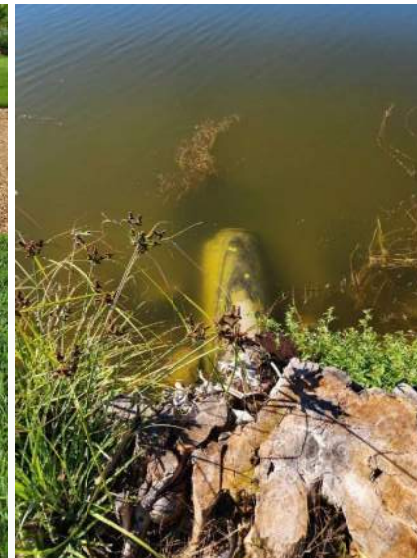
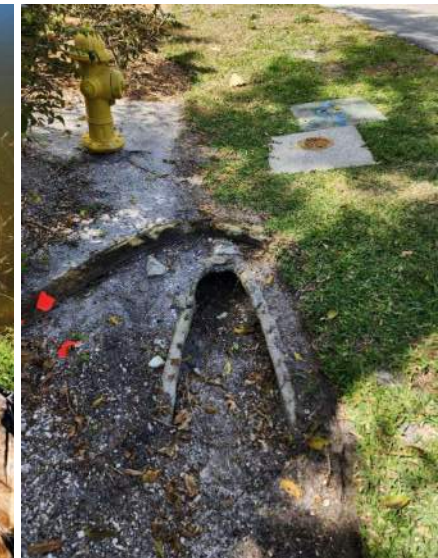
## 4. Surface Water Management Damage Repairs – Upcoming Repairs

- Visual Inspection of Newly Added Features
- Additional 658 Culvert Cleanings & 4.6 Miles of Swales - Scheduled May 2025
