Surface Water Management Master Plan Update Following Hurricane Ian (2022)

July 2025

JOHNSON
ENGINEERING

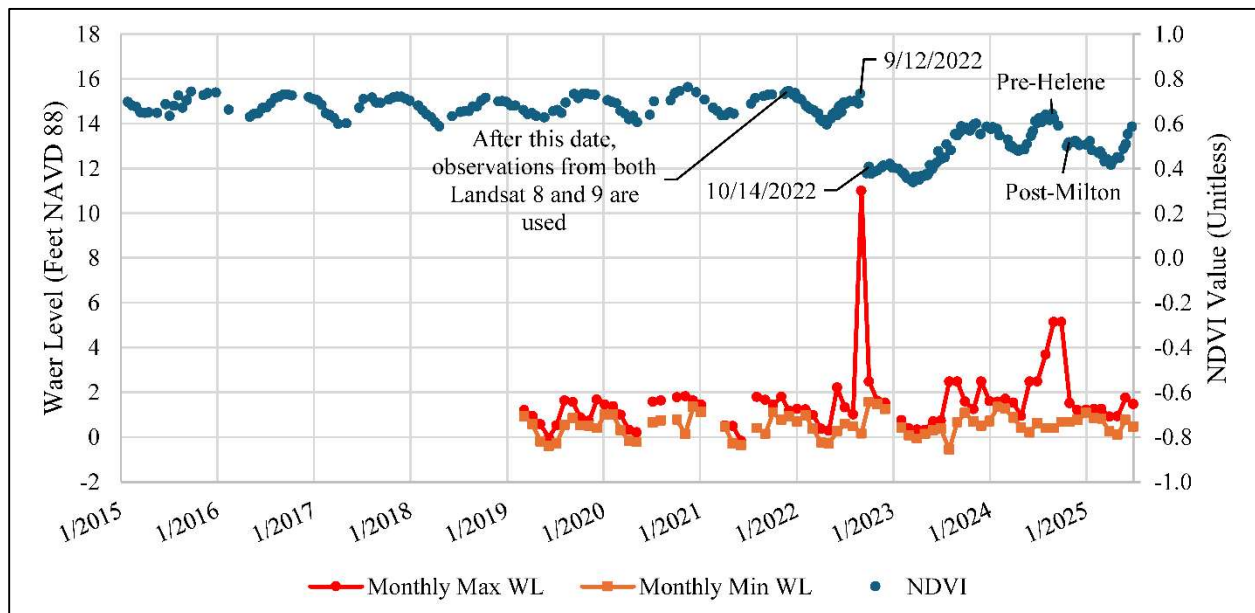
Figure 5. Water levels recorded at Beach Road Weir and average Landsat 8 and 9 NDVI values for the interior freshwater basins.

The initial drop in NDVI just after Ian was about 0.3. Throughout 2023 and 2024, NDVI increased and began to approach pre-Ian levels, but this recovery was reversed in the aftermath of hurricanes Helene and Milton in the fall of 2024. However, the island's vegetation is quickly rebounding and appears to be on track to return to pre-Helene levels this year.

Figure 5 also includes the monthly minimum and maximum water levels recorded at Beach Road Weir by SCCF from 2019 to 2025. Note that the maximum surge level from Hurricane Ian was not recorded since the monitoring equipment was inundated, so an estimate obtained from USGS was used. Water levels before and after Ian were compared to explore any changes which the hurricane may have caused. In the initial months following Hurricane Ian, there seemed to be a slight increase in the minimum water levels at Beach Road, but by the beginning of 2023, stages were similar to those experienced in 2019-2022. However, during the dry seasons of 2024 and 2025, water levels stayed unusually high, likely because of reduced ET. With only six years of data, it is difficult to determine how unusual these observations are. However, it seems likely that surface water levels will recover fully as vegetation recovers.

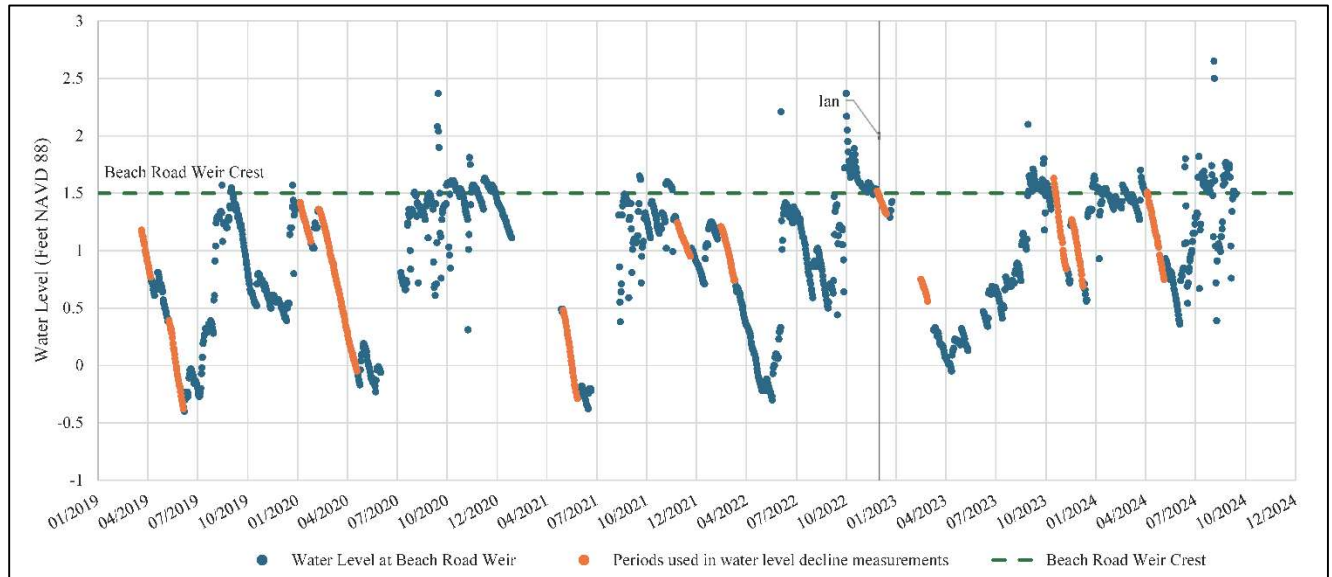
Figure 6. Water level and water level decline periods at Beach Road Weir.

Water level data upstream of Beach Road Weir was obtained from SCCF and analyzed to see if there were changes in the rate of decline of surface water levels during periods without rainfall and without weir gate operation. Under these conditions, the rate of decline should be roughly equivalent to ET. The expectation was that following Hurricane Ian and the associated vegetation changes, water levels would decline more slowly than before the hurricane due to a reduction in ET caused by plant stress. However, this did not appear to be the case. If anything, water levels have been declining more quickly a year after the hurricane. **Figure 6** shows water levels and the periods of decline analyzed for the period of record. It is unclear what may have caused the increased decline rates in late 2023 and early 2024, but two theories present themselves. One possibility is that, with less vegetation present in the wetlands, the water surface is exposed to more direct sunlight, causing an increase in evaporation rates which make up for the reduced evapotranspiration rates. The other possibility is that vegetative regrowth caused increased water uptake by plants.

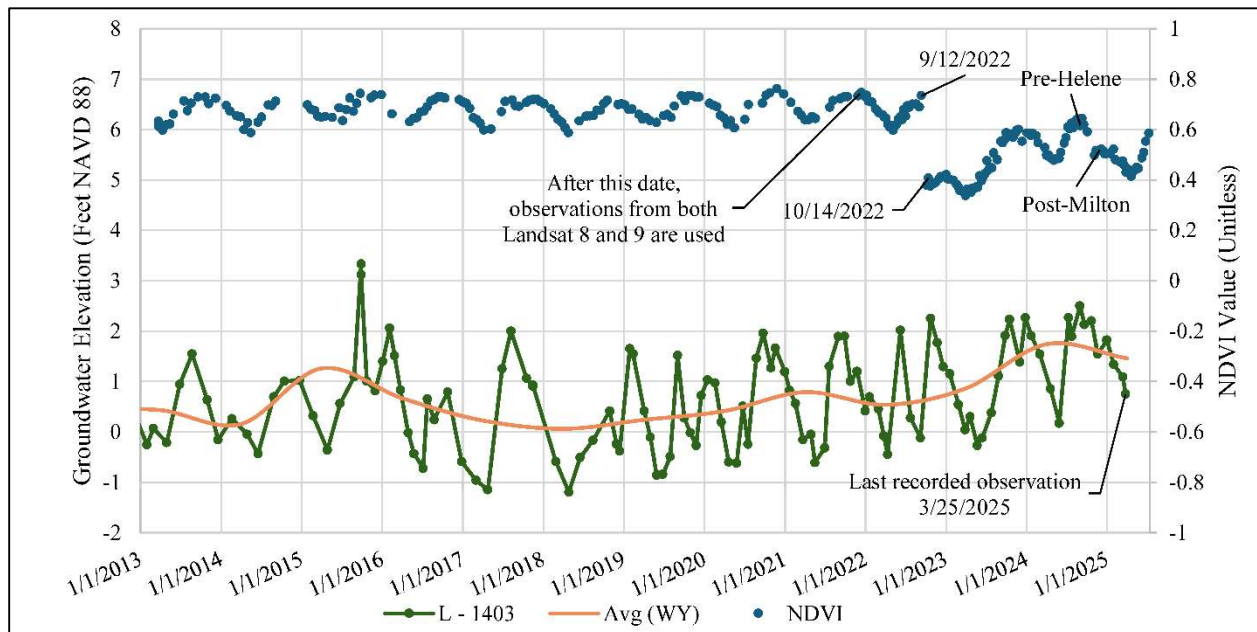
Figure 8. Water level at USGS well L-1403 and calculated Landsat 8 and 9 NDVI values for the interior basins over time. Orange line indicates average level per water year (WY).

As previously stated, it makes sense that loss of vegetation would cause water levels to recede more slowly following rainfall events. This was generally not found to be the case for surface water across the island, but an investigation into minimum groundwater levels illustrates the changes experienced by many Sanibel residents. Although minimum groundwater levels have been

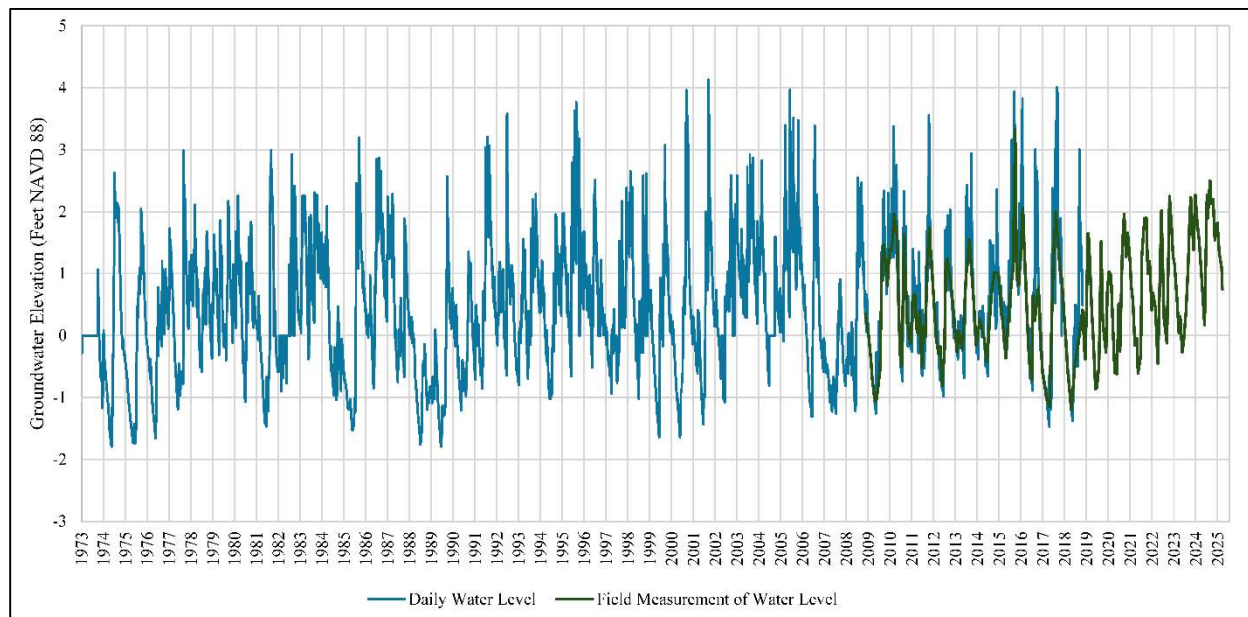
Figure 9. Long-term groundwater elevation at USGS well L-1403.

trending upwards since 2017 (see **Table 3**), they are well within the historical range for the period of record (see **Figure 9**). It seems unlikely that Hurricane Ian has caused any permanent changes to water levels on the island.

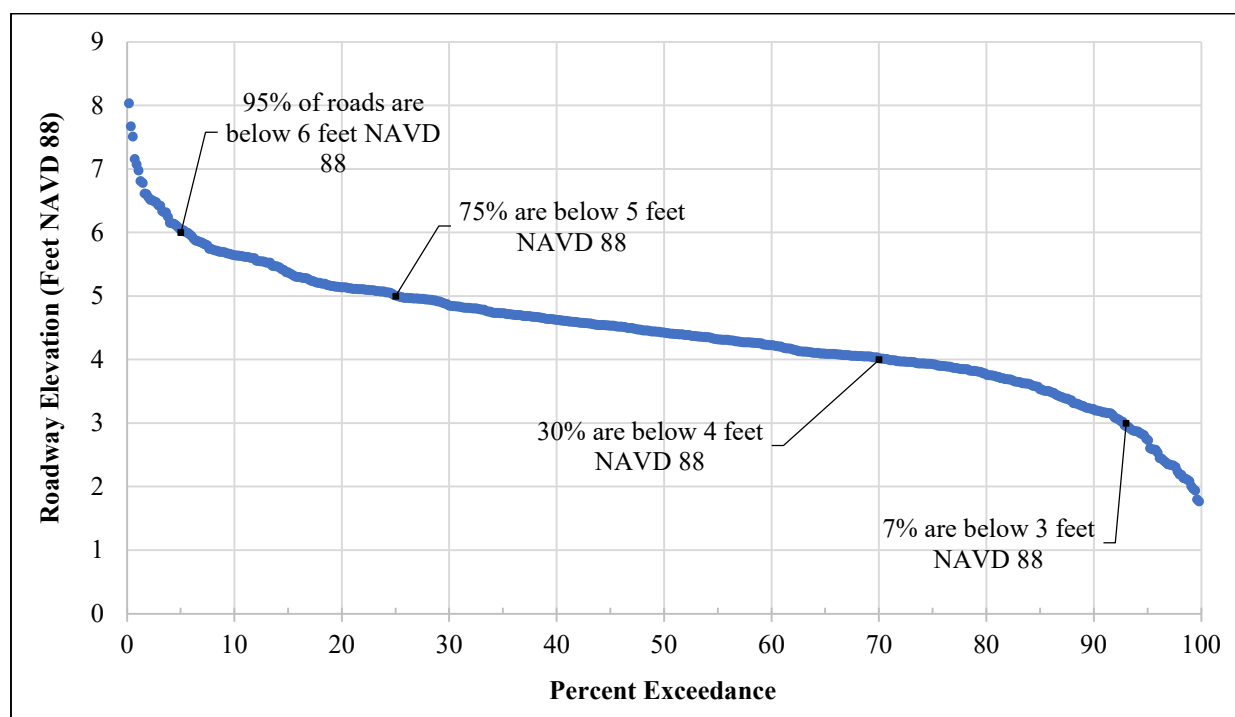
Figure 12. Percent exceedance curve for public roadways on Sanibel.

A citywide analysis of 62 miles of public roadway elevations was performed using Light Detection and Ranging (LiDAR) data from Lee County, collected in 2018-19. To generate a representative grid of the island, points were placed at road intersections and at regular intervals when no intersections were present. Mapping of the points and their corresponding elevations is provided in **Exhibit 4**. A percent exceedance curve is provided in **Figure 12** which shows the percentage of roadways below certain elevations.

Intermediate scenario, or 2.3 feet NAVD 88 in the Intermediate-High scenario. It is recommended that the minimum roadway elevation for Sanibel be at least 4.3 feet NAVD 88, which would require raising approximately 50% of the City's roadways. This provides protection of roadways from road base failure for the next 45 years in the Intermediate-High sea level rise scenario.

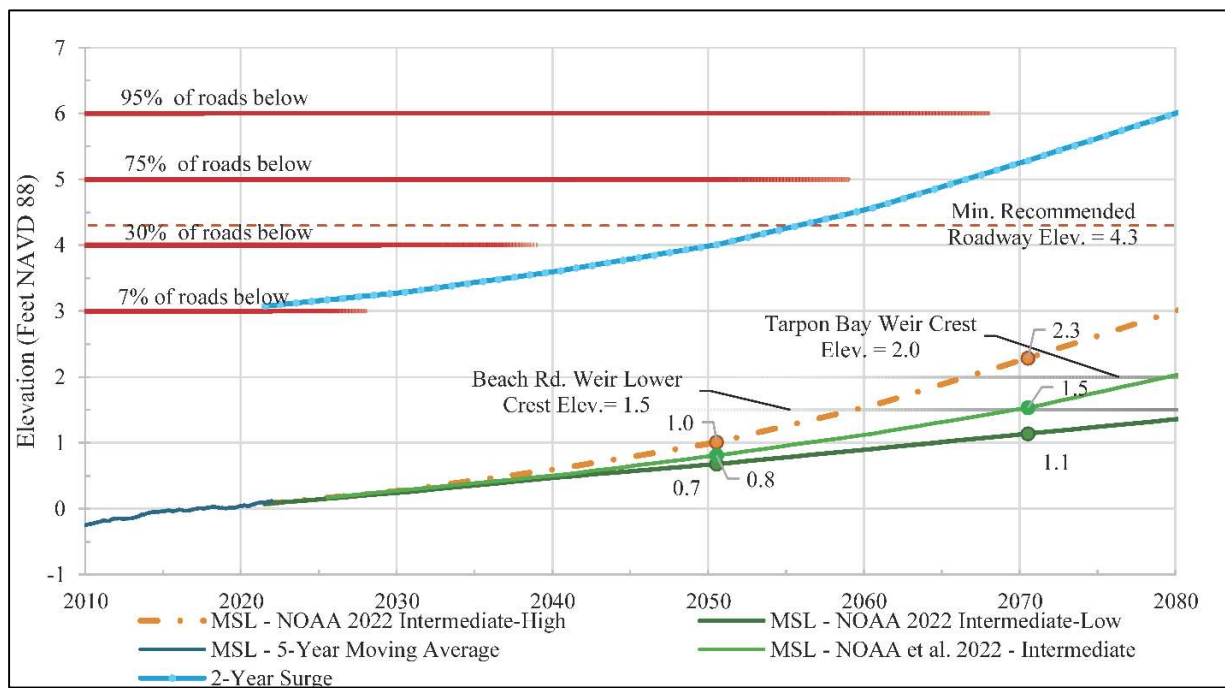
Figure 14. Sea level rise projections for Sanibel, with road elevations and weir crest elevations provided for reference.

elevation is layered onto the Intermediate-High curve. Critical elevations such as island-wide road crown elevations and the crest elevations of Tarpon Bay Weir and Beach Road Weir are also provided for reference. These are shown as horizontal lines to indicate the water level at which the infrastructure will become inundated.

This report recommends a minimum road elevation of 4.3 feet NAVD 88 for all new roadways, which would protect them from sea level rise until mean sea level reaches 2.3 feet NAVD 88 (assuming a target buffer of 2 feet to protect the road base material). Levels above 2.3 feet NAVD 88 would lead to a waterlogged base. Having a waterlogged base for long periods will damage a road, and total inundation can have an adverse effect on pavement life. Based on the Intermediate-High curve, significant road base failure is expected for up to 7% of public roadways by 2050, which is approximately 4.3 miles. Increasing the minimum existing roads to elevation 4.3 feet NAVD 88 (approximately 50% of roads, or 31 miles) will provide increased protection until 2070. By 2080, however, up to 75% of roads are anticipated to experience road base failure if the Intermediate-High curve becomes reality. When looking at the Intermediate-Low curve, approximately 20% of roadways (12.4 miles) are vulnerable to road base failure by 2080 and all would be protected if raised to a minimum elevation of 4.3 feet NAVD 88.

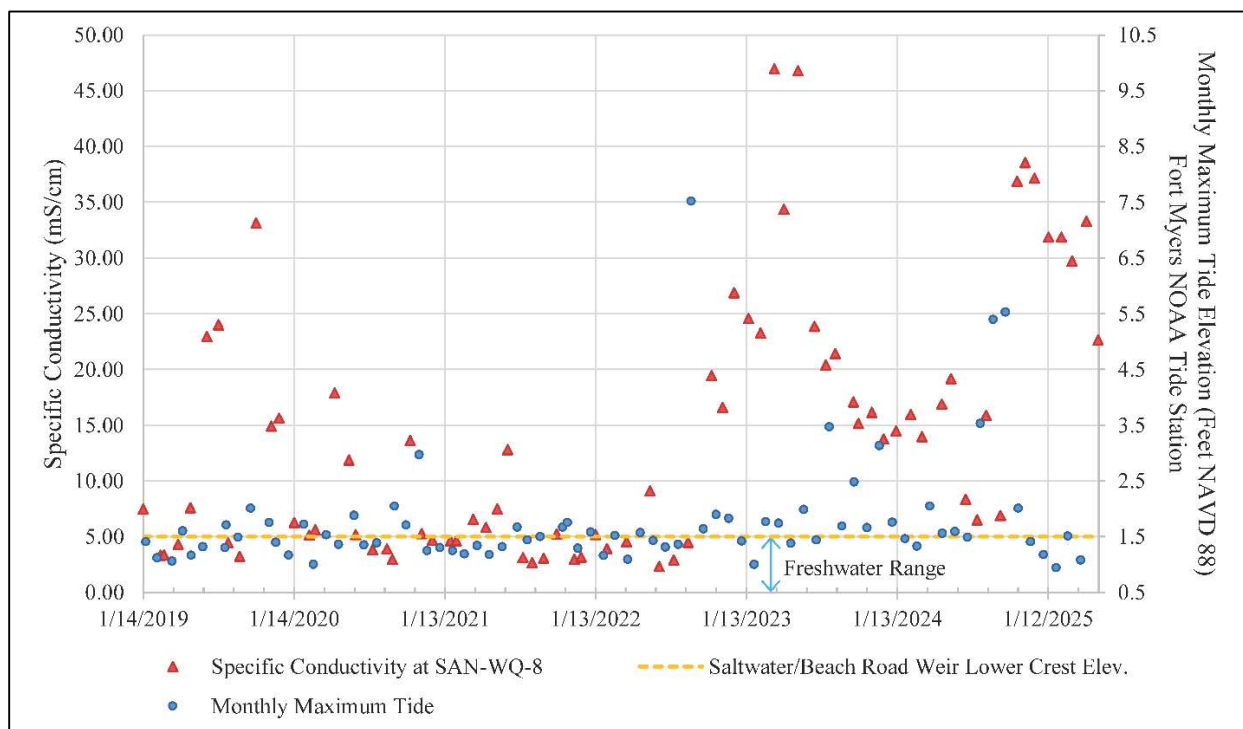
Figure 15. Specific conductivity upstream of Beach Road Weir and maximum monthly tide levels.

Of the measurements taken at Beach Road Weir from January 2019 to August 2022, most were above 5 mS/cm. This clearly indicates that saltwater is regularly entering the east basin, though it has historically been flushed out by rainwater shortly thereafter. The spikes in conductivity before 2022 appear to be correlated with tides which were higher than the fixed weir crest but lower than the top of the flap gate, so it is possible that the backflow prevention flap allows some saltwater backflow. Measurements taken in the west basin show a similar pattern.

In late September of 2022, Hurricane Ian made landfall in Southwest Florida, bringing massive storm surge with it. Conductivity was not measured in September 2022 due to Ian, and the monthly maximum tide shown on the graph (about 7.6 feet NAVD 88, recorded in Fort Myers) is much lower than the actual water level near the weir on Sanibel. USGS mapping on Sanibel shows the surge elevations ranged from 8 to 13 feet NAVD 88. Since 2022, conductivity levels have been consistently above pre-hurricane levels, showing how long it takes the interior basins to recover to freshwater conditions following such a surge event. There is ongoing flushing of the basin due to rainfall but also likely ongoing saltwater intrusion due to subsequent high tides and storm events. After over two years, the basins still have not recovered to the freshwater range and it remains to be seen how long it will take to return. Recommendations for improvements to the weirs and weir policy are provided in the next section.

Weir Flap Gate Modifications: Beach Road Weir already has a 1-foot flap gate which is designed to protect against saltwater intrusion from sea levels up to 2.5 feet NAVD 88. Based on historical specific conductivity data, it is possible that this flap is not sealed properly. If this is true, it is recommended that the flap gate be repaired. The City may also want to consider installing a larger flap gate to prevent saltwater intrusion at stages above 2.5 feet NAVD 88.
