## Impacts of Erosion along Southern Blind Pass Beach

Photos of erosion occurring along southern Blind Pass Beach 2/2/15 to 2/10/15

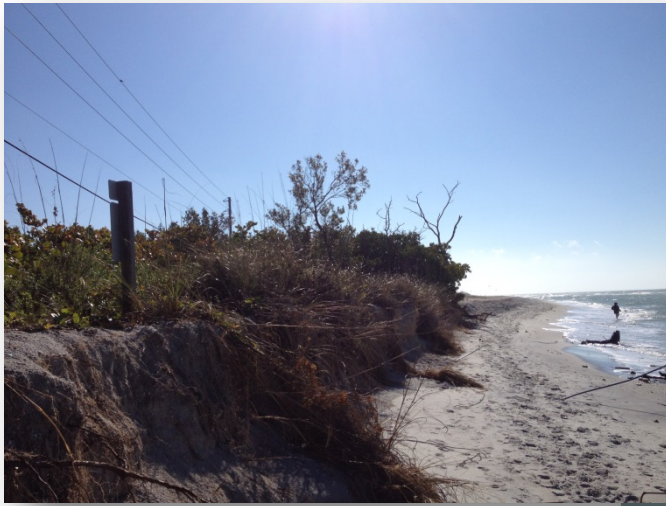
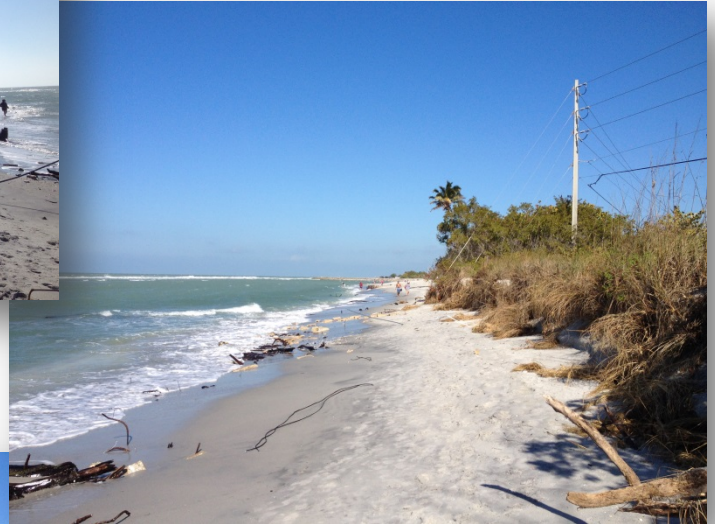
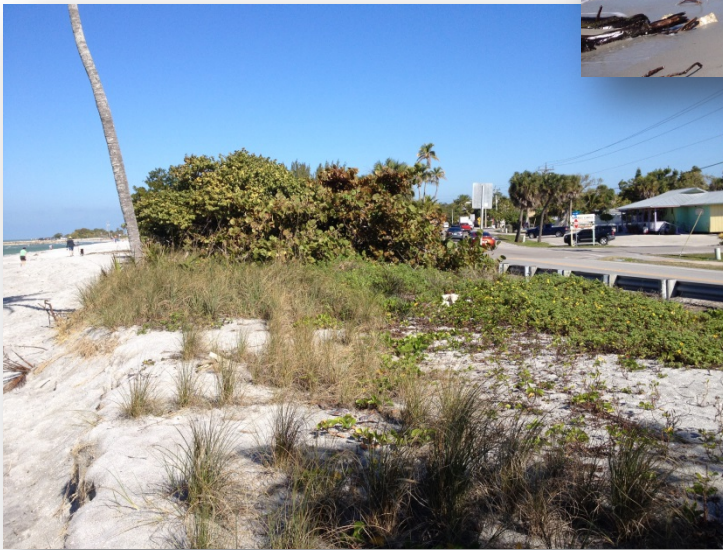
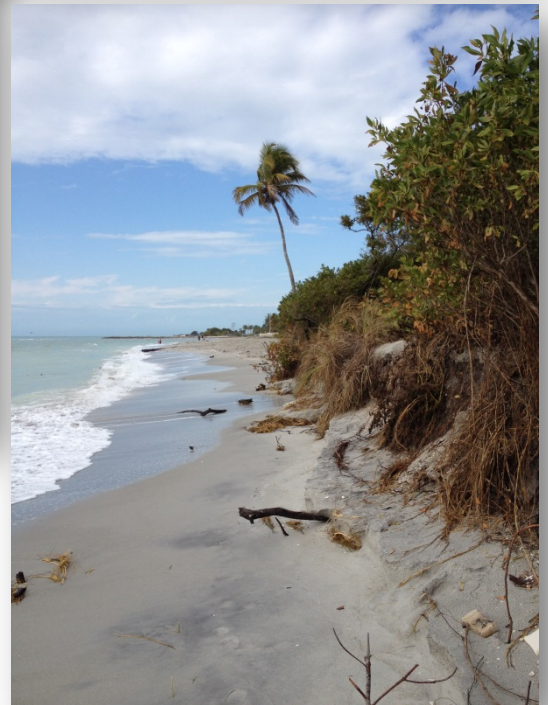
Southern Blind Pass Beach on Sanibel Island is currently experiencing significant erosion as a result of recent cold fronts. The erosion has resulted in a 4 to 5-foot escarpment along the beach dune within 30 feet of Sanibel-Captiva Road, the only evacuation route from northern Sanibel and Captiva Island. The City of Sanibel is very concerned about the timing of this erosion and as a precaution is obtaining a Field Permit from the FDEP to place up to 600 cubic yards of sand above the mean high water line in the event the erosion continues.
