# JN Ding Darling National Wildlife Refuge Road Safety Audit

**Prepared by:**  
**Federal Highway Administration**  
**Eastern Federal Lands Highway Division**

**Prepared for:**  
**U.S. Fish and Wildlife Service**  
**National Wildlife Refuge System**  
**January 2023**

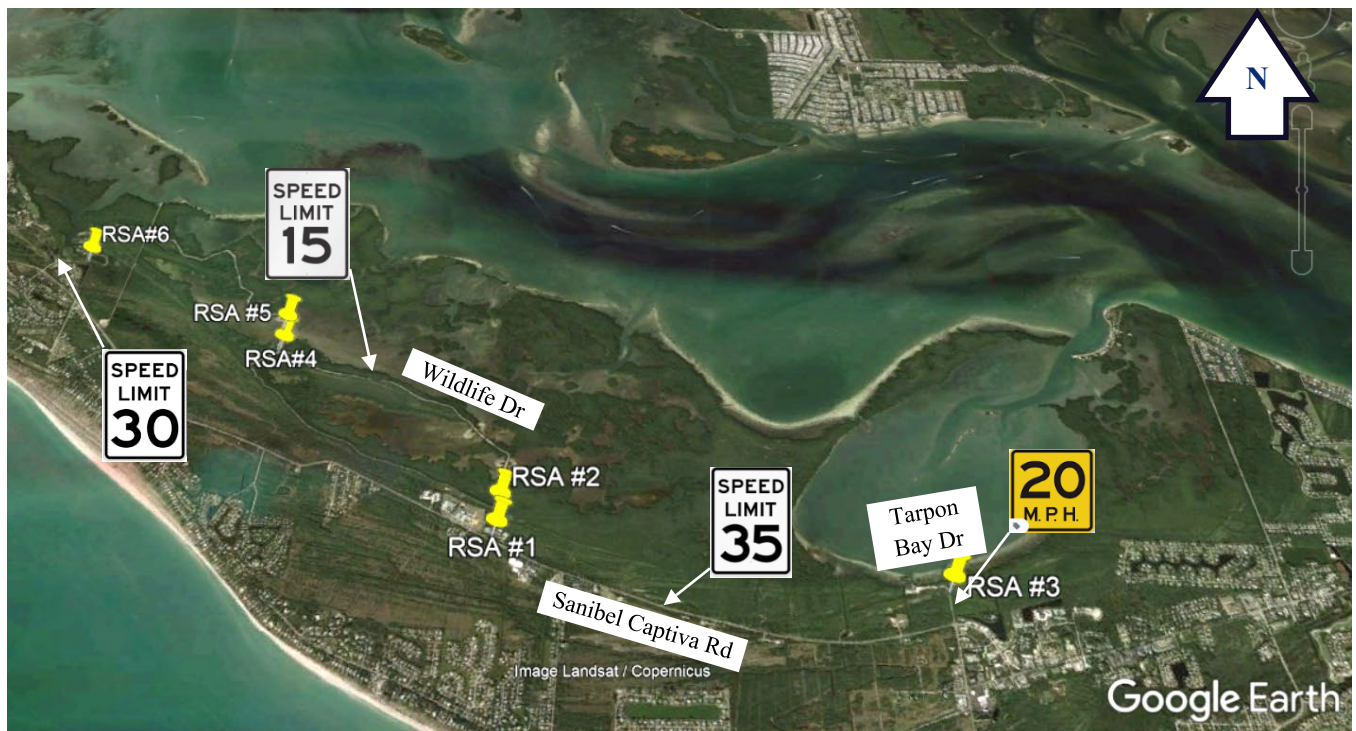
Figure 3. Speed Limit Data Map

The following describes the existing conditions of the site. This section begins with the refuge entrance and parking area. Then it is followed by the existing conditions along Wildlife Drive and Tarpon Bay Drive. The road that fronts the Refuge is Sanibel Captiva Road. This road has an Average Annual Daily Traffic (AADT) of 21,000 Vehicles Per Day (VPD) reported from 2021<sup>1</sup>. The speed limit on Sanibel Captiva Road is 35 mph, while for Wildlife Drive is 15 mph. The section of Wildlife Drive, between the Refuge exit and Sanibel Captiva Road, is posted at 30 mph. Tarpon Bay Drive has an advisory speed limit of 20 mph as shown in Figure 3.

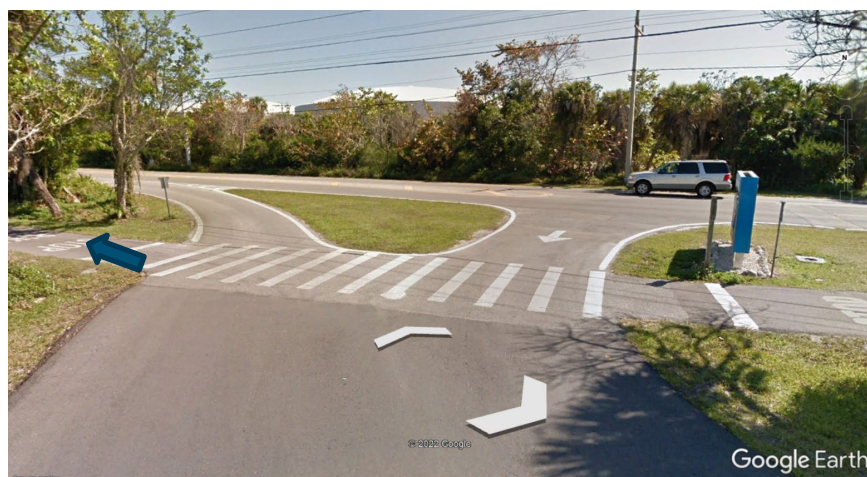
*Figure 4. Refuge Entrance Facing Towards Sanibel Captiva Road*

The road that intersects with the main entrance is Sanibel Captiva Road. The main entrance has two driveways as shown in Figure 4. Immediately upon entering, visitors cross an 8 feet wide shared-use path, then the driveway starts narrowing from 25 feet wide to approximately 12 feet wide. Some visitors park their vehicles at the entrance to take a picture in front of the JN Ding Darling Refuge sign, which causes congestion and potentially hinders visibility of the path users. At this location the shared-use path is signed with stop signs, however cyclists seldom stop. Also, vegetation blocks the view of the vehicles entering from westbound making it challenging for path users and drivers to see each other, see Figure 5. The Refuge reports that this location experiences many near misses between cyclists and motorists.

The refuge entrance currently experiences near misses between vehicles entering the Refuge and users of the multi-use path. Based on the field inspection, visibility is limited from trees and shrubbery obstructing the view. Vegetation clearing is recommended to improve sight distance to allow both motorists and path users to see each other when approaching the crossing at the entrance. Another reason may be that the path users do not anticipate that they have to stop as it is currently signed. After looking into Sanibel Crosswalk Policy, the current signage does not seem to meet the city policy or Florida Statute 316. The policy states: “Motorists are to stop for pedestrians within a crosswalk at an intersection that has a traffic control signal or at any crosswalk where signage so indicates [FS 316.(7)(a), (b)] Elsewhere, motorists shall yield the right-of-way to pedestrians in crosswalks [FS316.(7)(c)]. On sidewalks and within crosswalks, state law grants cyclists the same rights and duties of pedestrians. A person propelling a vehicle by human power upon and along a sidewalk, or across a roadway upon and along a crosswalk, has all the rights and duties applicable to a pedestrian under the same circumstances [FS 316.2065(9)].<sup>8</sup>” With this in mind, it is recommended that the Refuge consider removing the stop signage from the crosswalk for the trail users at the Refuge entrance. It is also recommended that trail crossing warning signs be installed for drivers to be aware of the shared-use path users.

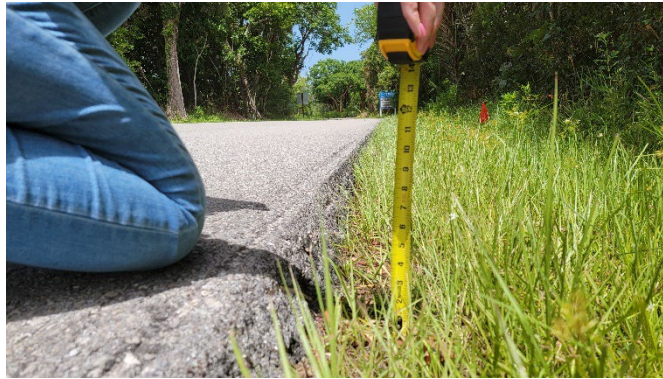
*Figure 6. Refuge Entrance and Edge of Pavement Drop Off*

The entrance driveway narrows towards the parking area. The narrow road width does not allow for a vehicle and a cyclist to travel side by side. There is a noticeable road edge drop off that ranges from 5 to 8 inches high, which can be hazardous to both vehicles and non-motorized travelers. Cyclists are very likely to encounter the drop off if they choose to move out of the way to allow for a vehicle to pass. The Refuge states there have been multiple incidents of cyclists veering off the pavement and needing first aid or medical attention.

Other challenges encountered at the Refuge entrance are narrow road segments and pavement edge drop offs. At the narrowest sections, there is limited distance for both vehicles and cyclists, leaving cyclists to oftentimes move over to allow vehicles to pass. This maneuver is risky near steep pavement edge drop offs. One option could be to widen the road and use a safety edge. This would allow cyclists some more space to maneuver and provide a chamfered pavement edge that makes it easier to travel back to the roadway as shown in Figure 21. The downside is that there is limited space to widen the road due to wetlands and this option might move the edge rutting farther out. Another option would be to install concrete pavers. This option helps maintain the natural characteristic of the roadside with its lattice or grid-like shape that allows vegetation to grow in the openings, while maintaining a stable roadside. The downside of this option is that the pavers are not recommended for high traffic areas. Figure 22 is a detail drawing of the concrete pavers installed on sections of Blue Ridge Parkway to address road edge rutting.

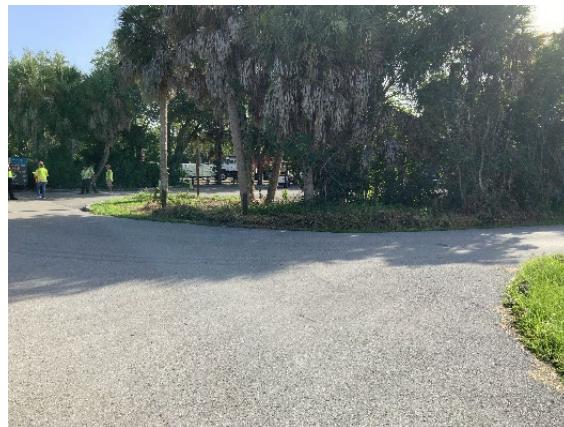
*Figure 7. Refuge Visitor Parking Lot Entrance*

As drivers come into the parking area, some do not anticipate the entrance of the parking area to be shortly after they turn right, due to vegetation obstructing the line of sight, see Figure 7. This and the tight radius cause some vehicles to have to back up so that they can make the turn. This is especially true of larger vehicles such as buses and RVs. When this happens, it causes a backup while the driver makes their adjustments.

The refuge parking currently has separate parking sections for visitors and employees. The current layout has a separate gravel driveway for Refuge employees, then further down the driveway there is a paved access for visitors. Some visitors have difficulty making the turn into the parking area, and as a result, create a bottleneck behind them as they try to adjust their vehicles. One solution is to reconfigure the layout of the parking lot. The following conceptual drawing shows both visitors and employees accessing the parking area using what is now the employee parking lot entrance. Employee parking will be signed, and other spots will be open to visitors. The reconfiguration provides wider turning radii for buses and RVs while maintaining a similar amount of parking spaces. The reconfigured parking area will stay one way like the existing one, so it is recommended that arrow pavement markings be installed to complement the one-way signage. The remaining portion of the entrance can be left for an additional egress or filled in with turf. It is also recommended that the existing signage be replaced with retroreflective signs at a minimum height of 7 feet since there are parking and pedestrian movements.

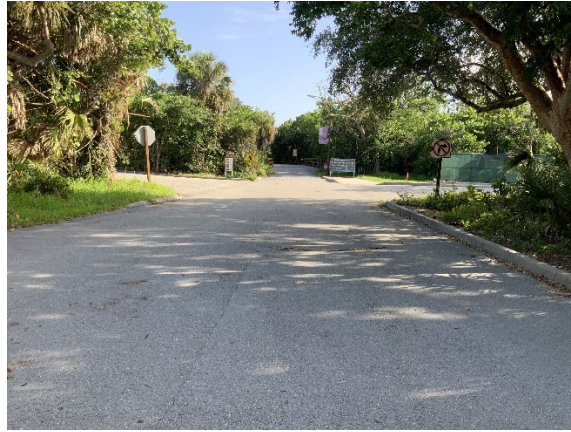
*Figure 8. Refuge Visitor Parking Lot Exit Area*

The parking exit area is frequently full of cyclists or groups of visitors trying to figure out which direction to go, causing backups for motorists trying to enter the refuge or exit the parking lot.

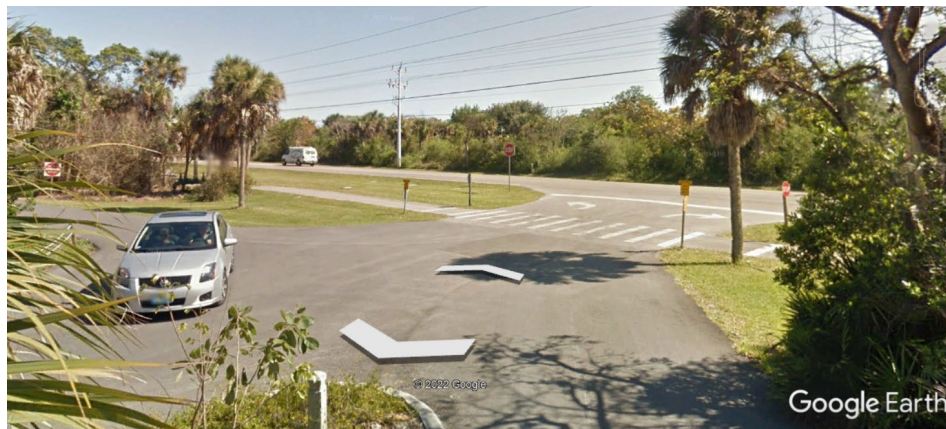
*Figure 9. Vegetation Obstructing View of Shared-Use Path at Parking Area Exit*

The parking area exit towards Sanibel Captiva Road is egress only, however despite the “Do Not Enter” signage, it is oftentimes mistakenly used as an entrance. The actual entrance is located approximately 625 feet east as depicted in Figure 11. One observation is during our visit, when using Google Maps for directions to the site, the Google Maps directions directed us to the exit. If this happens for other mapping app users, this could explain why some people are entering at the exit. This causes conflicts between exiting vehicles and trail goers using the shared-use path. Like the entrance, this location experiences near misses between vehicles and cyclists. The shared-use path crossing is stop controlled for its users, however path users tend not to not obey the signs. In addition, vehicles exiting at this location may have difficulty seeing eastbound path users due to the vegetation obstructing the view, as shown in Figures 9 and 10.

On multiple occasions, the Refuge experiences tourists entering through the parking area exit. When this happens, the risk of near misses with vehicles and multi-use path users increases. The exit is currently signed with “Wrong Way” signs on both sides. It is recommended that an “Exit Only” sign be placed facing both sides of traffic along Sanibel Captiva Road. Another option could be to install a non-traversable channelizing island. The channelizing island would provide a visual and physical deterrent to

vehicles from entering, see Figure 24. This location also experiences near misses from exiting vehicles with trail users that do not stop as it currently is signed. Taking the Sanibel crosswalk policy into consideration, it is recommended that the stop signage be removed from this location and trail crossing warning signage be installed.

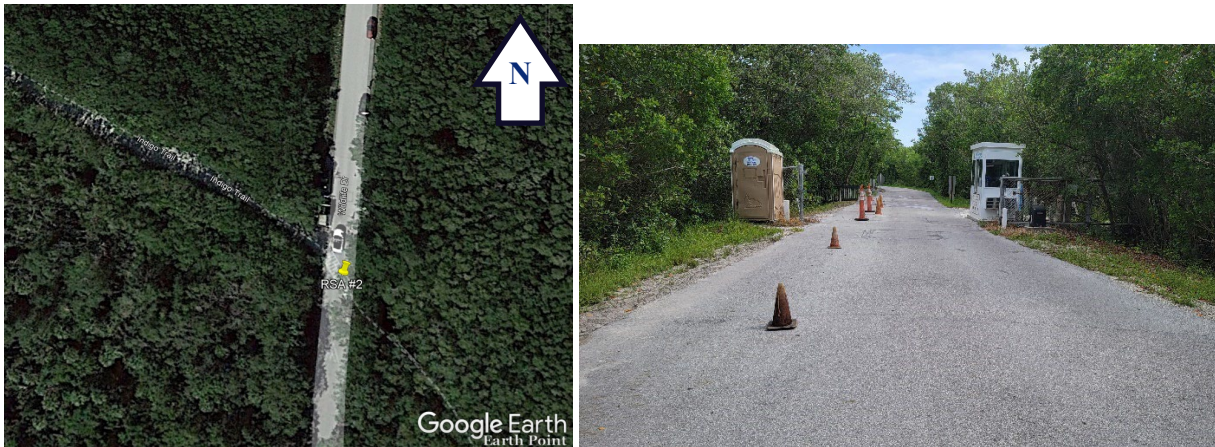
Figure 12. Map View and Picture Facing South of Wildlife Drive at Fee Booth

The fee booth is used for all visitors, motorists, cyclists, and pedestrians, to pay the entrance fee and to get directions on how to travel through the Refuge. The Refuge reports that oftentimes cyclists skip the line and move ahead of the waiting cars. Feedback from cyclists indicate that they move ahead of the line to avoid exhaust smoke, or they had not realized that cyclists are also required to pay an entrance fee. Traffic cones have been placed to keep non-vehicular guests from bypassing the booth. There is also a trail crossing in front of the fee booth that sometimes creates a bottleneck. It also lacks the area to get around the primary line of traffic, either for law enforcement to pass through, or for vehicles to turn

around upon discovering the fee requirement, as shown in Figure 12. In one instance it was reported enforcement was stuck at the booth for 20 minutes before being able to head towards the crash location. During peak season, fee booth queues can go as far back as the entrance. Previously the fee booth used to be at the entrance but was moved to this location to contain the queues inside the Refuge.

Currently the fee booth location experiences conflicts between all visitor types. There also seems to be confusion to visitors if the fee is applicable to all or only to motorists. One way to alleviate the conflict between cyclists and vehicles is by separating them. This can be achieved by providing a pay area for cyclists and hikers that is apart from vehicles. This will address the cyclists' concerns about breathing in vehicle exhaust while waiting in line. To keep the vehicle line and the cyclists and hikers fee lines moving, it is recommended to either install another toll booth on the right side of the road as depicted in Figure 25, or to have non-motorized visitors pay using a kiosk as depicted in Figure 26. It is also recommended that delineators separate the traffic, and that the crosswalk pavement markings be realigned for either option. This way it aligns towards the fee booth with another crosswalk going from fee booth to Indigo Trail to provide a visual indication for hikers and cyclists that they must also pay a fee.

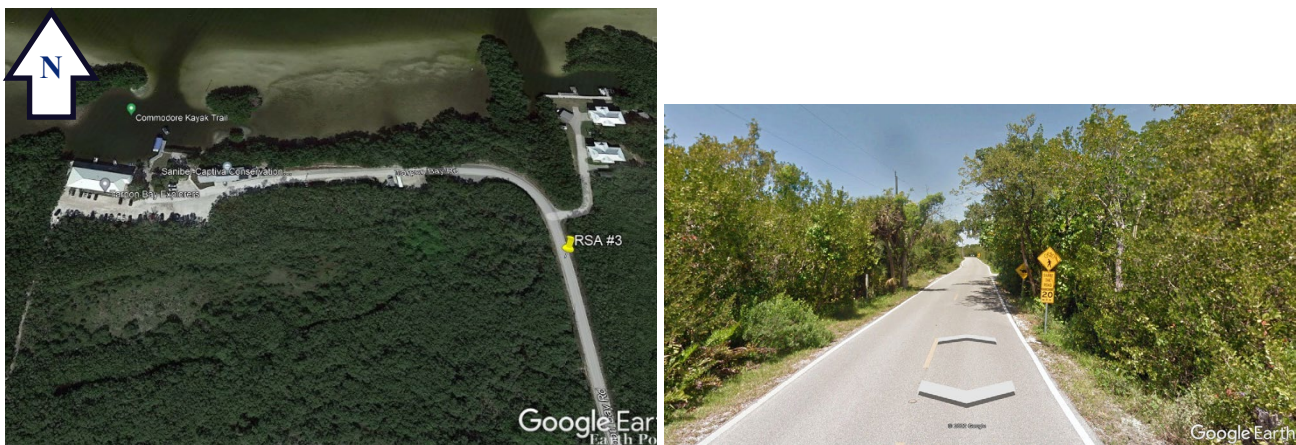
Figure 13. Map and Street View of Tarpon Bay Road Near Rental Concession

The next priority location is Tarpon Bay Road which is located north of Sanibel Captiva Road and leads up to Tarpon Bay Explorers. The road is a narrow two-way roadway with no shoulder and in some locations with steep shoulder drop offs. There is a 90-degree curve coming into Tarpon Bay Explorers causing a visibility issue. Tarpon Bay Explorers is a concessionaire and marine lab that offers bike rentals. This makes the road very popular for renters who are sharing the road with vehicles until they reach the shared-use path. Motorists sometimes come speeding around the sharp corner contributing to near misses between vehicles and cyclists. In one instance, it was reported a vehicle drove off the road hitting the trees near the curve.

Tarpon Bay Road is currently the only road that connects bicycle rental customers of the Tarpon Bay Concessionaire and the multi-use path along Sanibel Captiva Road. Customers and motorists share the narrow road with no shoulder. There are generally two alternatives to separate vulnerable road users from motorists: add a trail along Tarpon Bay Road or provide a trail elsewhere that provides the customers access to and from the concessionaire and the existing multi-use path. Due to the natural resources encountered on the island, both options would require a field assessment of the wetlands boundaries. A preliminary desktop assessment was done on the Tarpon Bay roadside path option and it is estimated that 0.08 miles could pass through estuarine wetlands and 0.04 miles may potentially pass through palustrine wetlands, see Appendix B for Preliminary Wetlands Assessment Memo. It is recommended that the path be installed along the east side of the road to avoid utility poles. It is also recommended that the portion of multi-use path that passes over wetlands be constructed as a boardwalk. The 1000-ft cut-through path option would cross over more wetlands than the Tarpon Bay Road option and would most likely be the more costly option due to wetlands mitigation, the path/boardwalk construction, and tree clearing. In addition to the path, it is recommended the installation of speed humps ahead of the curve and curve delineation as speed management countermeasures. Speed humps are gradual raised areas that have been shown to be effective at lowering speeds up to 10 mph.<sup>5</sup> Curve delineation can be done by providing chevron signs with reflective posts. This countermeasure can potentially reduce non-intersection type crashes of all severities by 27.5-percent. In addition to curve delineation, the curve should be analyzed to be a no passing zone. Per MUTCD standard, no passing zone markings shall be used at horizontal or vertical curves where the passing sight distance is less than minimum distance for it corresponding 85<sup>th</sup>-percentile or posted speed limit.

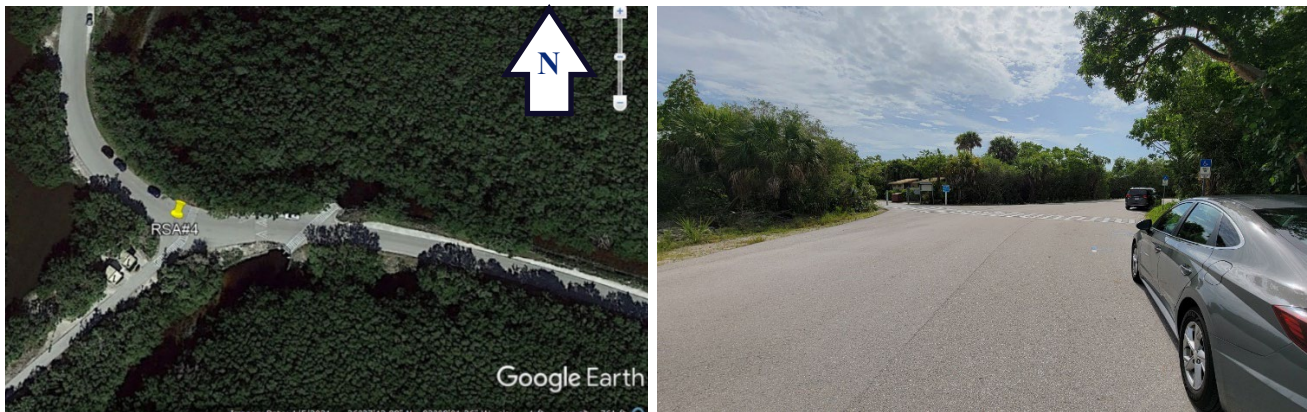
*Figure 14. Map View and Picture Facing West Wildlife Drive at Cross Dike Trail*

There are two crosswalks at this priority location. As you drive down Wildlife Drive, the first crosswalk encountered connects two wildlife observation areas. Approximately 50 feet from this crosswalk is a speed hump. Another 75 feet forward is another crosswalk connecting Cross Dike Trail to Wildlife Drive. This is a frequently visited stop by the Refuge visitors. There are restrooms located near the crossing along Cross Dike Trail, and visitors park their vehicles along the right side of Wildlife Drive to access the facilities. At these crossings, there is no connectivity between the crosswalks and there are visitors crossing on foot and bike. There are instances when visitors on bike use the restroom and then turn against traffic causing confusion, congestion, and near-misses at this crossing location. Vehicles also drive against traffic, and this occurs more often where the roadway widens near the trail.

At the crossing of Wildlife Drive with Cross Dike Trail there are instances of wrong way driving and biking. There are bathroom facilities at this location, and it seems that numerous visitors want to turn back towards the entrance instead of continuing along the one-way roadway. The roadway at this location is wide and vehicles have enough space to turn around. It is recommended that these movements be discouraged by installing delineators or pavement markings. When selecting delineators, it is recommended that the flexible type be installed in case one gets hit, the delineator bends downward from the bottom and is less likely to get damaged thus creating a maintenance issue. It is also recommended that the existing accessible signage (R7-8) be updated, and the one-way sign (R6-2) directed to cyclists be mounted at a minimum 7 feet height, replaced, and relocated closer to the roadway, see Figure 30. Approaching the first crosswalk, a speed hump is recommended to slow down motorists approaching the crossing, At the first crosswalk, a trail crossing sign (W11-15) and a special plaque that reads 2 XING are recommended to indicate to drivers that there are multiple crossings ahead.

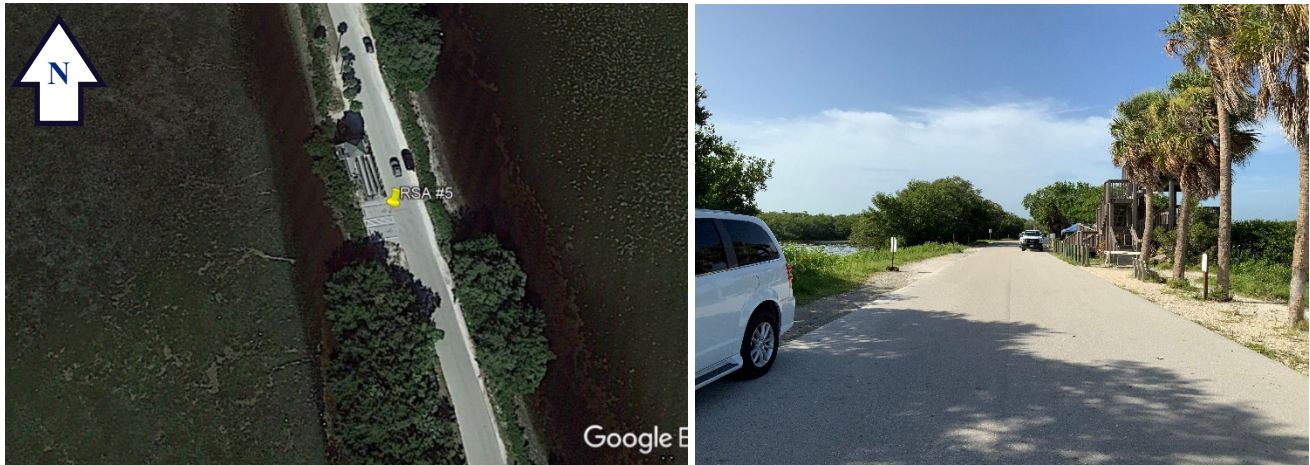
Figure 15. Map View and Picture Facing South of Wildlife Drive at Observation Tower

Along Wildlife Drive near the observation tower, there is limited parking at this popular attraction. The gravel parking is first come, first serve and offers enough space along the approximately 1160 feet long tangent portion of the road for approximately 60 vehicles, plus the tram, and two accessible parking spots. This is the location of one of two tram stops. The tram stops across the road and the visitors cross the street to the observation tower. This section of road is approximately 22 feet wide with an additional 7 feet of gravel parking area. The available roadway space narrows with the parked cars and tram car. The road is shared by cyclists and hikers and is a high point of congestion. This location is adjacent to wetlands or water on both sides.

The observation tower site is a popular site for visitors and one of two tram stops. Due to the high activity at this site, there is congestion between the vehicles, visitors crossing the road, cyclists, wide vehicles such as buses and the tram, and parking maneuvers. To help direct visitor crossing, it is recommended that a crosswalk with crossing signage (W11-15) be placed in front of the observation tower ramp and a speed hump to slow down vehicles approaching this location.

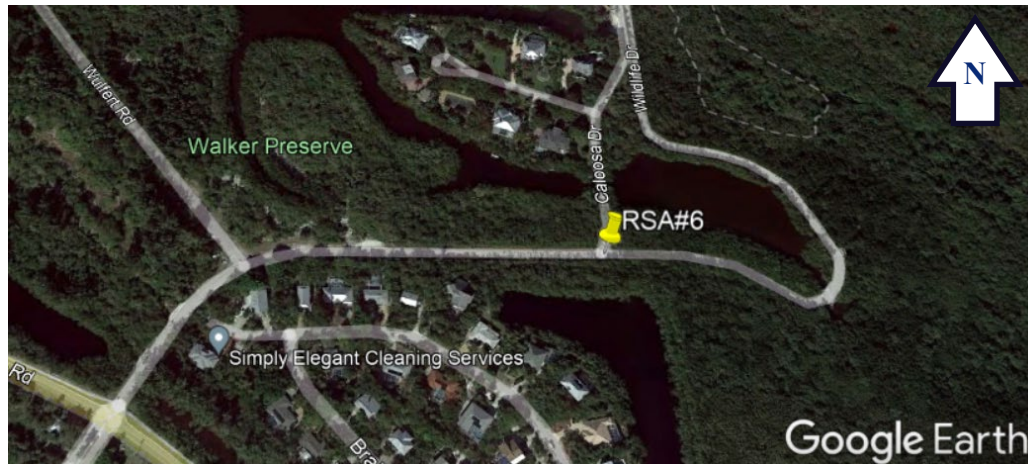
Figure 16. Map View of Wildlife Drive

The refuge exit, beginning at the series of curves nicknamed “Alligator Bend” through Refuge exit is another area of concern. This area has very narrow sections, 12 foot wide at its narrowest, where there is not enough space for a cyclist and a tram or bus to ride side by side.

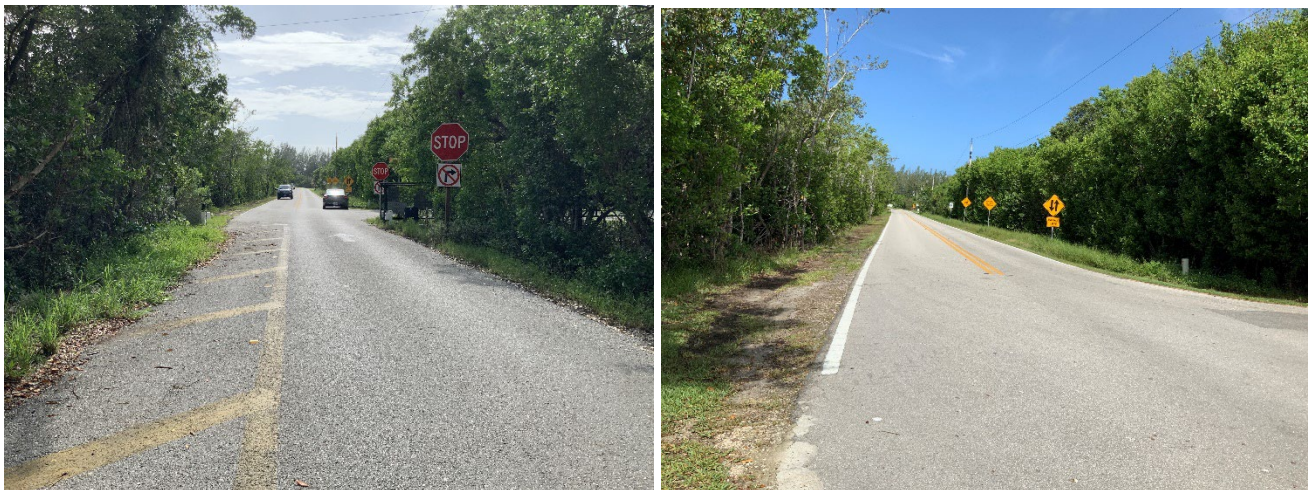
*Figure 18. Refuge Exit from Wildlife Drive to Refuge Exit Before and After the Exit Gate*

Coming out of the Refuge exit the area residents report that Refuge visitors, cyclists and motorists, coming from the one-way portion of Wildlife Drive and continue driving in the middle of the roadway where it turns into a two-way road. Figure 19 shows an example of cyclists going down Wildlife Drive against traffic. It was also reported that drivers speed through, even around the horizontal curves that have limited visibility causing crashes and near misses.

At the section of Wildlife Drive between the Refuge’s exit and Sanibel Captiva Road, the roadway turns from one way to two way. Currently there are many incidents of cyclists going against traffic on this section of roadway, resulting in near misses between vehicles and bikes. It is recommended that the shared-use path be extended from Sanibel Captiva Road to the Refuge exit and it be placed on the south side of the road to avoid the utility poles. Adding this path would require wetlands in field delineation. A preliminary desktop assessment estimates approximately 350 feet of the proposed shared-use path passes
