HISTORIC STRUCTURE SURVEY AND LIMITED ARCHAEOLOGICAL TESTING SANIBEL LIGHTHOUSE AND KEEPERS' QUARTERS (8LL00097) LEE COUNTY, FLORIDA

May 2024

HISTORIC STRUCTURE SURVEY SANIBEL LIGHTHOUSE AND KEEPERS' QUARTERS (8LL00097) LEE COUNTY, FLORIDA

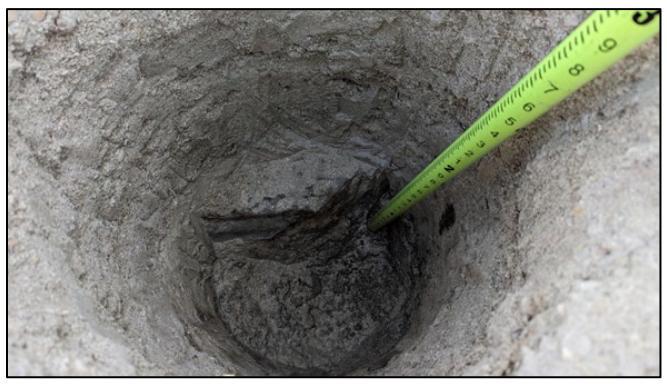
the previous monitoring projects discussed above. Three shovel tests did evidence historic materials; however, they appeared to be in storm deposit and not in situ. Shovel test 1 did find part of the foundation related to one of the Keeper's Quarters supports (**Photo 5**). While this informative, it is not new or unexpected. The lack of material artifacts is likely due to hurricane and storm erosion of the coastline, past development and soil removal projects, and possible past deposition practices designed to keep pests aways from the light keeper's quarters. Historic aerials show significant change in the coastline over time. **Figure 6** shows

Photo 5. ST 1 with foundation.

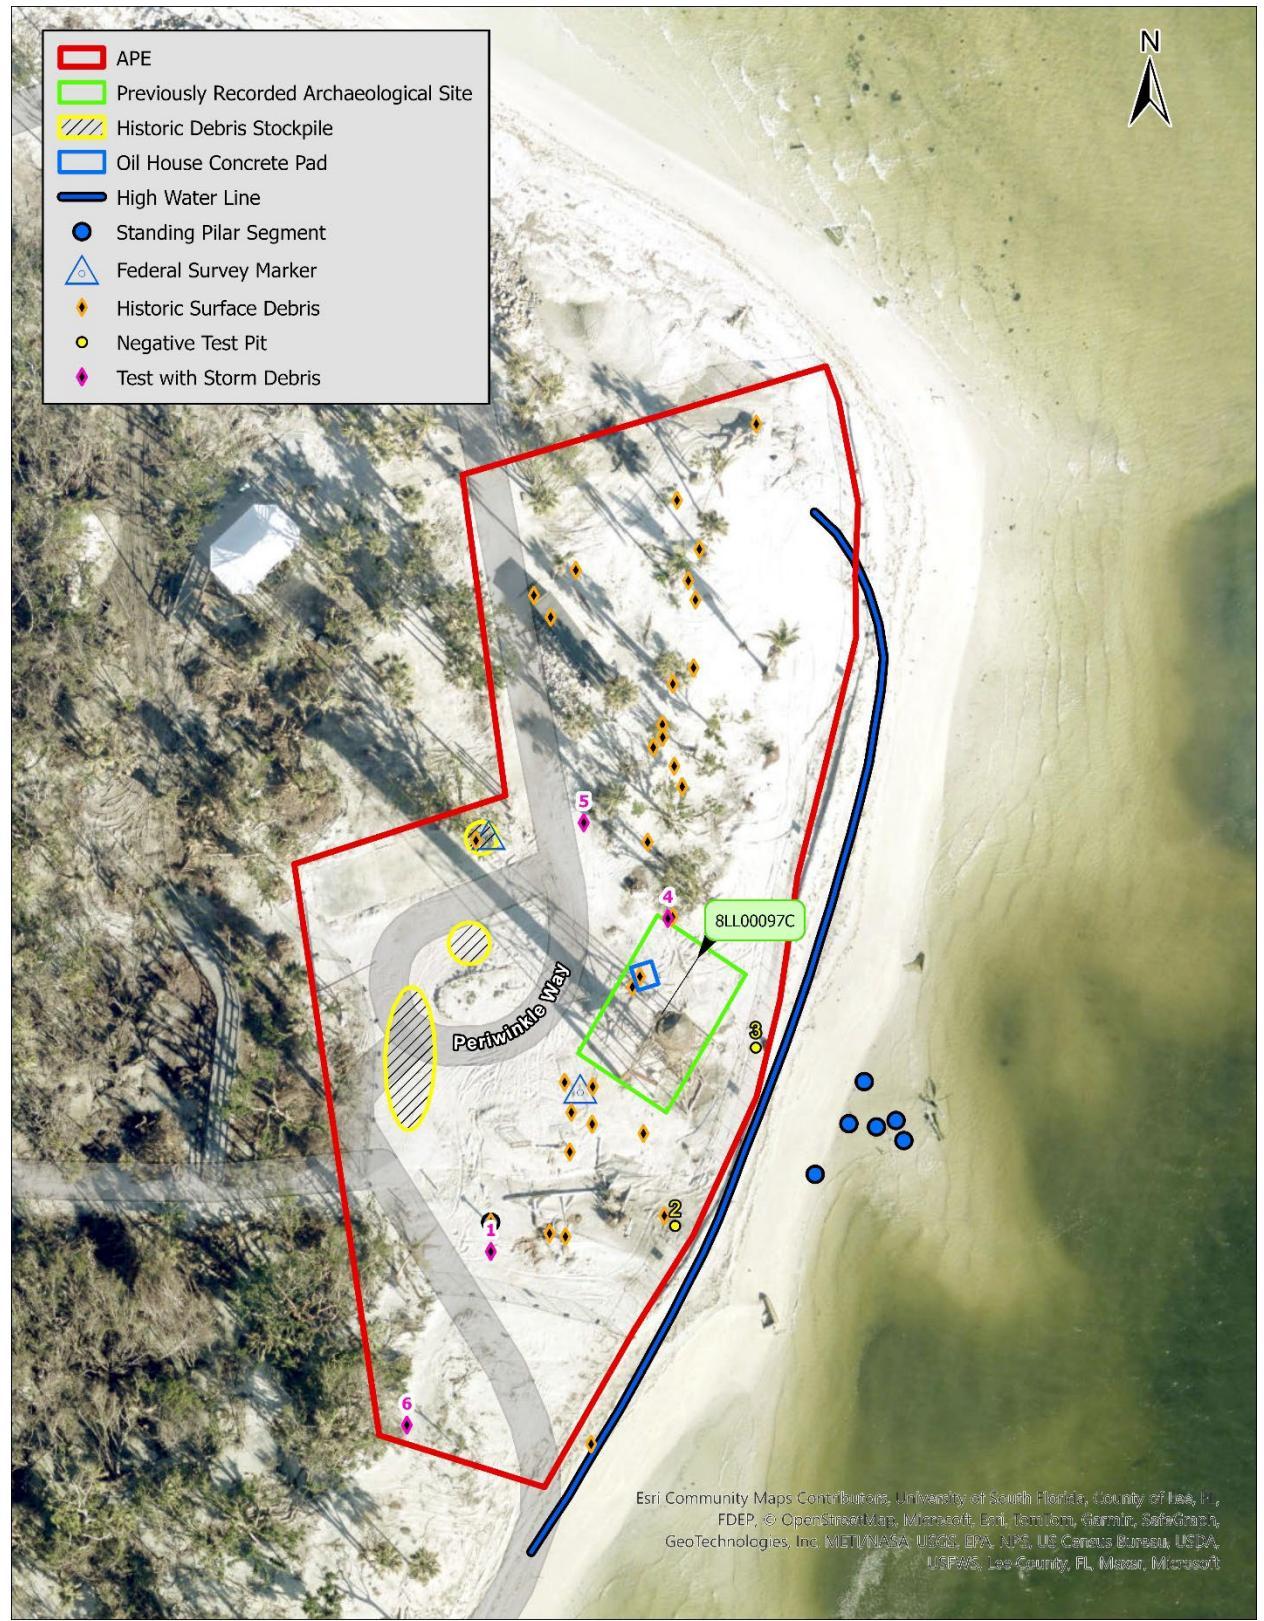
Archaeological field survey included surface reconnaissance and the excavation of six shovel tests throughout the property, none of which produced intact cultural materials or evidence of subsurface features (**Figure 5**). Testing followed the planned methodology with no significant shifts. The majority of identified cultural materials were on the surface. The surface scatter consisted of materials related to the lighthouse including large chunks of concrete, metal, footer posts, and wood beams. These results are consistent with

Figure 5. Archaeological results. The yellow dots mark excavated storm debris, the red dots are the location of the Federal Survey markers, the teal dots are negative shovel tests, the dark blue dots are offshore pilings, and the blue line marks the highwater line.

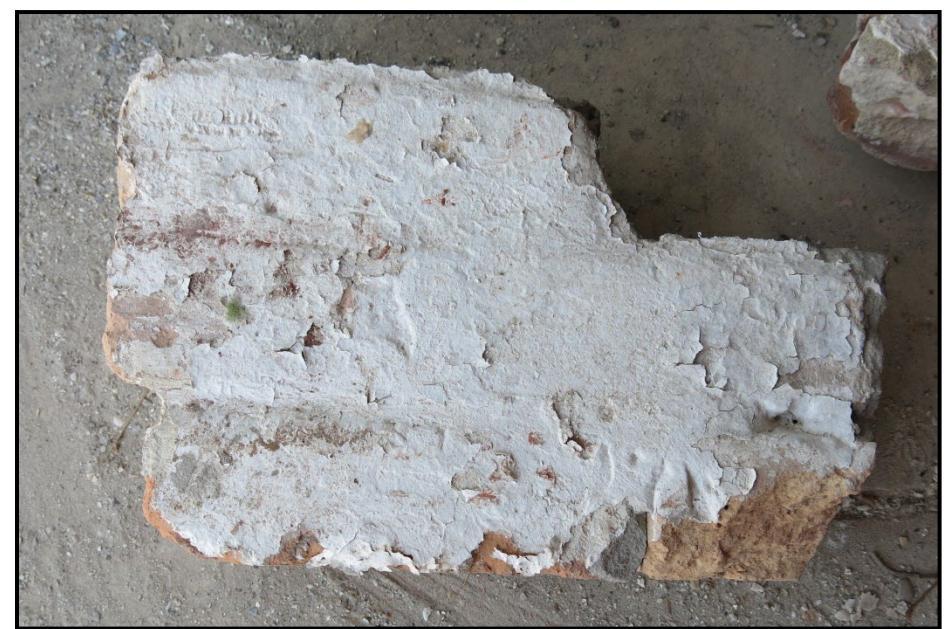
Common brick with white paint (Photos 6 through 8) Source: Oil house Dimensions: 8 ¹/₂" x 4 ¹/₄" x 2 ³/₄" and 8¹/₈" x 4 ¹/₄" x 2 ¹/₂"

Photo 6. A segment of the oil house wall comprised of common brick and intact mortar covered with paint on the exterior surface.

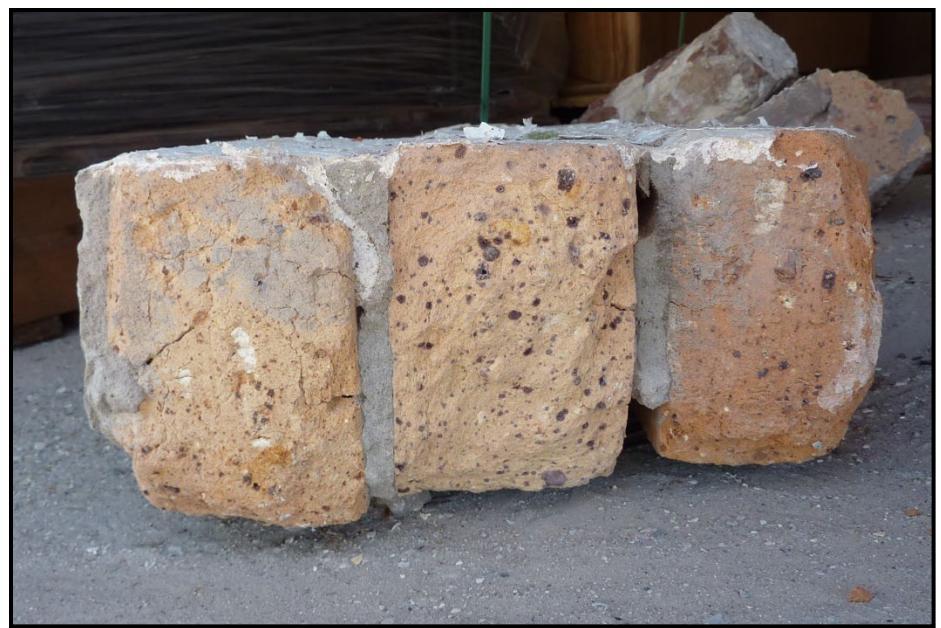
Photo 7. A segment of the oil house wall comprised of common brick and intact mortar covered with paint on the exterior surface. The exterior surface is located on the top of the pictured segment. Note the variations in brick color.

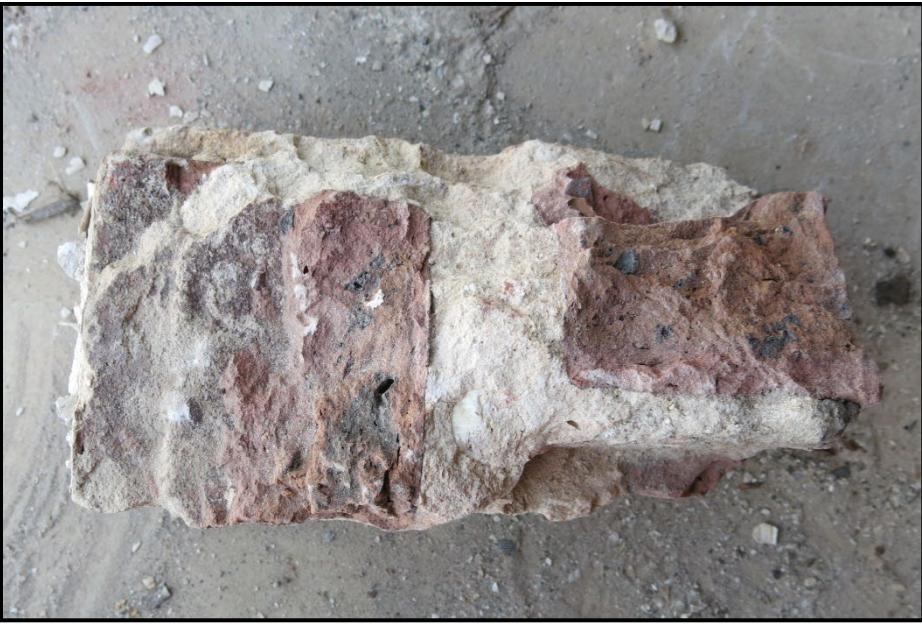
Photo 8. A segment of the oil house wall comprised of common brick and intact mortar covered with paint on the exterior surface. The exterior surface is located on the left side of the pictured segment. Note the variations in brick color.

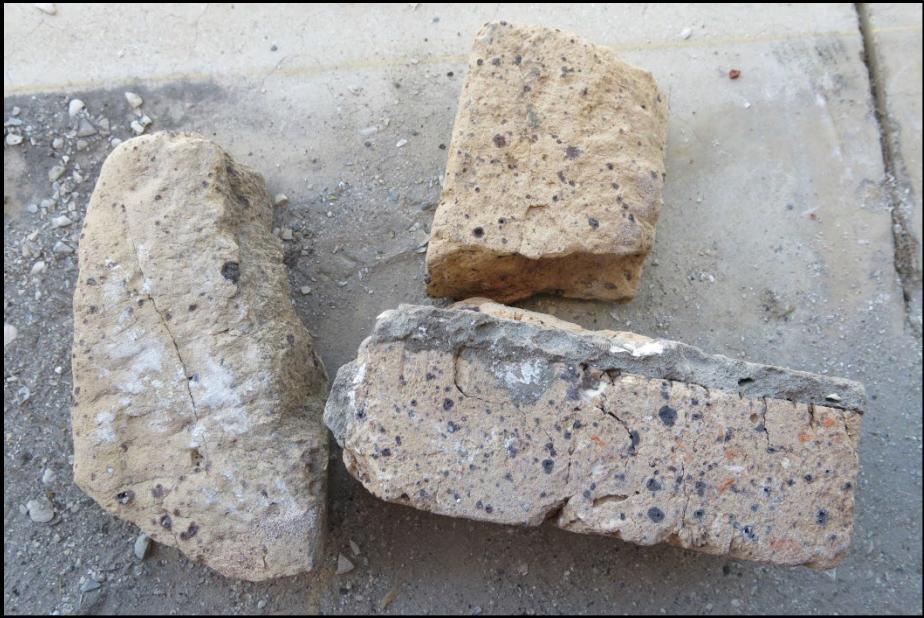
Common brick – unpainted (Photo 9) Source: Internal wall structure of oil house or oil house foundation Dimensions: 8 ¼" x 4 ¼" x 2 5%"

Photo 9. Three examples of individual unpainted common bricks.

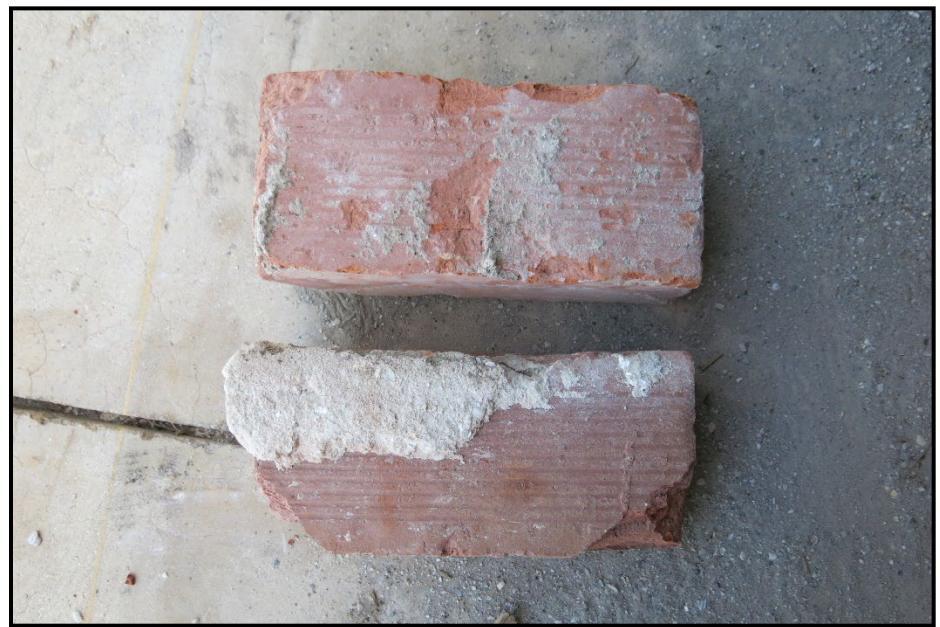
Face brick – striated (Photos 10 and 11) Source: Cistern Dimensions: 8 ¹/₂" x 3 ⁷/₈" x 2 ¹/₂"

Photo 10. Examples of face brick (striated) identified within the relocated rubble pile. Intact segments of the cistern walls can be seen in Debris Pile – Group No. 2 below.

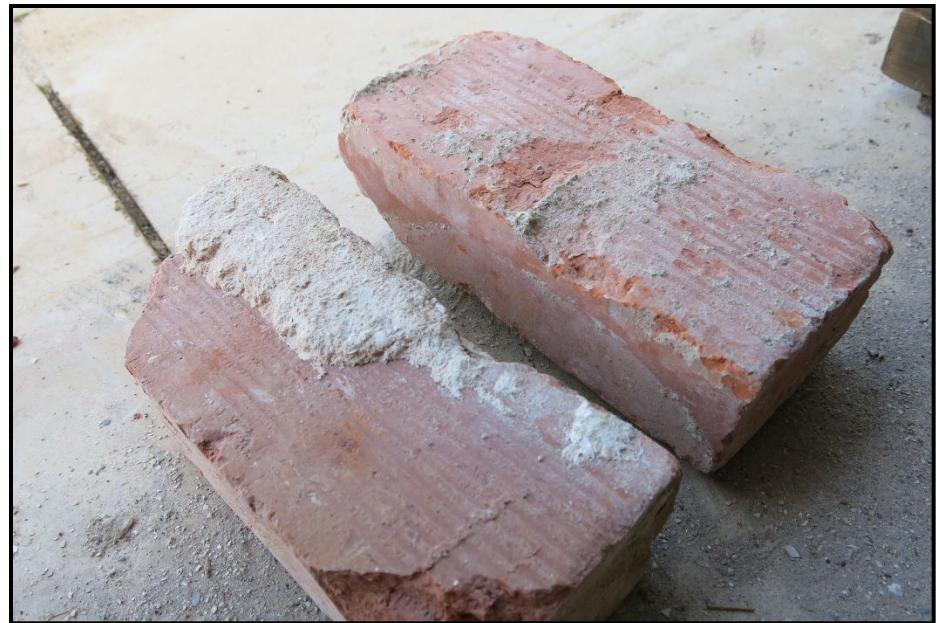
Photo 11. Examples of face brick (striated) identified within the relocated rubble pile. Intact segments of the cistern walls can be seen in Debris Pile – Group No. 2 below.

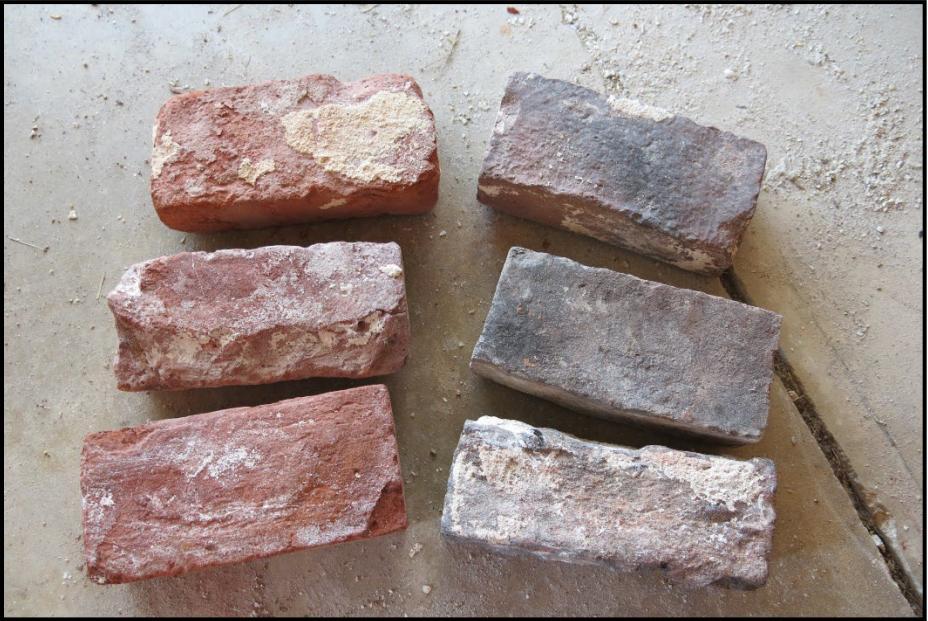
- Face brick charred (Photos 12 and 13)
 Source: Keepers' Quarters chimneys (charred brick from interior top of chimney or inner hearth)
 - Dimensions: 7 ³/₄" x 3 ⁵/₈" x 3 ³/₈" Face brick – plain (**Photos 12 and 13**)
- Face brick plain (Photos 12 and 13) Source: Keepers' Quarters chimneys (exterior) Dimensions: 7 ⁷/₈" x 3 ³/₄" x 2 ¹/₈"

Photo 12. Three weathered examples of face brick (plain) (left) and face brick (charred) (right).

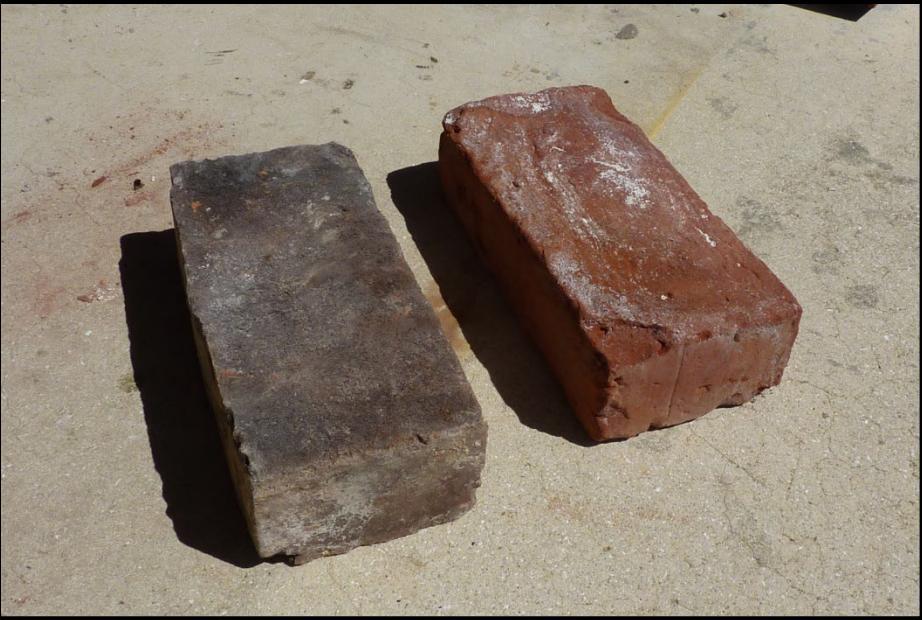
Photo 13. Examples of face brick (charred) (left) and face brick (plain) (right).

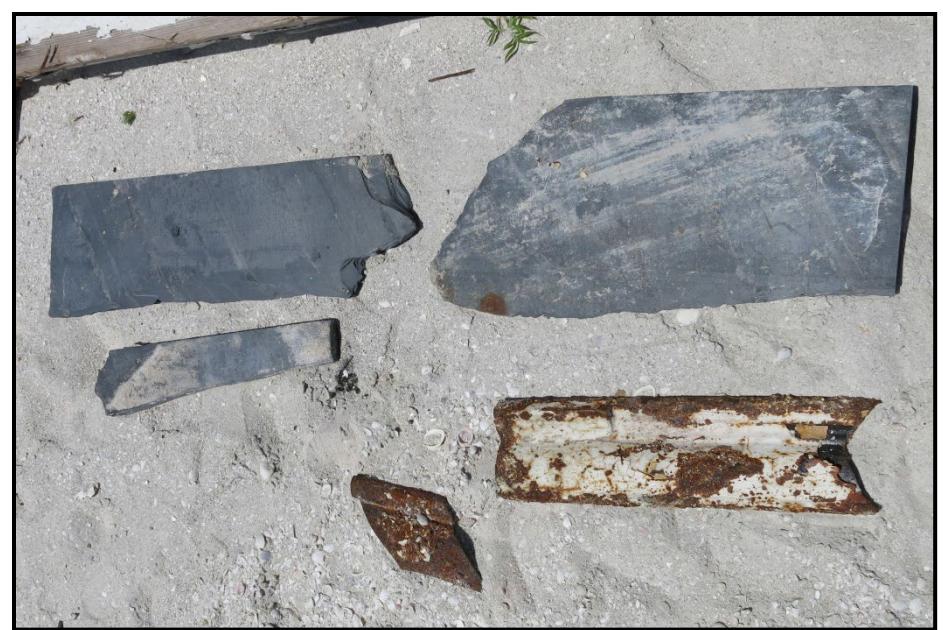
Each of the Keepers' Quarters was equipped with two brick chimneys and at least one of the two chimneys per building was known to connect to a coal burning fireplace. The resources within Group No. 4 include five large segments of slate that served as the hearth of the fireplace. The resources within Group No. 5 include two segments of a cast iron surround that would have been installed on the coal burning fireplace. An example of an intact coal burning fireplace found within the Keepers' Quarters can been seen in **Photo 24**. During the mid-1800s, coal became the preferred method of heating buildings rather than wood. Fireplaces and chimneys were altered to accommodate the transition in fuel types, resulting in a smaller fireplace that was taller and shallower than the standard woodburning fireplace (Polson 2013, Duke 2022). In addition, coal burning fireplaces were typically embellished with cast iron surrounds and inserts which were equipped with metal grates for holding the burning coals. The horse-shoe arch shape was a common design as it was easily created during the metal casting process and surrounds included a "summer cover" to close off the fireplace when it was not in use (Duke 2022).

Photo 21. Three of the five recovered segments of slate from the Keepers' Quarters hearth (top) and two segments of the cast iron coal burning fireplace surround (bottom).

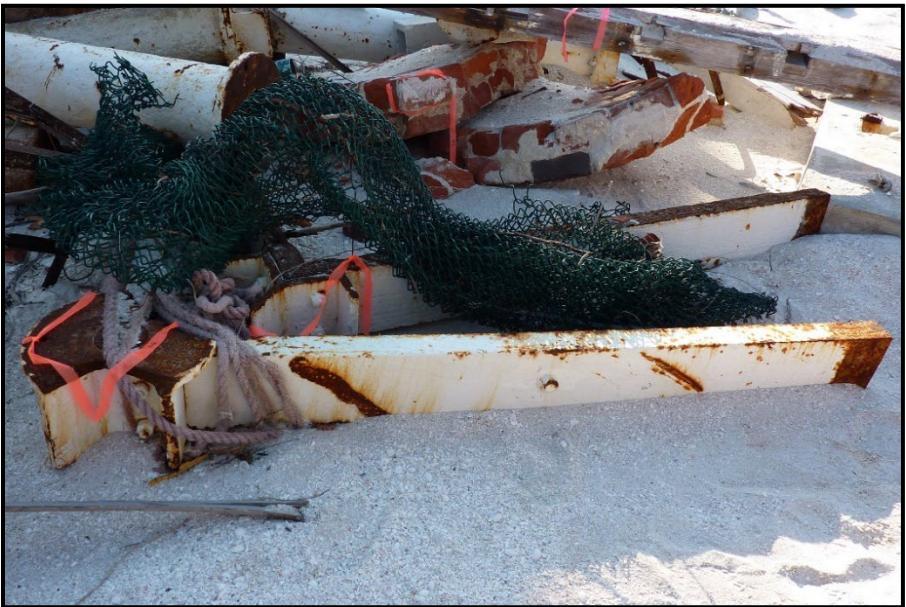
The two resources are each comprised of two metal members situated perpendicular to each other to form a right angle. A circular segment is located at the vertex of the two members and may have functioned as a fulcrum during construction, but this is unclear. The resources are painted and covered in a significant amount of rust. The dimensions of the metal girders could not be determined due to their placement under other large-scale debris. Group No. 6 and 7 are examples of the structural building techniques utilized to construct the Keepers' Quarters in the coastal environment, similar to Groups No. 1 and 3; however, these are examples of metal, rather than wood, construction methods. An example of these bracketed girders can be seen in situ in **Photo 27**.

Photo 25. Two bracketed metal girders located within the debris pile (Group No. 6 and 7).

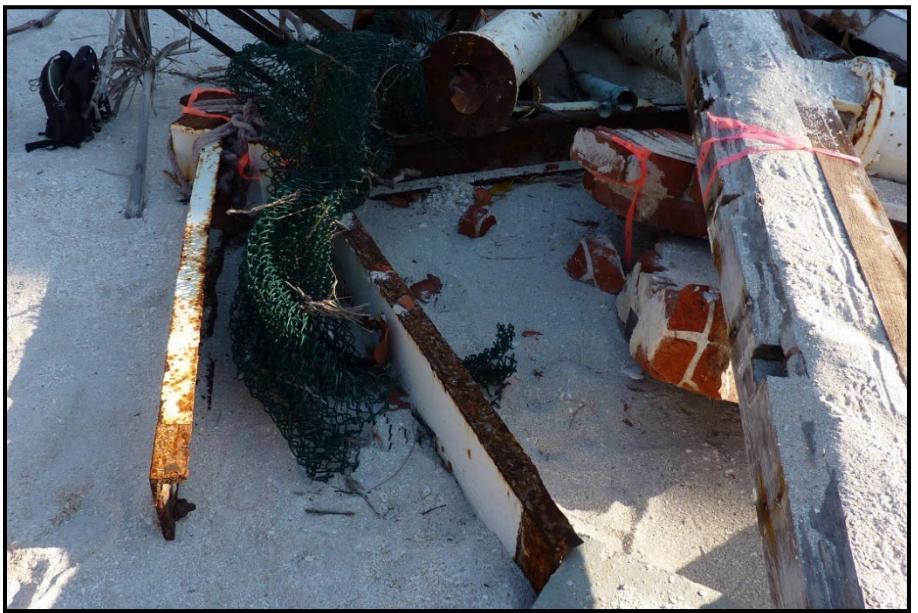
Photo 26. Two bracketed metal girders located within the debris pile (Group No. 6 and 7).
