**HISTORIC STRUCTURE SURVEY
AND LIMITED ARCHAEOLOGICAL TESTING
SANIBEL LIGHTHOUSE AND KEEPERS' QUARTERS
(8LL00097)
LEE COUNTY, FLORIDA**

**City of Sanibel
Planning Department
2475 Library Way
Sanibel, FL 33957**

**Archaeological Consultants, Inc.
8110 Blaikie Court, Suite A
Sarasota, Florida 34240
(941) 379-6206**

May 2024

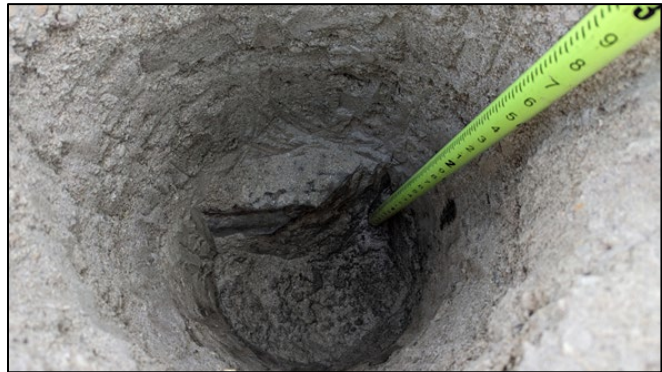
Photo 5. ST 1 with foundation.

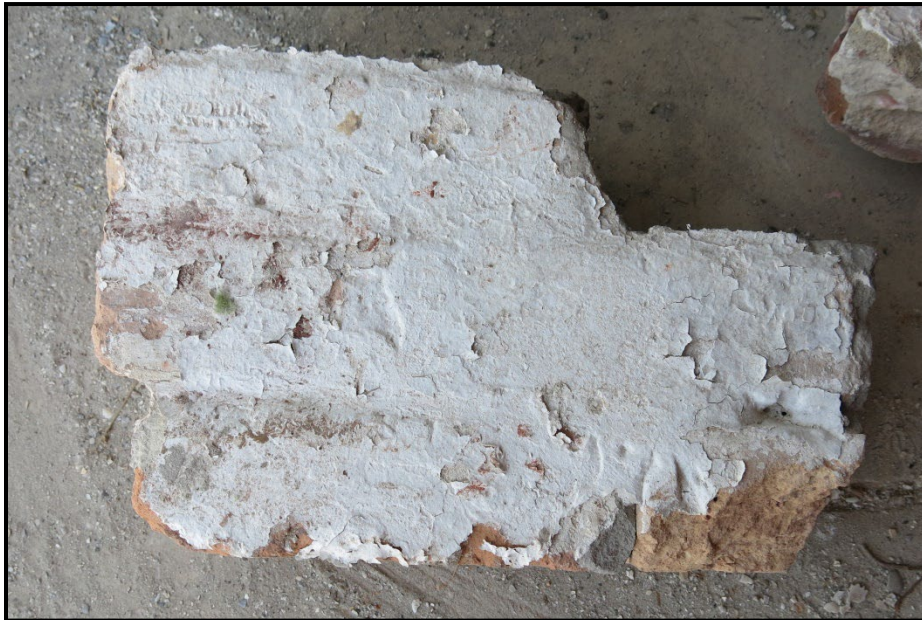
Photo 6. A segment of the oil house wall comprised of common brick and intact mortar covered with paint on the exterior surface.

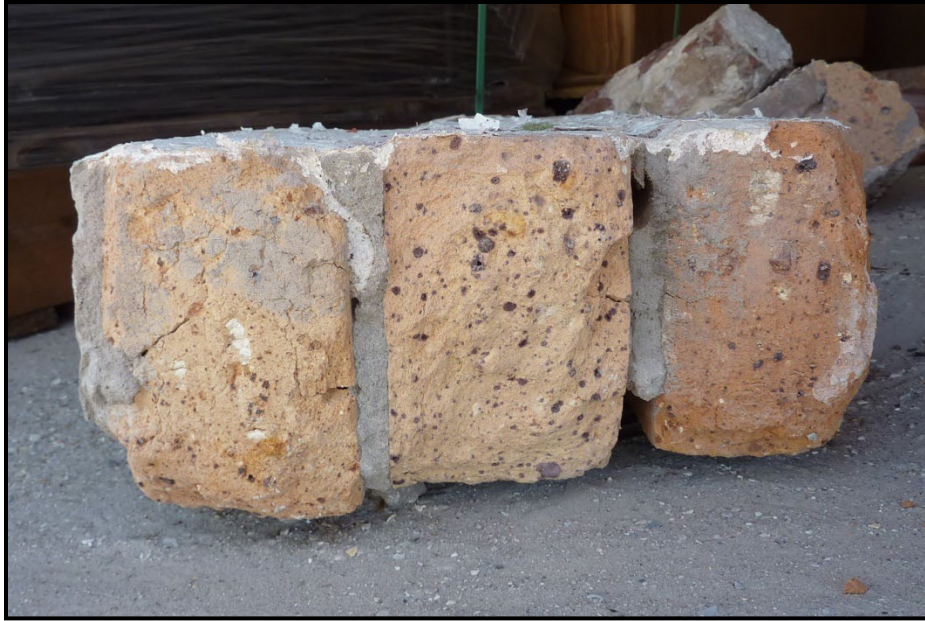
Photo 7. A segment of the oil house wall comprised of common brick and intact mortar covered with paint on the exterior surface. The exterior surface is located on the top of the pictured segment. Note the variations in brick color.

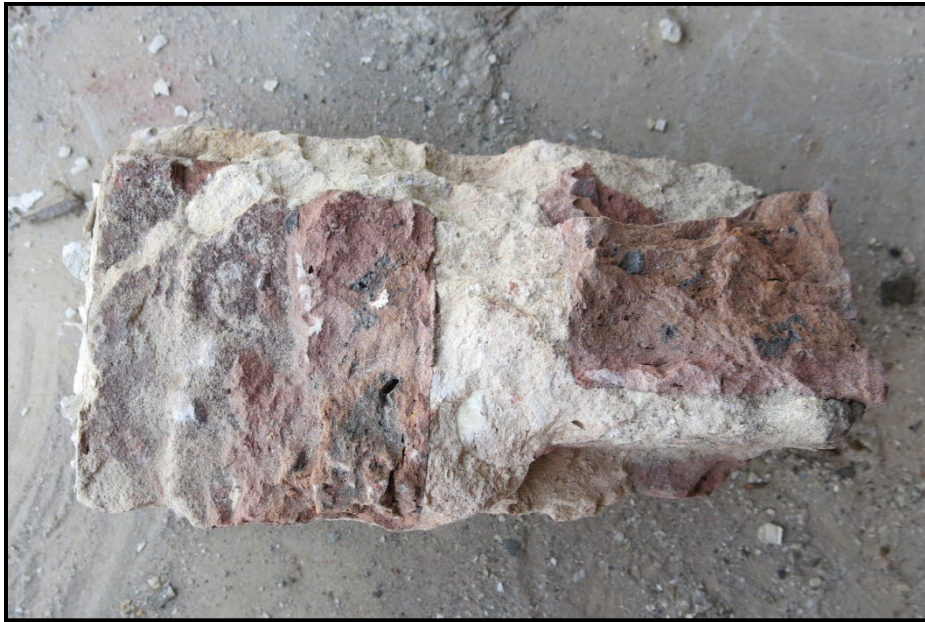
Photo 8. A segment of the oil house wall comprised of common brick and intact mortar covered with paint on the exterior surface. The exterior surface is located on the left side of the pictured segment. Note the variations in brick color.

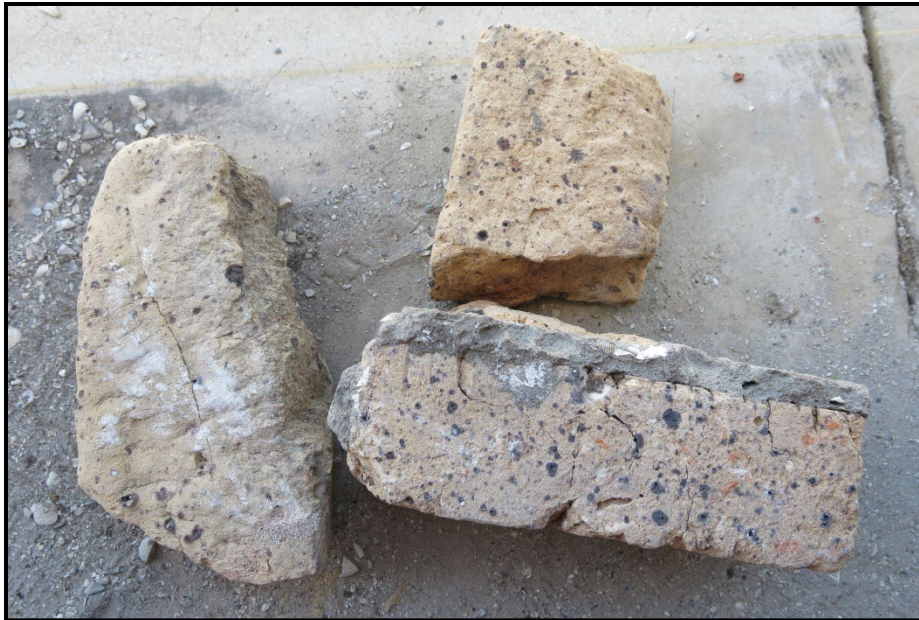
2. Common brick – unpainted (**Photo 9**)
Source: Internal wall structure of oil house or oil house foundation
Dimensions: 8 ¼” x 4 ⅛” x 2 ⅝”

Photo 9. Three examples of individual unpainted common bricks.

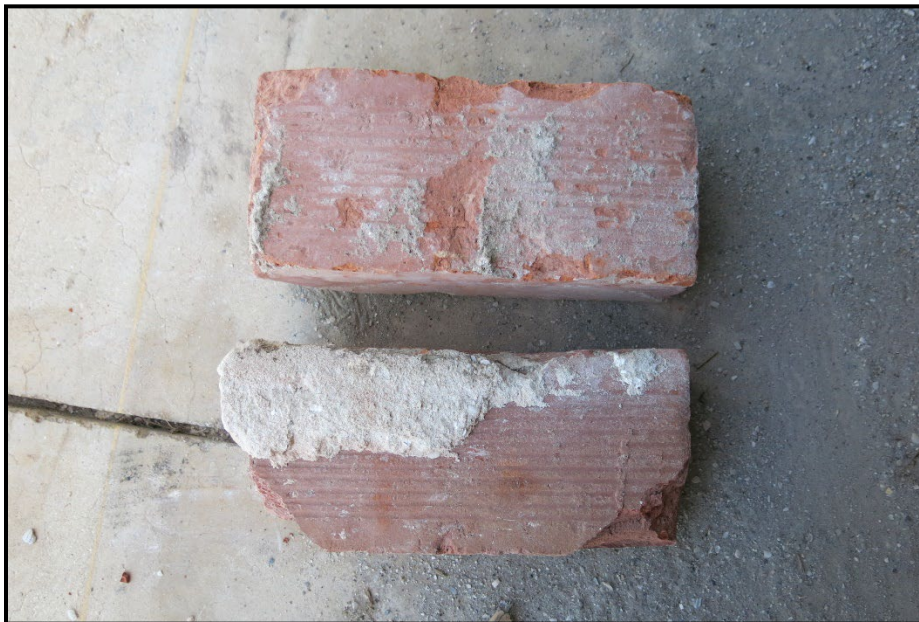
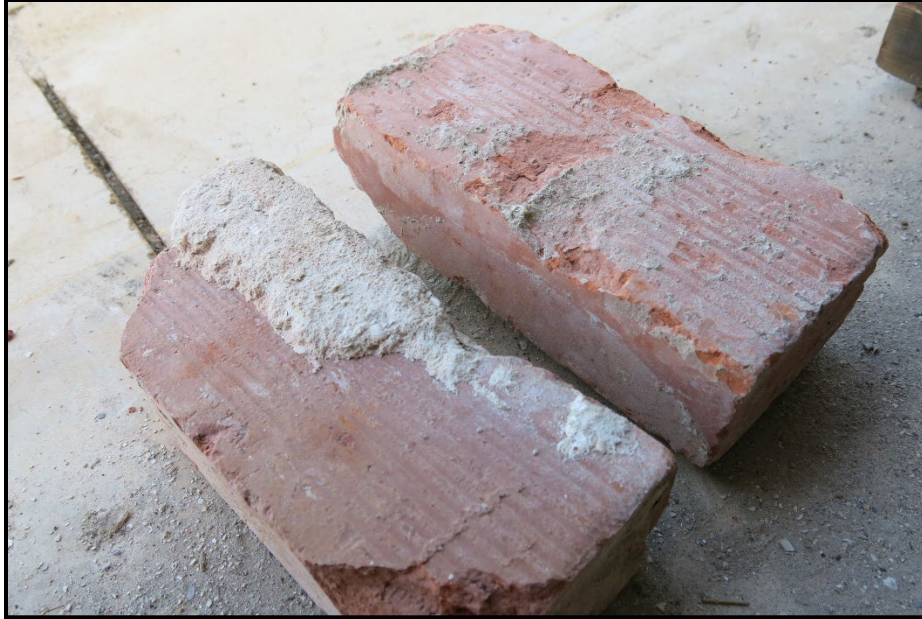
3. Face brick – striated (**Photos 10 and 11**)
Source: Cistern
Dimensions: 8 ½” x 3 ⅞” x 2 ½”

Photo 10. Examples of face brick (striated) identified within the relocated rubble pile. Intact segments of the cistern walls can be seen in Debris Pile – Group No. 2 below.

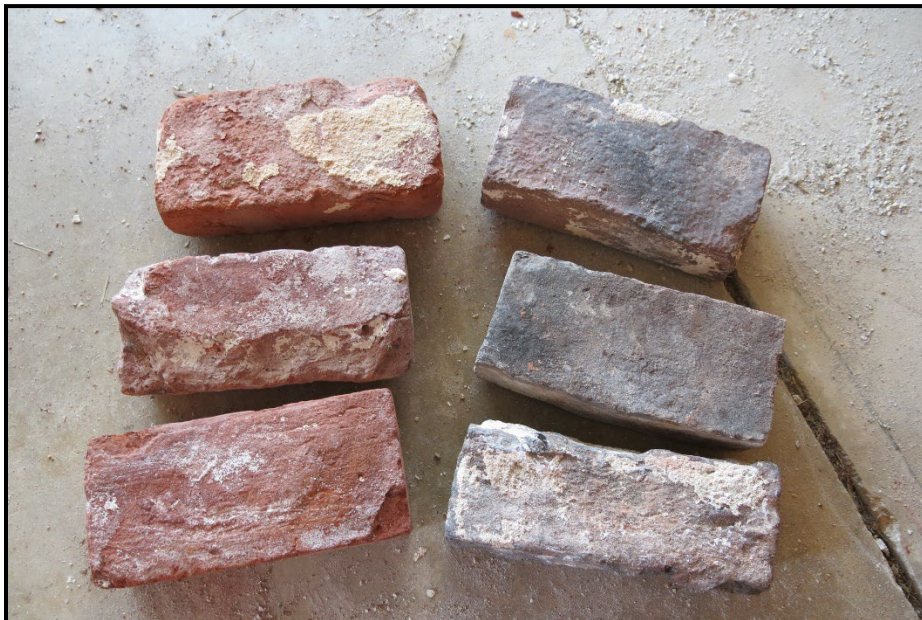
4. Face brick – charred (**Photos 12 and 13**)
 Source: Keepers’ Quarters chimneys (charred brick from interior top of chimney or inner hearth)
 Dimensions: 7 ¾” x 3 ⅝” x 3 ⅜”
5. Face brick – plain (**Photos 12 and 13**)
 Source: Keepers’ Quarters chimneys (exterior)
 Dimensions: 7 ⅞” x 3 ¾” x 2 ⅛”

Photo 12. Three weathered examples of face brick (plain) (left) and face brick (charred) (right).

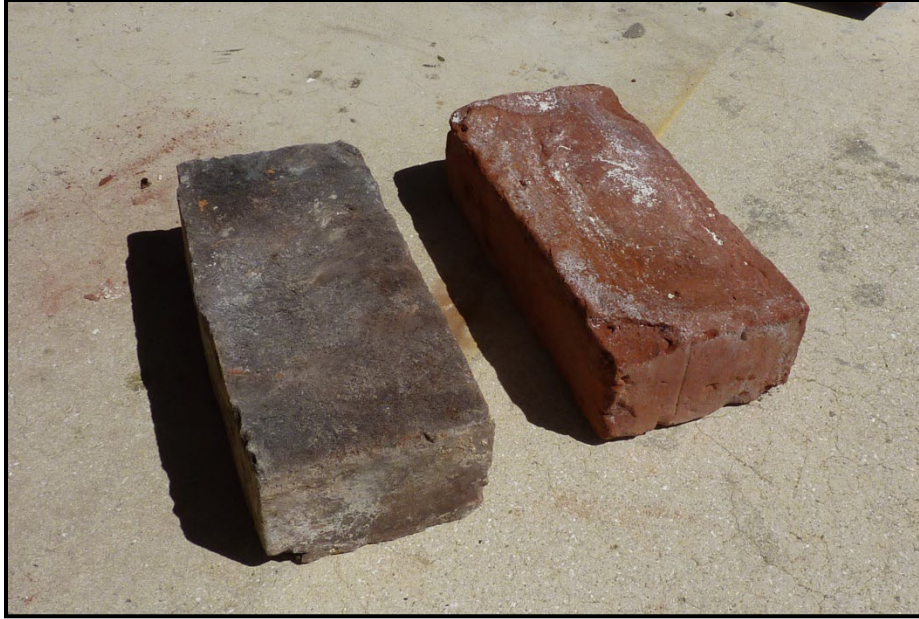
Photo 13. Examples of face brick (charred) (left) and face brick (plain) (right).

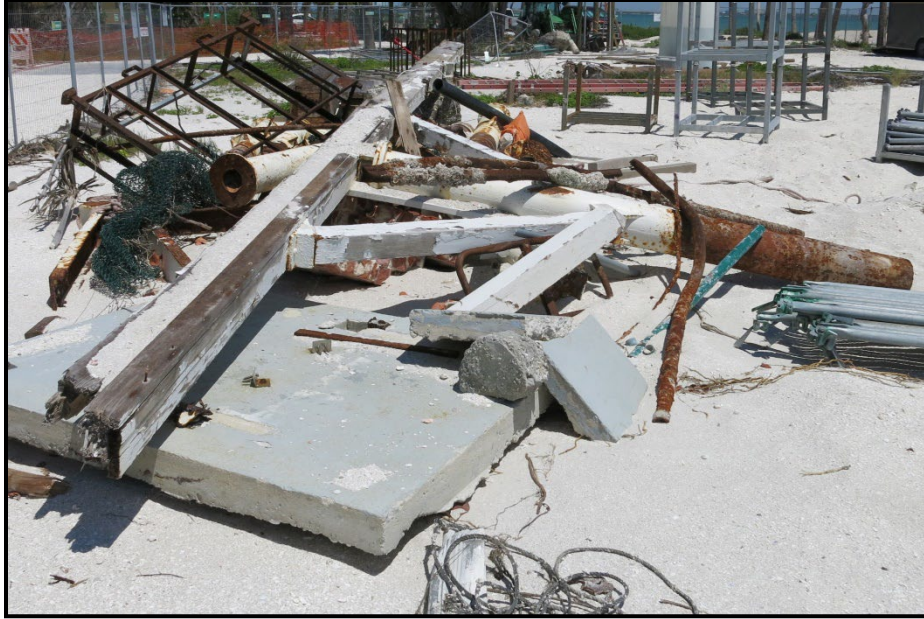
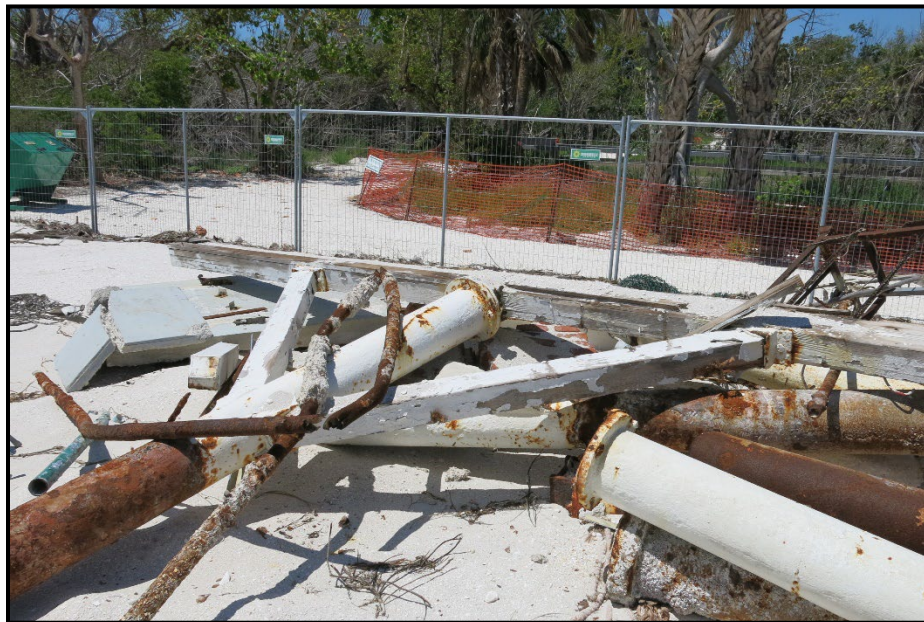
Group No. 1 – Wooden girder with intact metal support post and wooden brackets (Photos 14 and 15)

The dimensions of the wooden girder are approximately 36' x 11 ¼" x 5 ½". The ends of the girder were broken during the destruction of the Keepers' Quarters and as such, the original length of the girder is unknown. The elements of Group No. 1 are an example of the structural building techniques utilized to construct the Keepers' Quarters in the coastal environment. Supporting buildings and structures found at light stations were typically raised three to five feet above the ground by continuous brick or brick pier foundations due to the proximity to water (Johnston and Jones 2002). The Keepers' Quarters at the Sanibel Lighthouse, however, rested on cylindrical metal support posts rather than brick. The wooden girder with intact metal support post and wooden brackets also utilized mortise and tenon joints; however, the joints were destroyed during the destruction of the Keepers' Quarters. An example of relatively intact mortise and tenon joints and a description of the construction method can be found in Group No. 3 below.

Photo 14. Wooden girder with intact metal support post and wooden brackets.

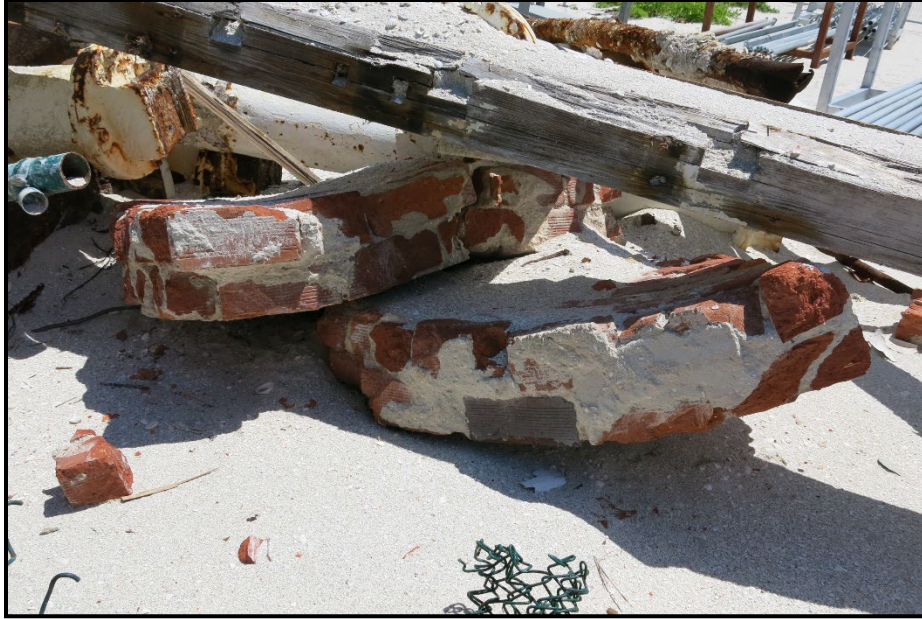
Group No. 2 – Intact segments of the brick cistern (Photo 16)

Two curved segments of the former brick cistern were identified within the debris pile. These segments are constructed with striated brick laid two wythes thick and held together with mortar. In addition to keepers' quarters, oil houses, and privies, light stations were commonly equipped with cisterns to hold freshwater, which was not easily accessible in remote, seaside locations such as Sanibel Island (Johnston and Jones 2002). This cistern was located behind the Keepers' Quarters at the Sanibel Lighthouse (**Photo 16**).

Photo 16. Two curved segments of the cistern walls comprised of striated face brick constructed two wythes thick with intact mortar.

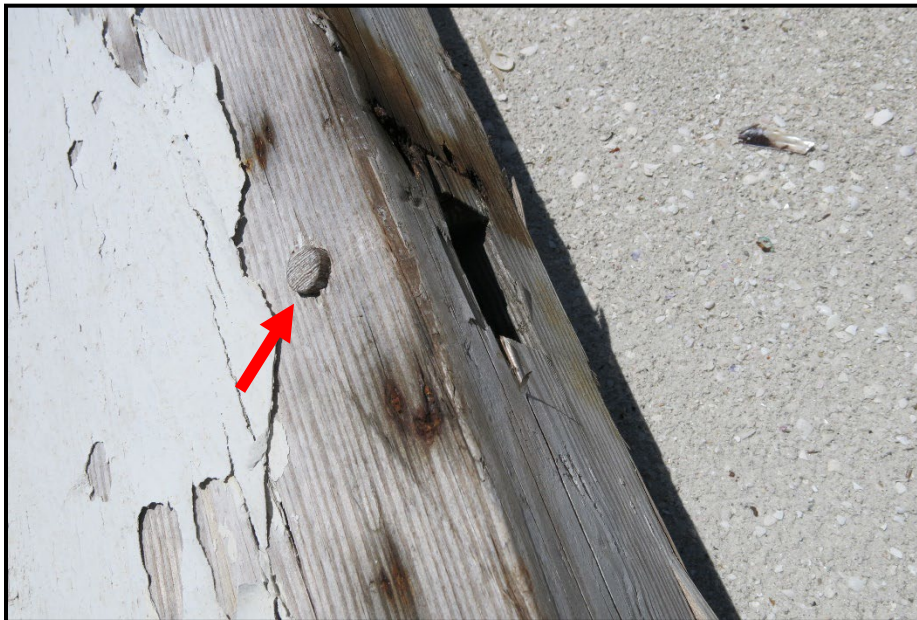
Photo 19. An example of a partially intact mortise and tenon joint along the top of the wooden girder. The rectangular cavity to the right is the mortise and the cylindrical wooden peg to secure the tenon (broken off) is visible to the left and indicated by the red arrow.

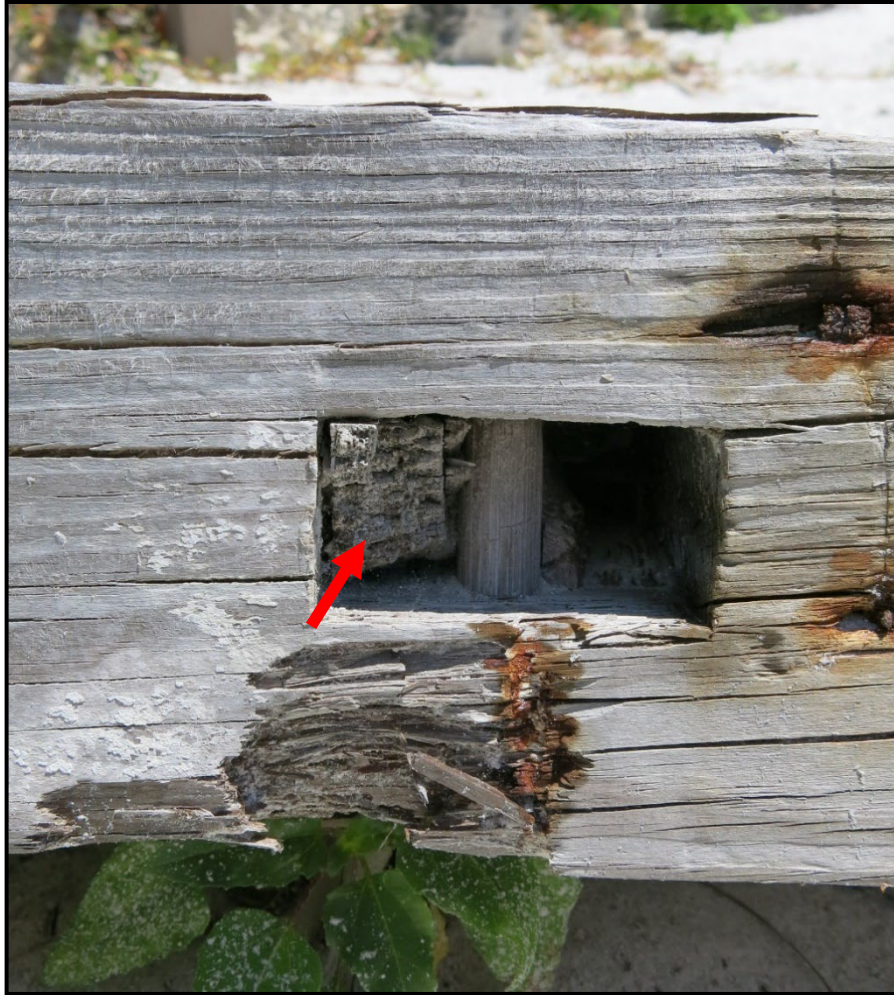
Photo 20. An example of a partially intact mortise and tenon joint along the top of the wooden girder. The rectangular cavity is the mortise, and it is bisected by a cylindrical wooden peg to secure the tenon. The tenon has broken off and only a small segment remains within the mortise (red arrow).

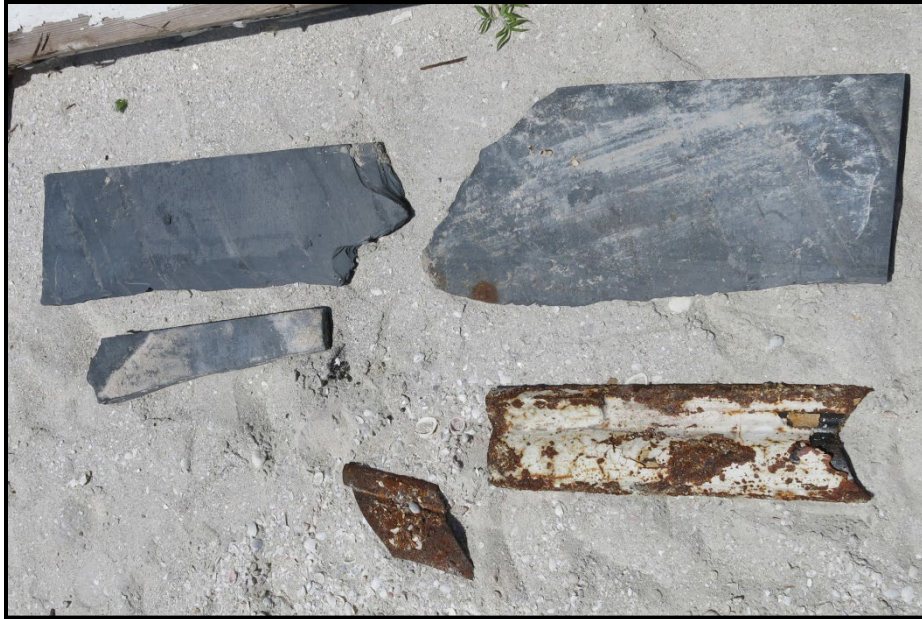
Photo 21. Three of the five recovered segments of slate from the Keepers' Quarters hearth (top) and two segments of the cast iron coal burning fireplace surround (bottom).

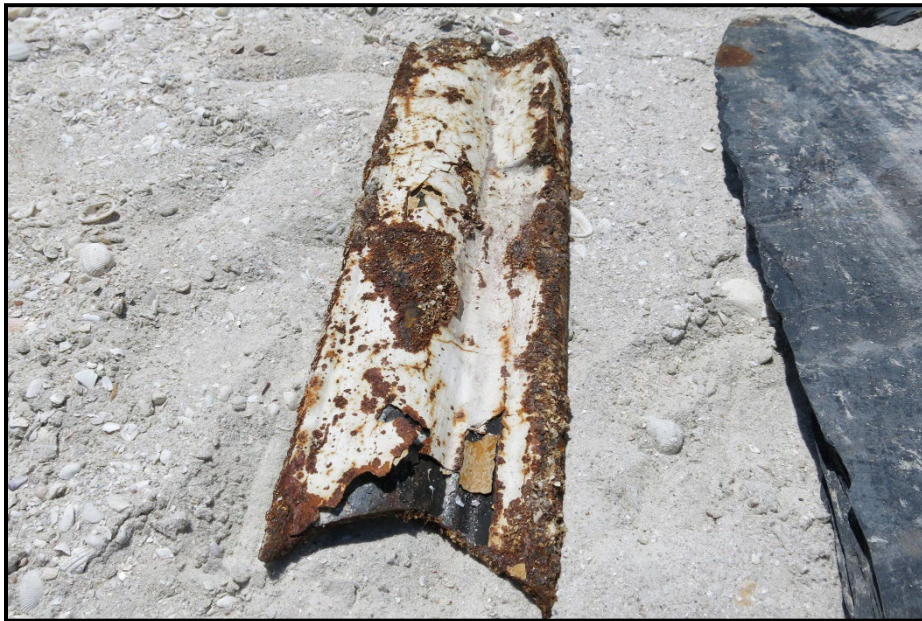
Photo 22. The larger of the two segments of the cast iron coal burning fireplace surround. Note the decorative curved detailing and the paint is peeling, revealing the bare cast iron.

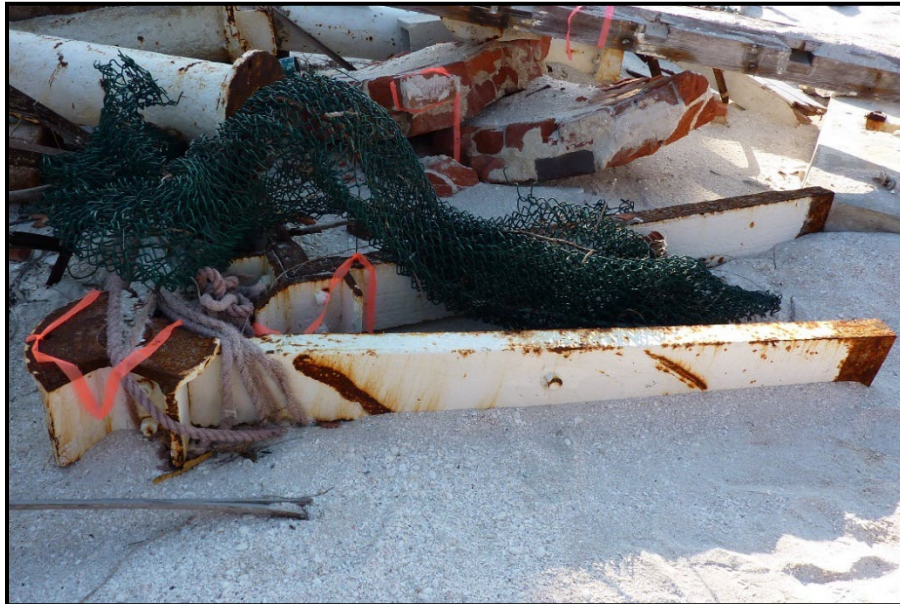
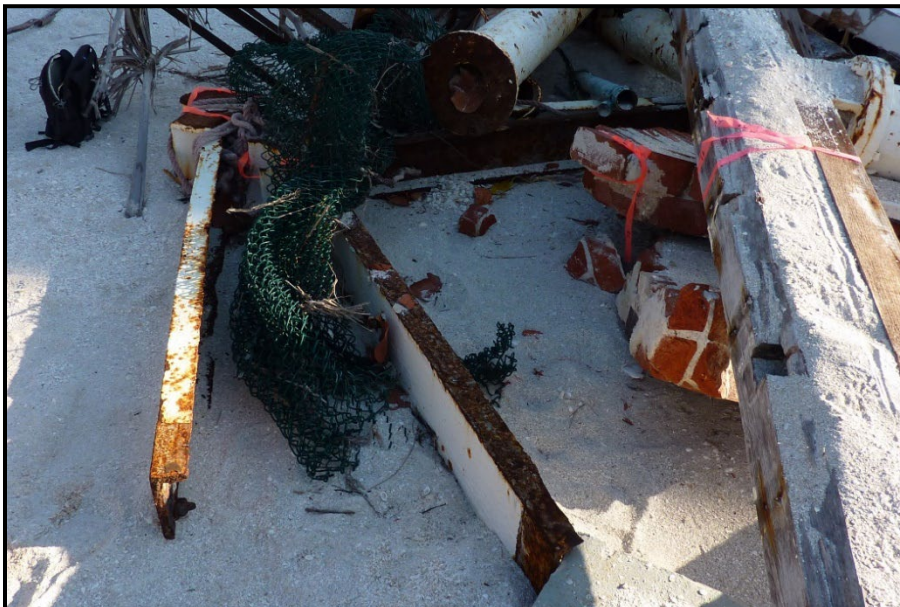
Group No. 6 (aka Flag No. 8) and Group No. 7 – Metal Girders from the Keepers’ Quarters (Photos 25 and 26)

The two resources are each comprised of two metal members situated perpendicular to each other to form a right angle. A circular segment is located at the vertex of the two members and may have functioned as a fulcrum during construction, but this is unclear. The resources are painted and covered in a significant amount of rust. The dimensions of the metal girders could not be determined due to their placement under other large-scale debris. Group No. 6 and 7 are examples of the structural building techniques utilized to construct the Keepers’ Quarters in the coastal environment, similar to Groups No. 1 and 3; however, these are examples of metal, rather than wood, construction methods. An example of these bracketed girders can be seen in situ in **Photo 27**.

Photo 25. Two bracketed metal girders located within the debris pile (Group No. 6 and 7).

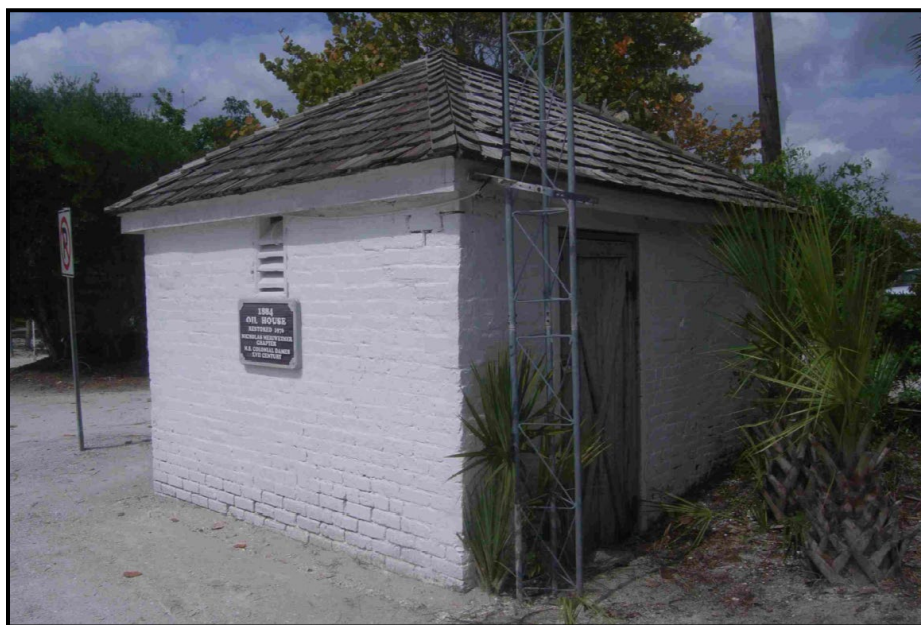
The Sanibel Lighthouse oil house was a rectangular brick building with a pyramidal roof covered in wooden shakes (**Photo 30**). The brick walls were painted white. A single wooden door entry was located on the south elevation, facing the lighthouse. No windows were present on the building; however, a metal vent was located on the east and west elevation beneath the roofline. A wooden sign on the building read:

Photo 30. The oil house, looking northeast, prior to destruction by Hurricane Ian (FMSF n.d.). The oil house was located immediately adjacent to the north side of the Sanibel Lighthouse.

- a) Small debris/artifacts could be put on display within the museum setting.
 - b) The excavation and maintenance of the oil house foundation as a part of the historic property would provide visitors the opportunity to visualize where supporting buildings and structures were located prior to Hurricane Ian.
