CITY OF SANIBEL RESOLUTION 25-060

A RESOLUTION OF THE CITY COUNCIL OF THE CITY OF SANIBEL, FLORIDA, ACCEPTING AND ADOPTING THE CITY'S 2025 SURFACE WATER MANAGEMENT MASTER PLAN UPDATE; AND PROVIDING AN EFFECTIVE DATE.

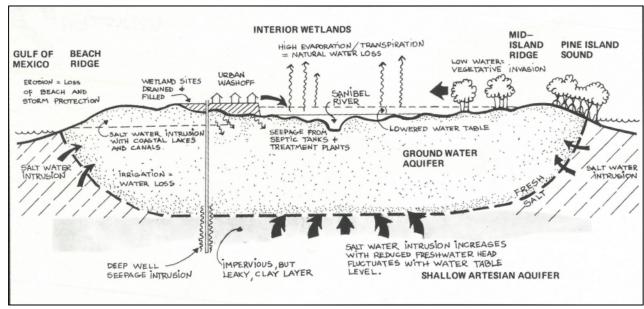
interior wetland areas of Sanibel. This water budget is still valid today. A cross section of the island is provided in **Figure 1** to serve as a pictorial representation of the water budget.

Figure 1. Graphical representation of the water budget of the freshwater basins on Sanibel, taken from *The Sanibel Report* (1976).

Open-water evaporation and ET account for nearly all yearly outflow from the interior freshwater wetlands on Sanibel, as shown in **Table 2**. Estimates of evaporation and ET can be difficult to verify, especially for wetlands on barrier islands, but approximations were made in the 1976 report using a pan evaporation coefficient of 0.7 for the basin.

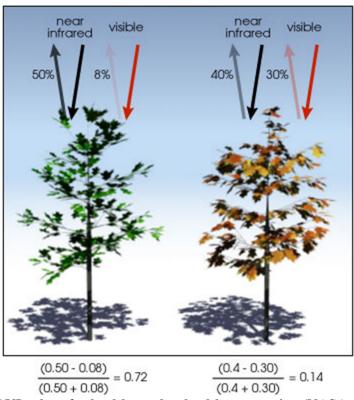
Figure 2. Example NDVI values for healthy and unhealthy vegetation (NASA, 2000).

16 days. Consequently, an image of Sanibel is now taken every 8 days. Landsat Spectral Indices products are courtesy of the U.S. Geological Survey Earth Resources Observation and Science Center. Surface reflectance and top of atmosphere datasets from Landsat 8 were used in NDVI calculations for the period of record. Surface reflectance data is atmospherically corrected and is especially useful when comparing images of a region over time (USGS, 2022). Top of atmosphere data requires less processing and can be filtered by the amount of cloud cover present. NDVI values range from -1.0 to +1.0, with more positive numbers indicating denser or healthier vegetation (see also **Figure 2**).

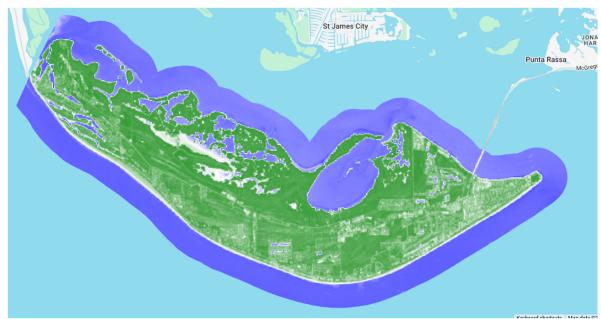
Figure 3. Map showing NDVI values before Hurricane Ian (average Nov. 2013 to Sept. 2022).

Long-term average NDVI values for Sanibel before and after Hurricane Ian in 2022 are provided in **Figure 3** and **Figure 4**. The figures are on a scale of green to white to blue, with green being healthy vegetation, white being no or dead vegetation, and blue being open water. Satellite images with greater than 1% cloud cover were excluded from the analysis, which used top of atmosphere

data. **Figure 3** shows the pre-Hurricane Ian period from November 2013 to September 2022, and **Figure 4** shows the period after the storm, November 2022 to September 2023. The hurricane clearly had a tremendous impact on plant life.

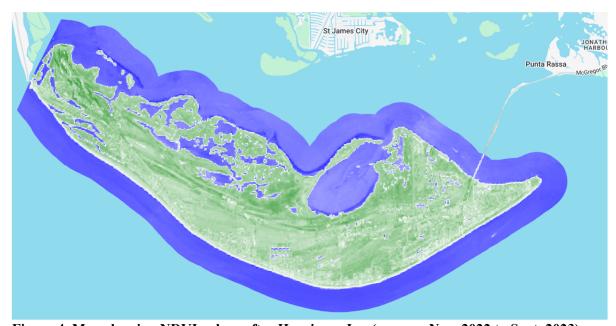
Figure 4. Map showing NDVI values after Hurricane Ian (average Nov. 2022 to Sept. 2023).

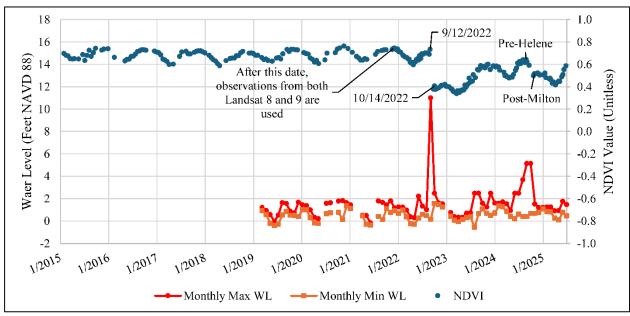
Figure 5. Water levels recorded at Beach Road Weir and average Landsat 8 and 9 NDVI values for the interior freshwater basins.

Landsat 8 and 9 surface reflectance data shown in **Figure 5** was processed to exclude cloudy pixels from the images and shows the average NDVI value over the interior freshwater basins from 2013

Monthly minimum and maximum water levels recorded at Beach Road Weir by SCCF from 2019 to 2025 is also included in **Figure 5**. Note that the maximum surge level from Hurricane Ian was not recorded since the monitoring equipment was inundated, so an estimate obtained from USGS was used. Water levels before and after Ian were compared to explore any changes which the hurricane may have caused. In the initial months following Hurricane Ian, there seemed to be a slight increase in the minimum water levels at Beach Road, but by the beginning of 2023, stages recovered to within about 6" of those experienced in 2019-2022. However, rather than fully returning to the typical annual lows seen in previous years, water levels did not fall as low during the dry seasons of 2024 and 2025, likely because of reduced ET. With only six years of data, it is difficult to determine how unusual these observations are, but it seems likely that surface water levels will recover fully as vegetation recovers.

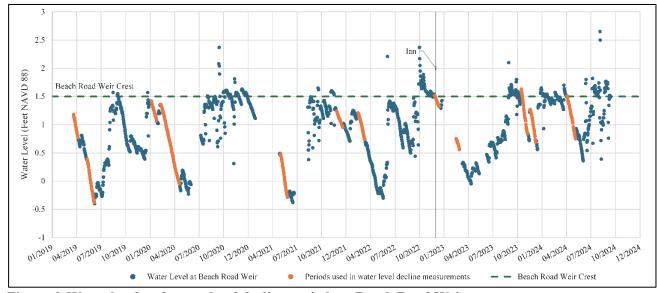
Figure 6. Water level and water level decline periods at Beach Road Weir.

Water level data upstream of Beach Road Weir was obtained from SCCF and analyzed to see if there were changes in the rate of decline of surface water levels during periods with minimal rainfall and without weir gate operation (see **Figure 6**). Under these conditions, the rate of decline should be roughly equivalent to the combined effects of ET, open-water evaporation, upstream groundwater inflows, and groundwater outflows from the basin.

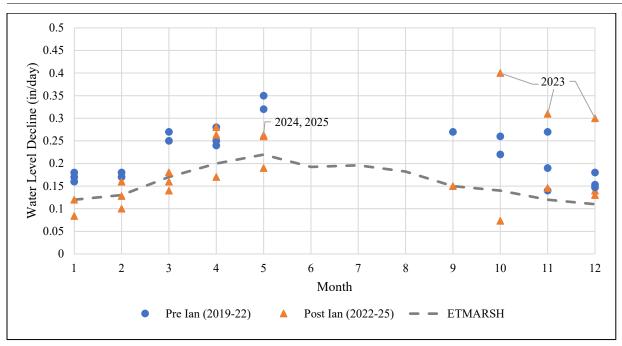
Figure 7. Water level decline rate at Beach Road Weir in inches per day during periods without opening of sluice gates or discharge over weir.

Before discussing the results of this analysis, which are shown in **Figure 7**, it is necessary to explain the use of wet marsh potential ET (ET_{marsh}) as a reference point with which to compare results. ET_{marsh} is a long-term regional average of wetland ET, with monthly values obtained from *Evapotranspiration Estimation for South Florida* (Abtew, 2003) and pro-rated to agree with Sanibel's estimated annual ET_{marsh} of 58-59 inches per year (SFWMD, 2003). This is 10% higher than the open water evaporation rate of 53 inches per year stated in the 1976 *Sanibel Plan*. It should be noted that ET varies greatly from day to day and is significantly influenced by meteorological factors such as solar radiation, relative humidity, and wind speed. ET on a sunny day is higher than ET on a cloudy day, and since the decline rates measured mostly consider days without significant rainfall, the periods of measurement are likely to be sunnier on average than if all days are considered, as in ET_{marsh}. It should therefore come as no surprise that many of the measured decline

rates exceed ET_{marsh}. It is also important to remember that ET_{marsh} is a long-term average for a given month and is not specific to the years we are considering. **Figure 7** shows water level decline rates at various times and includes ET_{marsh} for each month as a comparison. Decline rates before Ian (represented by the blue dots) are consistently greater than ET_{marsh}, as predicted. The expectation was that following Hurricane Ian and the associated vegetation changes, water levels would decline more slowly than before the hurricane due to a reduction in ET caused by plant stress, and this was true for most post-Ian periods of analysis (represented by the orange triangles) except in late 2023, where water level decline rates exceeded pre-Ian conditions. It is unclear what may have caused the increased decline rates in late 2023, but two theories present themselves. One possibility is that, with less vegetation present in the wetlands, the water surface is exposed to more direct sunlight, causing an increase in evaporation rates which make up for the reduced evapotranspiration rates. Another possible explanation is that vegetative regrowth caused increased water uptake and storage by plants.

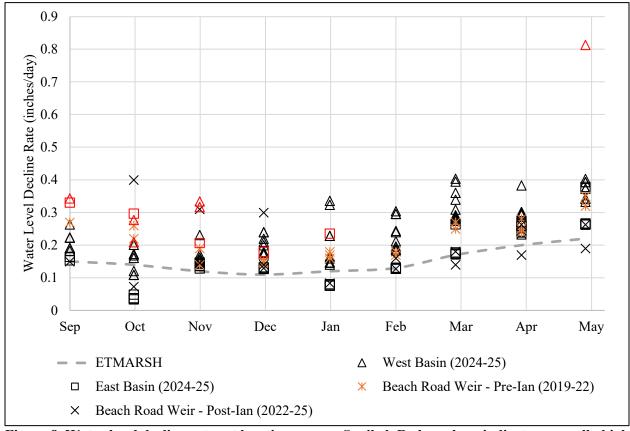
Figure 8. Water level decline rates at locations across Sanibel. Red markers indicate unusually high post-Ian decline rates.

Further investigation into water level decline rates across the island was performed in order to understand current conditions. Using water level data obtained from surface water monitoring locations across the island, decline rates were calculated for 2024 and 2025, as shown in **Figure 8** and **Table 3**. Periods analyzed had minimal rainfall and no weir gate operation. Since the majority of these monitoring locations were installed in 2024, it was not possible to compare current decline rates with those before Ian. However, **Figure 8** and **Table 3** include ET_{marsh} for each month as a comparison. As discussed earlier, it is generally to be expected that the measured water level decline rates will be greater than ET_{marsh}, so instances where this was not the case were notable. One key takeaway from the data is the difference in decline rates which exists between the east and west basins. In general, the west basin has higher decline rates than the east basin.

Significant variability is present, but much of this variability can be explained. Unusually high decline rates are indicated in **Figure 8** as data points with red outlines. Sensors JE-2124 and JE-2125 recorded higher decline rates in late 2024 than did other sensors in the west basin. It is likely that this occurred because the water level at these sensors was above the Tarpon Bay Weir crest elevation, so drainage into the Sanibel River may have been occurring. Additionally, sensor JE-2127 has markedly higher decline rates than other east basin sensors. As discussed in **Section 2.1**,

JE-2127's rapid rate of decline is likely due to its location in a retention area that is adjacent to a drainage ditch. The rapid recovery seen is caused by percolation into the adjacent ditch. Another unusual observation was the rapid decline rate found at sensor JE-2123 in May 2025. Something abnormal is clearly occurring since the sensor drops below the low tide elevation and below all other sensors in the west basin, at twice the rate of other sensors in the basin.

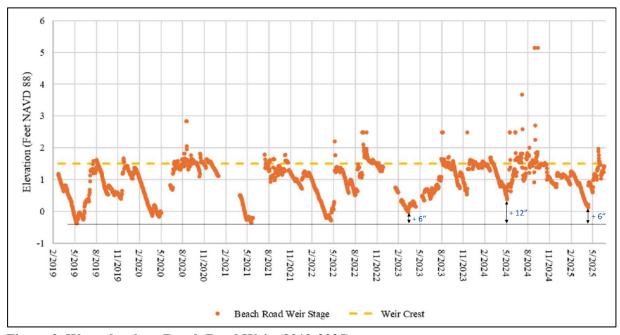
Figure 9. Water levels at Beach Road Weir (2019-2025).

Figure 9 and Figure 10 were created to visualize any differences between the weirs as well as any changes in water levels over time. Water levels at Beach Road Weir and Tarpon Bay Weir are shown for 2019 through 2025. An interesting takeaway from Figure 9 and Figure 10 is that Tarpon Bay Weir, and by extension the entire west basin, often reaches lower stages than does Beach Road Weir and the east basin. This aligns with the conclusion drawn from Table 3 that water levels decline more rapidly in the west basin than in the east basin. So, even though the west basin's weir has a higher crest elevation than the east basin's does, the west basin declines more quickly and

Another notable observation is the difference in minimum annual water levels seen at both weirs. For the dry seasons of 2019 through 2022, Beach Road Weir's minimum annual water level hovered around -0.5 feet NAVD 88. This changed after Ian, and minimum water levels in 2023, 2024, and 2025 were approximately 6 to 12 inches higher than in the previous four years (see **Figure 9**). 2024 exhibited a particularly significant increase of nearly 12 inches, which may be partially attributable to unusually high amounts of rainfall in the first three months of 2024. Tarpon Bay Weir tells a more complex story. The minimum water level at Tarpon Bay Weir fluctuates but is typically at or below -0.75 feet NAVD 88, which is below sea level and would have allowed

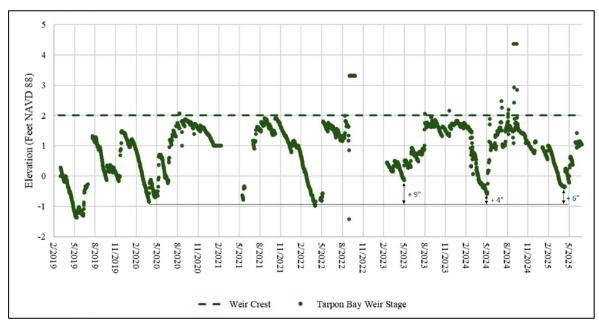
Figure 10. Water levels at Tarpon Bay Weir (2019-2025).

saltwater intrusion into the freshwater lens. As at Beach Road Weir, minimum annual water levels are higher than those in previous years, with increases ranging from about 4 inches to 9 inches. Interestingly, 2024 sees an increase of just 4 inches at Tarpon Bay Weir, as opposed to nearly a foot of change in 2024 at Beach Road Weir. And, in 2024, water at Tarpon Bay Weir is a foot lower than water at Beach Road Weir. However, it should be remembered that this is a manipulated system, so differences may be partially due to human intervention, such as opening of the weir gates.

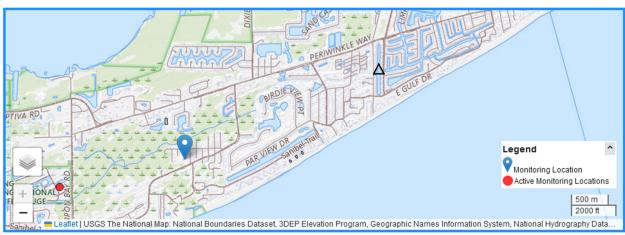
Figure 11. Location of USGS well L-1403 (blue marker) and Beach Road Weir monitoring equipment (black marker).

In addition to the water level analyses discussed previously, groundwater data was evaluated at USGS surficial aquifer well L-1403, which is located in the east basin along Casa Ybel Road (see **Figure 11**). The well was installed in the early 1970s, and daily measurements were taken from 1973 until 2018. Periodic field measurements have also been recorded over the years, typically once per month, although this is not always the case. Any data from November 2018 or later comes exclusively from the field measurements, and it should be noted that since this data is taken infrequently, it likely fails to capture the extremes, both high and low, of the water table. It should also be noted that although measurements are typically taken once per month, no measurements have been posted online since March 2025.

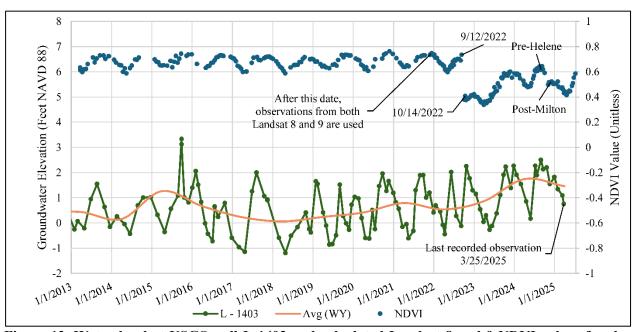
Figure 12. Water level at USGS well L-1403 and calculated Landsat 8 and 9 NDVI values for the interior basins over time. Orange line indicates average level per water year (WY).

Most of the water leaving the interior basins on Sanibel has historically done so through evapotranspiration, a process inherently tied to plants. Given that plant populations have experienced a significant decline after Hurricane Ian, it would make sense for water levels to recede more slowly following rainfall events. **Figure 12** shows the relationship between NDVI (i.e., vegetative health) and groundwater at L-1403 over the period from 2013 to 2024. The average groundwater stage for each water year is included to show the overall trend.

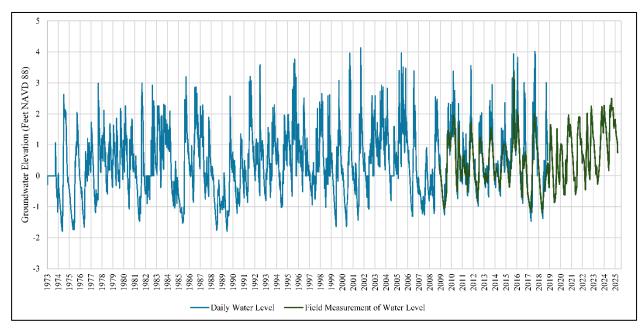
Figure 13. Long-term groundwater elevation at USGS well L-1403.

trending upwards since 2017 (see **Table 4**), they are well within the historical range for the period of record (see **Figure 13**). It seems unlikely that Hurricane Ian has caused any permanent changes to water levels on the island.

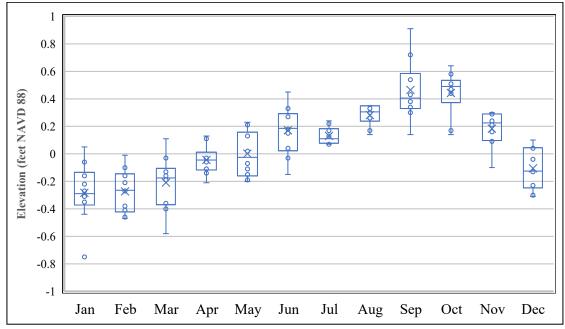
Figure 14. Monthly mean sea level, 2015-2024 at NOAA Fort Myers Tide Station 8725520.

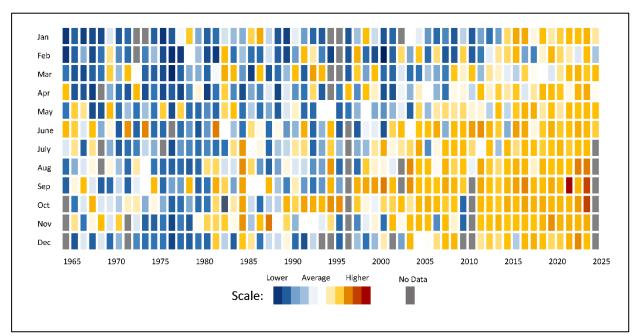
Figure 15. Overall trend of monthly maximum tide elevation at NOAA Fort Myers Tide Station 8725520.

Sanibel's low-lying profile and status as a barrier island make it particularly vulnerable to hurricanes and storm surge. **Figure 15** shows how the monthly maximum tide at the Fort Myers tide gauge has increased over time. Refer to **Table 6** for the numerical values of the ten highest water levels recorded at the gauge, as well as the storm events they correspond with. It is notable that five of the highest ten records occurred during the past three wet seasons.

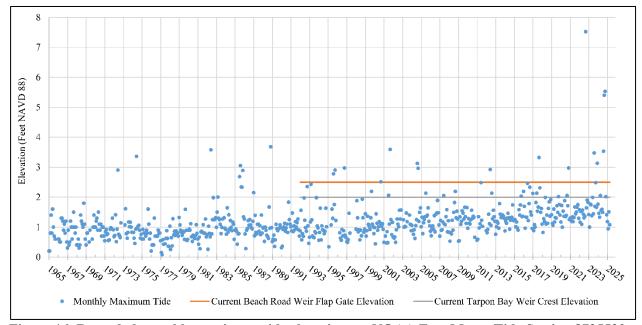
Figure 16. Recorded monthly maximum tide elevations at NOAA Fort Myers Tide Station 8725520.

Over the course of Sanibel's history, storm surge has wholly inundated the island with saltwater multiple times, though there was a long period of relative calm prior to 2022, as shown in **Figure** 16. Plans for stormwater management on Sanibel must consider the island's unique susceptibility to saltwater flooding and sea level rise.

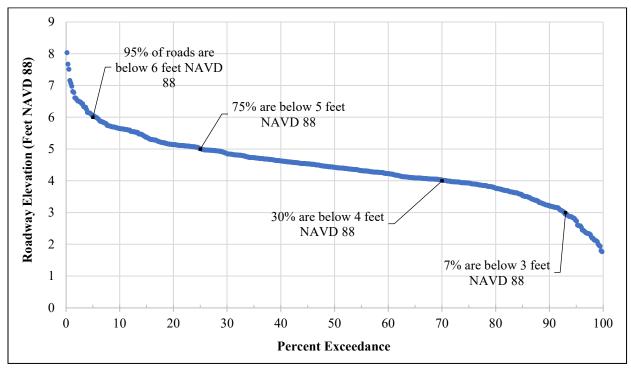
Figure 17. Percent exceedance curve for public roadways on Sanibel.

A citywide analysis of 62 miles of public roadway elevations was performed using Light Detection and Ranging (LiDAR) data from Lee County, collected in 2018-19. To generate a representative grid of the island, points were placed at road intersections and at regular intervals when no intersections were present. Mapping of the points and their corresponding elevations is provided in **Exhibit 4**. A percent exceedance curve is provided in **Figure 17** which shows the percentage of roadways below certain elevations.

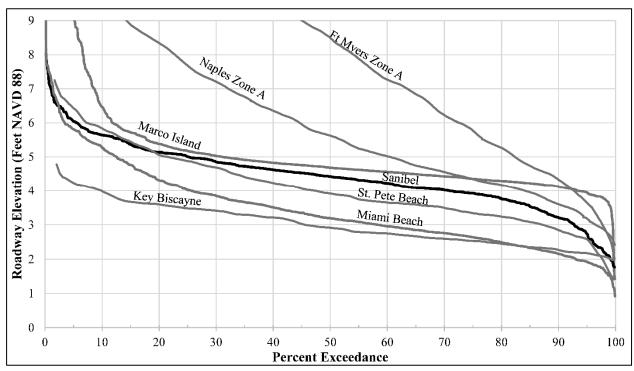
Figure 18. Comparison of percent exceedance curves for Sanibel vs. other coastal municipalities.

This roadway elevation analysis was repeated for several other coastal areas using LiDAR data from SFWMD, last updated in 2023. These areas were: City of Fort Myers Hurricane Evacuation Zone A, City of Naples Hurricane Evacuation Zone A, City of Marco Island, City of Miami Beach, City of Key Biscayne, and City of St. Pete Beach. Marco Island, Miami Beach, Key Biscayne, and St. Pete Beach were chosen because they are barrier islands, like Sanibel. Hurricane Evacuation Zone A for Fort Myers and Naples were chosen due to their proximity to Sanibel. **Figure 18** compares the percent exceedance curves for all these municipalities with Sanibel's. Sanibel's roadways are generally more elevated than three of the four other barrier islands studied but are lower than the nearest two mainland areas.

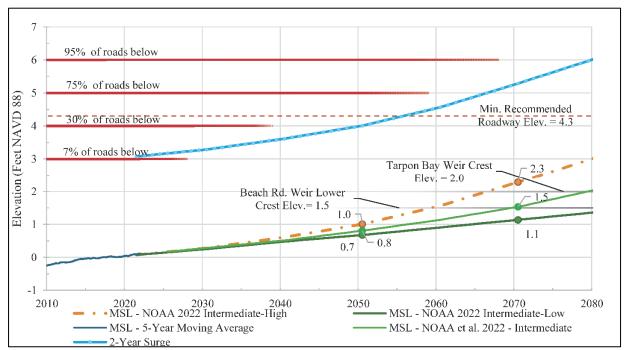
Figure 19. Sea level rise projections for Sanibel, with road elevations and weir crest elevations provided for reference.

Sea level rise projections for Sanibel are provided in **Figure 19** and are based on the 2022 Intermediate-Low, Intermediate, and Intermediate-High curves developed by the National Oceanic and Atmospheric Administration for the Fort Myers Tide Station 8725520. Labeled data points are included at the planning horizons of 2050 and 2070. Additionally, the expected 2-year storm surge

elevation is layered onto the Intermediate-High curve. Critical elevations such as island-wide road crown elevations and the crest elevations of Tarpon Bay Weir and Beach Road Weir are also provided for reference. These are shown as horizontal lines to indicate the water level at which the infrastructure will become inundated.

This report recommends a minimum road elevation of 4.3 feet NAVD 88 for all new roadways, which would protect them from sea level rise until mean sea level reaches 2.3 feet NAVD 88 (assuming a target buffer of 2 feet to protect the road base material). Levels above 2.3 feet NAVD 88 would lead to a waterlogged base. Having a waterlogged base for long periods will damage a road, and total inundation can have an adverse effect on pavement life. Based on the Intermediate-High curve, significant road base failure is expected for up to 7% of public roadways by 2050, which is approximately 4.3 miles. Increasing the minimum existing roads to elevation 4.3 feet NAVD 88 (approximately 50% of roads, or 31 miles) will provide increased protection until 2070. By 2080, however, up to 75% of roads are anticipated to experience road base failure if the Intermediate-High curve becomes reality. When looking at the Intermediate-Low curve, approximately 20% of roadways (12.4 miles) are vulnerable to road base failure by 2080 and all would be protected if raised to a minimum elevation of 4.3 feet NAVD 88.

Based on the current 2-year storm surge of 3 feet NAVD 88 shown in **Figure 19**, regular overtopping of the lower crest of both weirs has already begun. This is occurring even with the current 1-foot flap gate on Beach Road Weir, designed to offer protection against saltwater intrusion from sea levels up to 2.5 feet NAVD 88. To confirm this, specific conductivity data collected upstream of Beach Road Weir over the past 5 years was reviewed along with data collected throughout the west basin.

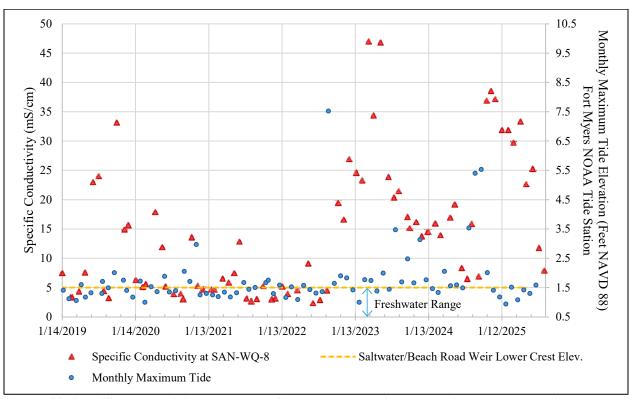
Figure 20. Specific conductivity upstream of Beach Road Weir and maximum monthly tide levels.

Specific conductivity is a measure of a solution's ability to conduct electricity and is an indirect measurement of the concentration of dissolved ions in solution. It is often used in place of directly measuring the salinity of a sample. Generally, freshwater's specific conductivity is between 0 and 5 millisiemens per centimeter (mS/cm), ocean water tends to have a value of about 55 mS/cm, and brackish water is in between 5 and 55 mS/cm. **Figure 20** plots specific conductivity at Beach Road Weir along with maximum monthly tide measurements, and **Figure 21** plots specific conductivity at three locations in Sanibel's west basin as shown in **Exhibit 8**.Conductivity data points above the yellow line indicate that water above the Beach Road Weir is brackish, and tide points above the yellow line indicate that the monthly maximum tide exceeded the Beach Road Weir's lower crest elevation of 1.5 feet NAVD 88.

In late September of 2022, Hurricane Ian made landfall in Southwest Florida, bringing massive storm surge with it. Conductivity was not measured in September 2022 due to Ian, and the monthly maximum tide shown on the graph (about 7.6 feet NAVD 88, recorded in Fort Myers) is much lower than the actual water level near the weir on Sanibel. USGS mapping on Sanibel shows the surge elevations ranged from 8 to 13 feet NAVD 88. After Ian, conductivity levels peaked and remained consistently above pre-hurricane levels until summer 2024, showing how long it takes the interior basins to recover to freshwater conditions following such a surge event. Conductivity levels spiked again at the end of the 2024 hurricane season, but, due to heavy rainfall in 2025, are nearly fully recovered as of August 2025. Recommendations for improvements to the weirs and weir policy are provided in the next section.

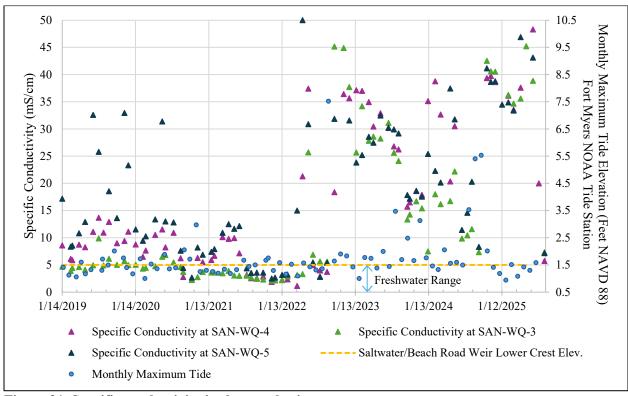
Figure 21. Specific conductivity in the west basin.

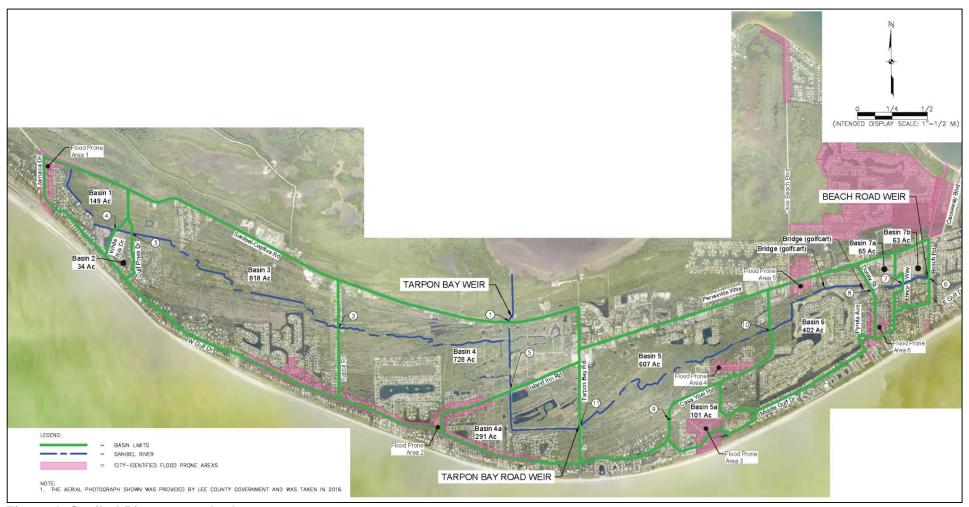
Figure 1. Sanibel River watershed.

Figure I illustrates the roadways listed above. The watershed map further divides the river into basins that are used in the model. A summary of the structures included in the model is shown in **Table I**. These structures are identified by numbers in the leftmost column of **Table I**, and their locations are shown in **Figure 2**.

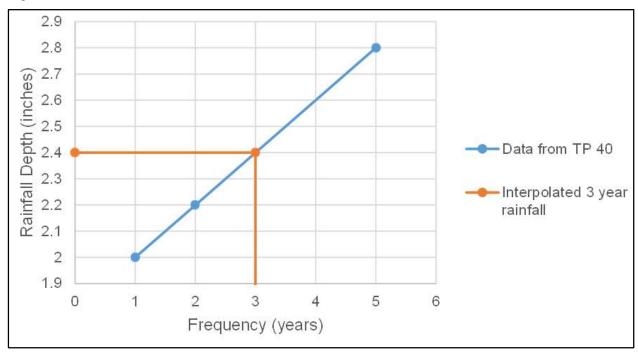
Figure 2. 3-Year, I-Hour Rainfall Depth.

The rainfall depth of the 3-year, I-hour event is estimated at 2.4 inches. This value was obtained from plotting the depths for the I-year, I-hour; the 2-year, I-hour; and the 5-year, I-hour from the TP-40 Rainfall Frequency Atlas of the United States, U.S. Department of Commerce Weather Bureau, and interpolating. See **Figure 2**.

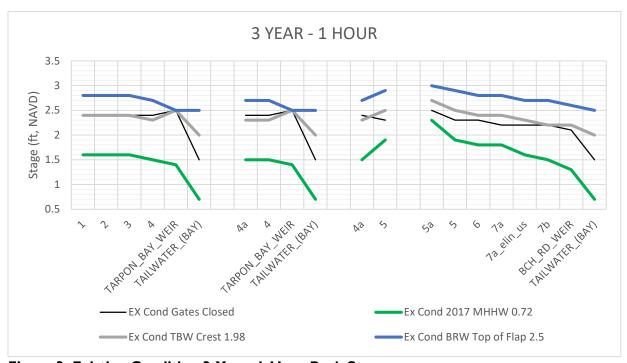
Figure 3. Existing Condition 3-Year, I-Hour Peak Stages.

A summary of the peak stages is shown graphically in Figure 3 through Figure 6.

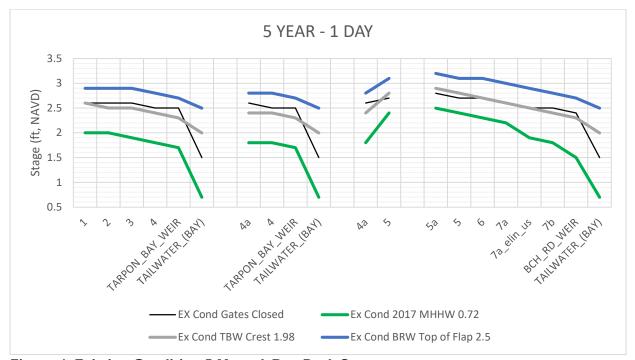
Figure 4. Existing Condition 5-Year, I-Day Peak Stages.

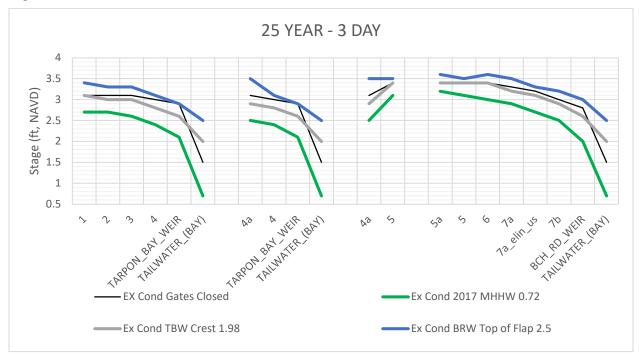
Figure 5. Existing Condition 25-Year, 3-Day Peak Stages.

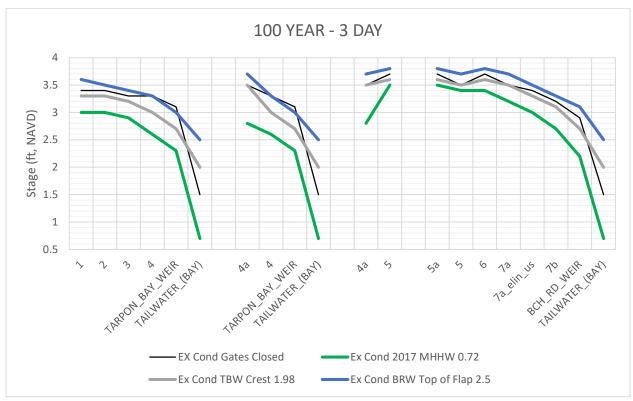
Figure 6. Existing Condition 100-Year, 3-Day Peak Stages.

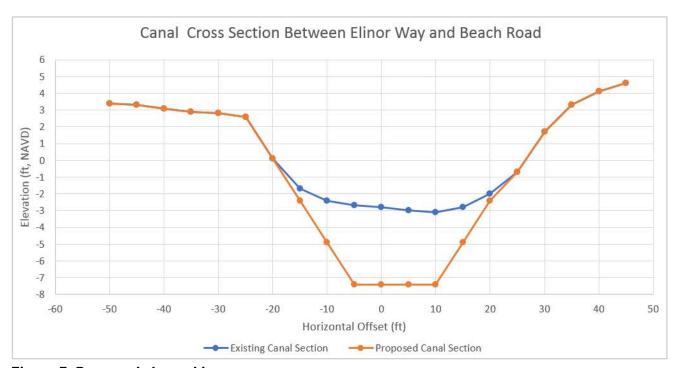
Figure 7. Proposed channel improvements.

The potential improvements analyzed consisted of adding two additional box culverts under Sanibel-Captiva Road (for a total of six barrels) and performing a dredge on approximately 1,100 LF of canal between Elinor Road and Beach Road. The dredging project is already underway, and it is expected to be completed by fiscal year 2026. The canal improvements target a portion of the River that has limited undeveloped floodplain, and the flow is confined mostly to within the river banks. The proposed change to the cross section is shown in **Figure 7**.

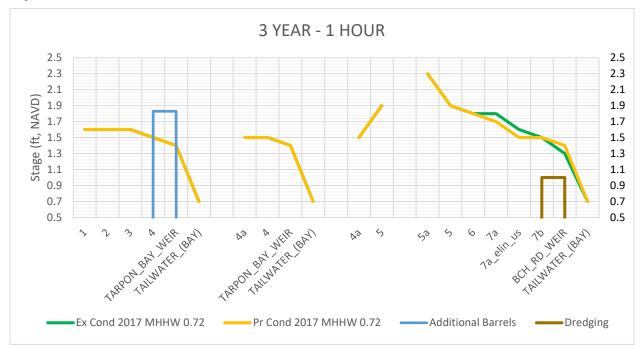
Figure 8. Proposed Improvements 3-Year Peak Stages.

The potential improvements were added to the existing conditions modeled previously and modeled in ICPR. A summary of the peak stages is shown graphically in **Figure 8** through **Figure 11**.

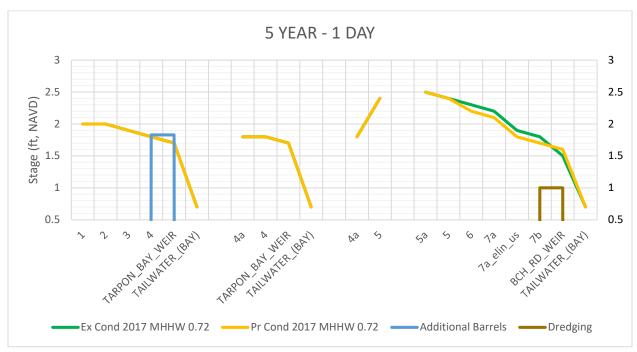
Figure 9. Proposed Improvements 5-Year Peak Stages.

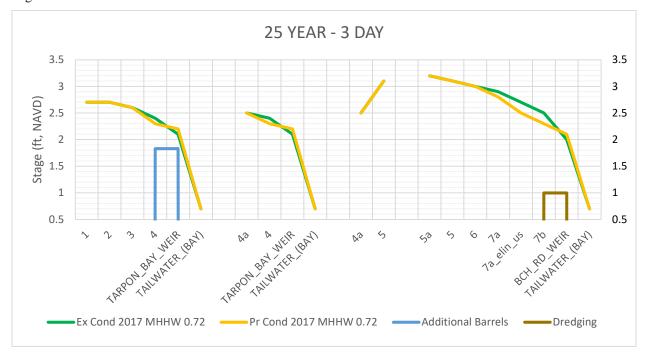
Figure 10. Proposed Improvements 25-Year Peak Stages.

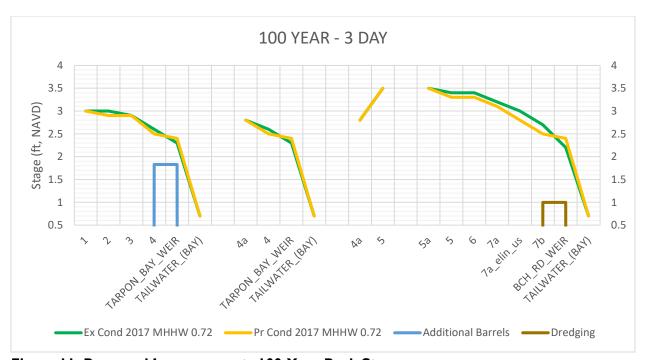
Figure 11. Proposed Improvements 100-Year Peak Stages.

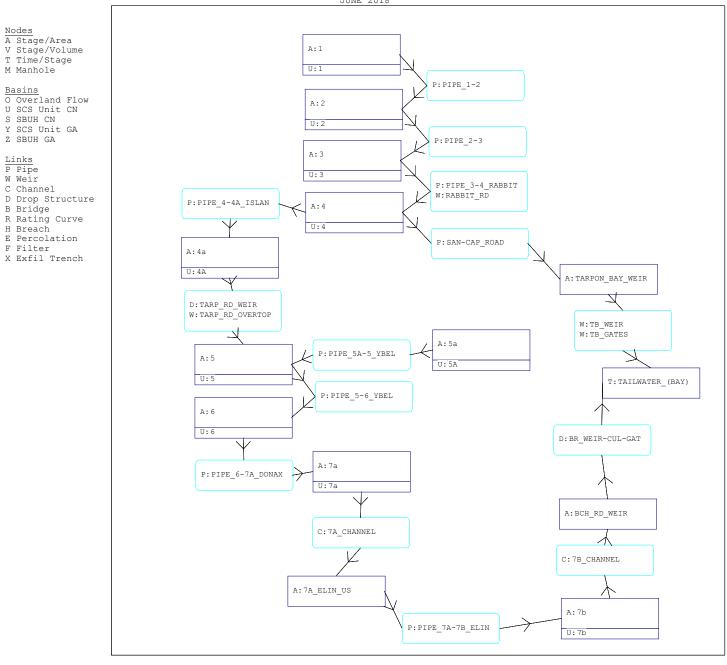
SANIBEL RIVER EXISTING CONDITION - 2100 MSL NODE DIAGRAM JUNE 2018

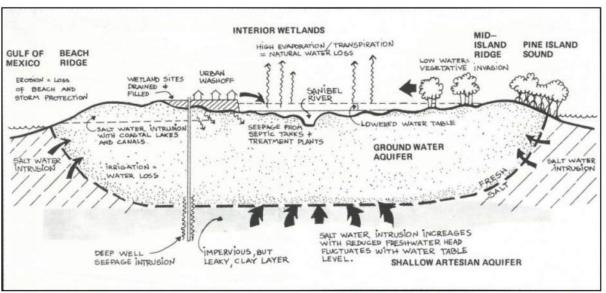
Figure 1. Graphical representation of the water budget of the freshwater basins on Sanibel, taken from The Sanibel Report (1976).

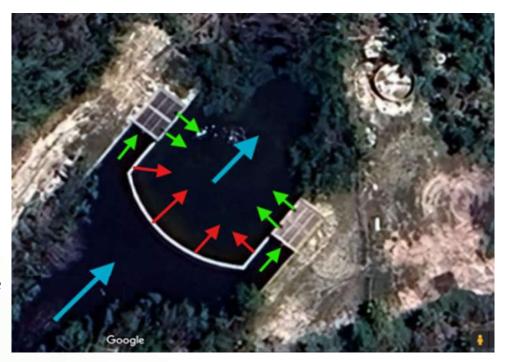
Tarpon Bay Weir

RED-Weir Overflow (>3.2 NGVD)

GREEN- Flow through Gates when tide is lower

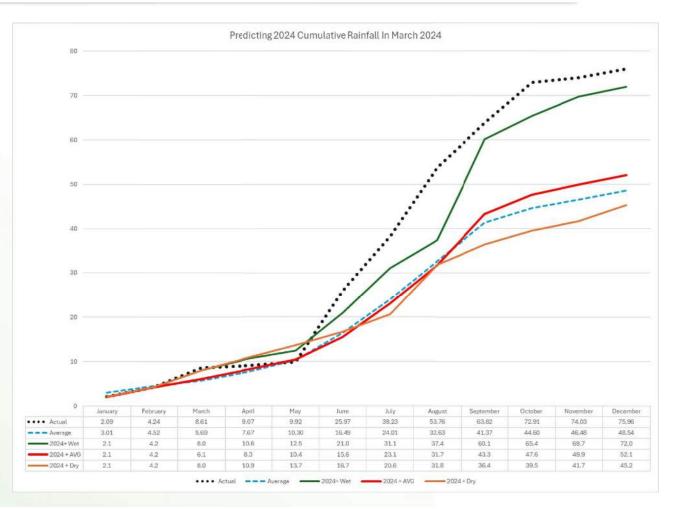
JUNE 2024

Rain 21.28"
Frequent Openings
6/12 - 6/17

6/1	6/10	6/19	6/25	6/30
West					
Basin	0.62	1.71	2.18	2.15	2.17
East					
Basin	1.57	2	2	2.16	2.43
Rain	0	4"	19"	19"	21.3"

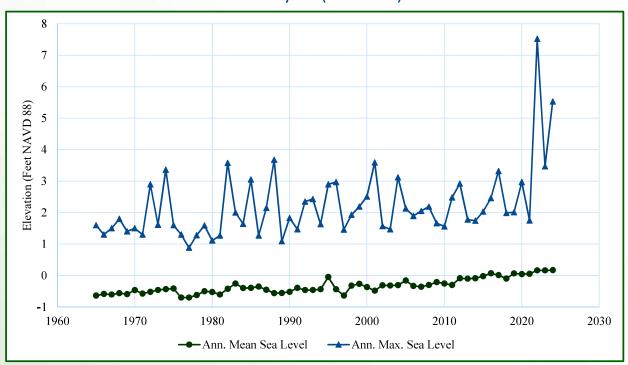
NOAA Tide Station – Fort Myers (8725520)

10 Highest Water Levels 1965 to Present

Rank	Peak EL	Date
1	7.52	2022-09-28
2	5.53	2024-10-10
3	5.4	2024-09-27
4	3.68	1988-11-23
5	3.59	2001-09-14
6	3.58	1982-06-18
7	3.53	2024-08-04
8	3.47	2023-08-30
9	3.36	1974-06-25
10	3.32	2017-09-11

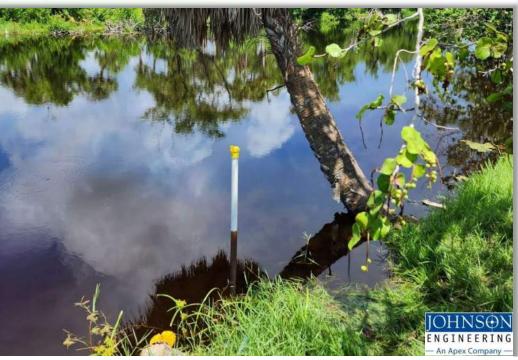
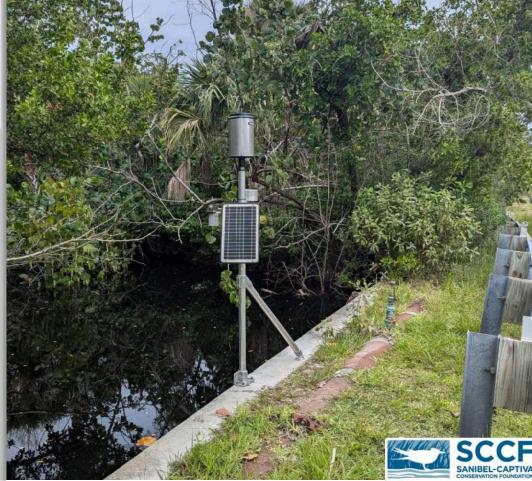
2. Data Collection & Review

- Water Level Datalogger Installations
 - > 10 Locations Installed by Johnson Engineering
 - 4 Locations Installed by SCCF

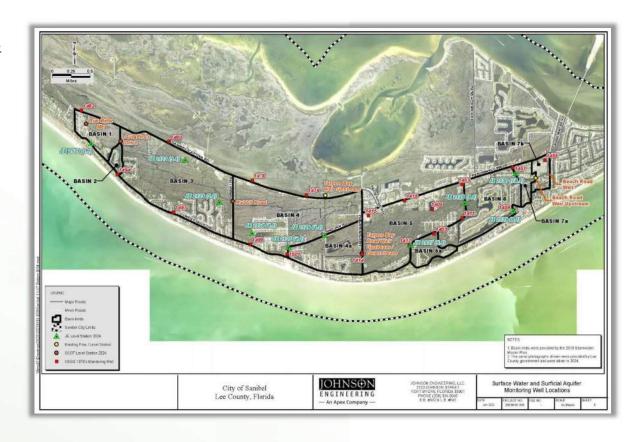
2. Data Collection & Review – Surface Water

- The basins generally act as a level pool & runoff is efficiently conveyed to the Sanibel River, as designed.
- Surface water levels in the interior wetlands are similar to those in 1977.

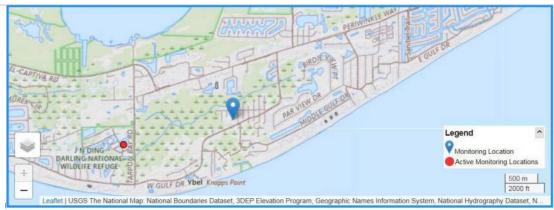
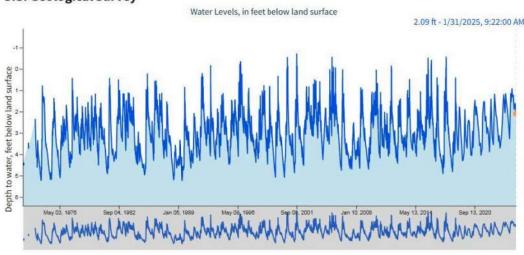
L -1403 U.S. Geological Survey

2. Data Collection & Review – Groundwater

- Interior groundwater percolation is still occurring similarly to past observations, going back to 1953.
- Due to the Island's low-lying profile, there is little to no deep percolation out of the system. This is consistent with The Sanibel Report (1976).

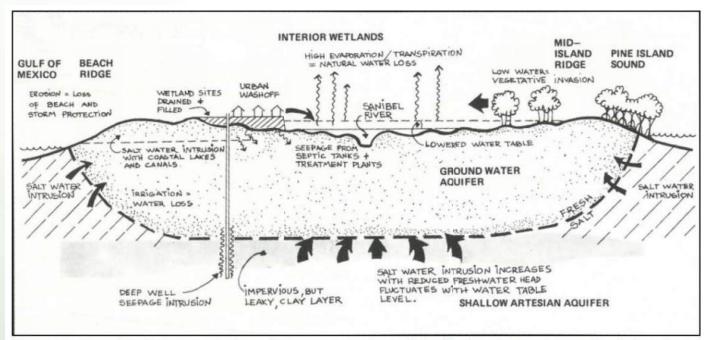
2. Data Collection & Review – Water Budget

• Evaporation & evapotranspiration (ET) account for nearly all yearly outflows from Sanibel, not runoff through the weirs.

Figure 1. Graphical representation of the water budget of the freshwater basins on Sanibel, taken from The Sanibel Report (1976).

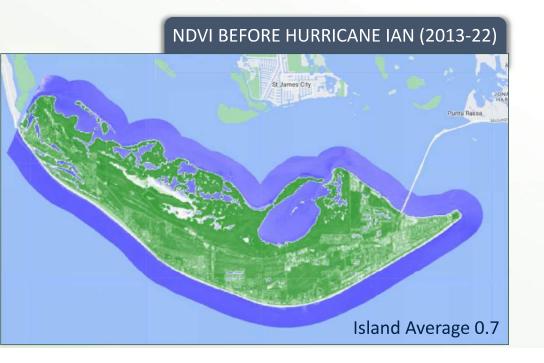
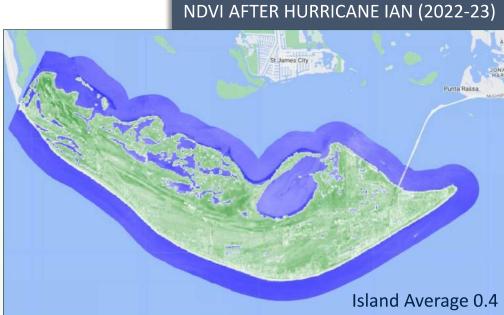
2. Data Collection & Review – Water Budget

An analysis of satellite imagery of Sanibel using the Normalized Difference Vegetation Index (NDVI) shows Hurricane Ian had a devastating impact on plant life.

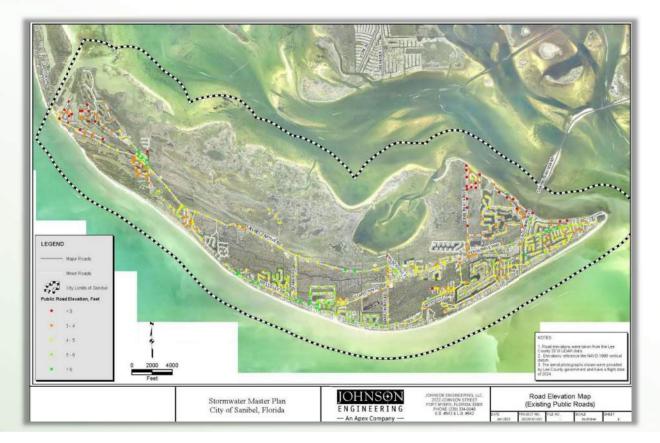
3. Surface Water Management Resiliency – Roadway Elevation Analysis

• 75% of roads on Sanibel are below elevation 5 feet NAVD 88.

- 75% of roads on Sanibel are below elevation 5 feet NAVD 88.
- The Intermediate Low sea level rise projection for 2080 anticipates 20% of roadways will be vulnerable to failure.
- Increasing the minimum roadway elevation to 4.3' feet NAVD 88 would protect all roadways through 2080 (Int.-Low Scenario).

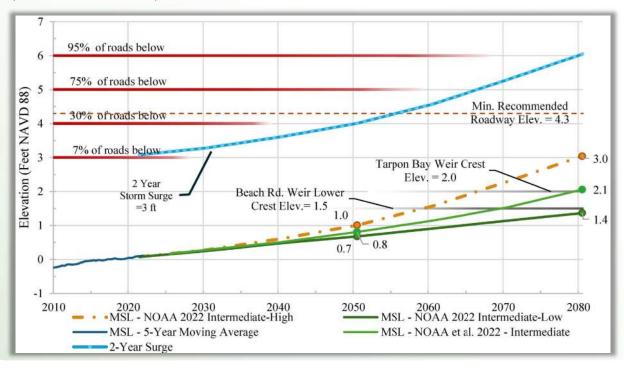
3. Surface Water Management Resiliency – Roadway Elevation Analysis

- The Intermediate Low sea level rise projection for 2080 anticipates 20% of roadways will be vulnerable.
- Increasing the minimum roadway elevation to 4.3' feet NAVD 88 would protect all roadways through 2080 (Int.-Low Scenario).

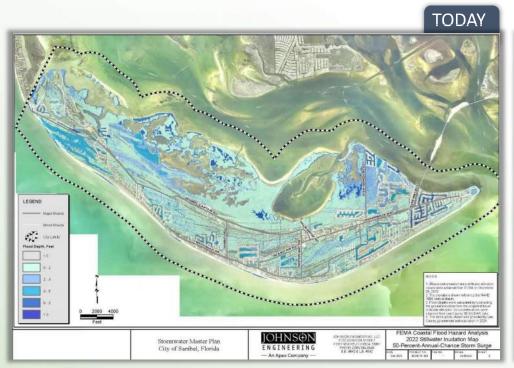
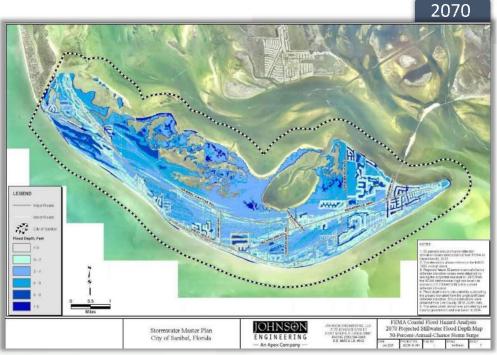
3. Surface Water Management Resiliency – 2-Year Storm Surge

- Minimal Flooding Today in the 2-Year Surge Event
- Impacts of Storm Surge Anticipated to Worsen
- Ability to Maintain a Freshwater Wetlands Increasingly Difficult

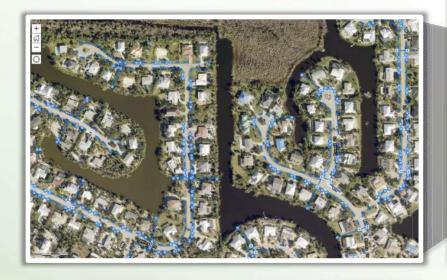
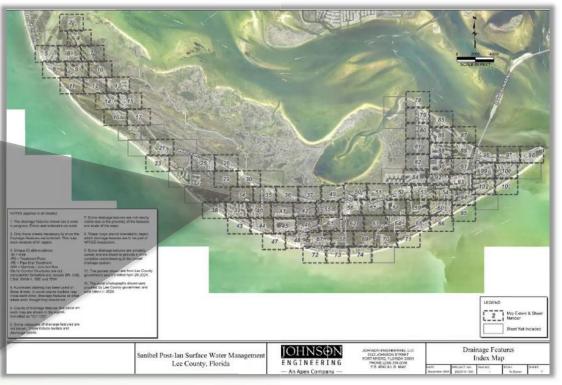
4. Surface Water Management Damage Repairs – Mapping Update

- Previous Mapping Focused on Primary Infrastructure
- Developed Comprehensive Map to Include Driveway Culverts
 - > 820 Culverts Added to Map
 - > 1,763 Pipe Ends Added to Map
 - > 2,224 Swales Added to Map
 - > Updated Drainage Map Book & GIS Map

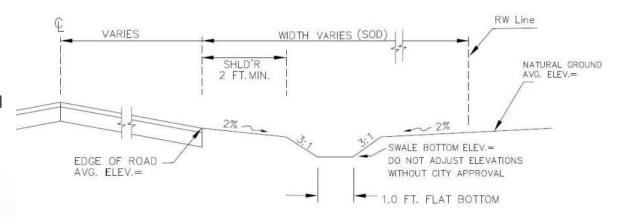
TYPICAL SWALE SECTION

- Public works ROW permits are free of charge.
- Swales exist for a reason.
- No rocks, stones, mulch or pine straw.
- No trees, shrubs or bushes.
- Sod and/or native ground covers only.

NO SCALE

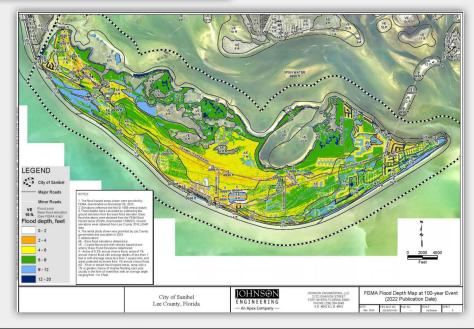
Occurs when streams and rivers exceed their capacity. Sanibel has two interior watersheds that collect rainfall and outfall via two weirs to Pine Island Sound.

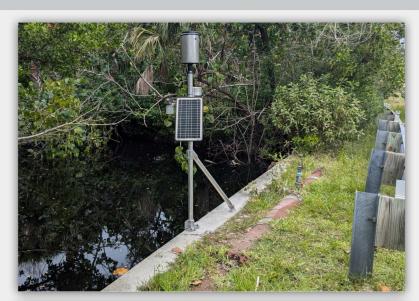
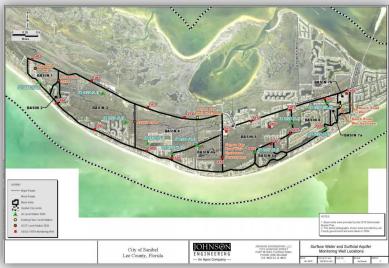
SURFACE WATER

- Installed 14 water level data recorders.
- The basins generally act as a level pool and runoff is efficiently conveyed to the Sanibel River, as designed.
- Surface water levels in the interior wetlands are similar to those in 1977.
- New roadside culverts could help with the slow recovery along West Gulf Drive.

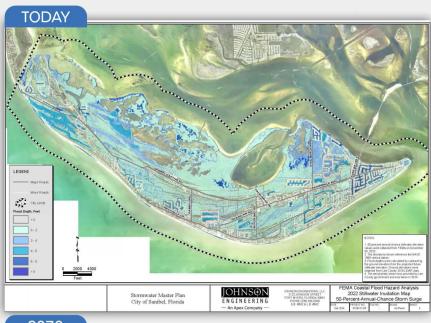
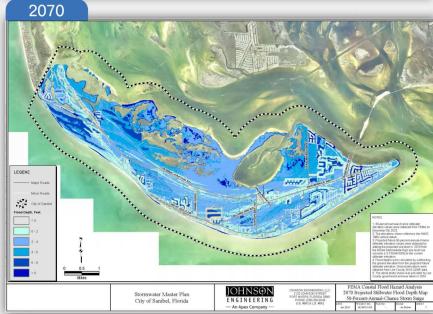
2-YEAR STORM SURGE

- The 2-year storm surge events are anticipated to significantly worsen over the next 50 years.
- The ability to maintain a freshwater system on Sanibel's interior will grow increasingly difficult with continued sea level rise.
- Minimal flooding occurs today in the 2-year storm surge event.
