## Sanibel Golf Course Fertilizer and Lake Management Recommendations Report Card Program

### Post-Hurricane Ian, Debby, Helene, and Milton Update

**Reporting Period:  
October 2024-September 2025**

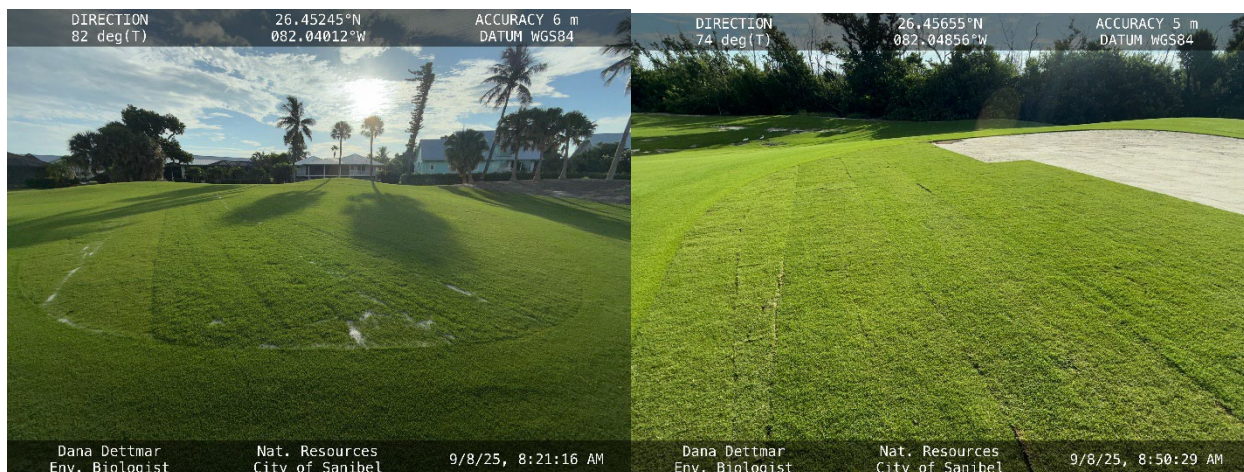
- In 2024, The Dunes completed a turf grass renovation, changing from predominantly Bermuda grass to paspalum. Initially, Bermuda grass was to remain on the greens; however, the greens have now also been converted to paspalum. The change was made because paspalum has a higher salt tolerance compared to all other turf species and has a higher probability of survival when inundated by saline water.
- Paspalum also has lower nutrition (fertilizer) requirements. Since converting to paspalum, there has been no wall to wall fertilizer applications in over a year. This should undoubtedly have a positive impact on water quality.
- Soil tests continue to show elevated salt levels, which requires additional gypsum applications.

Paspalum replacement on greens

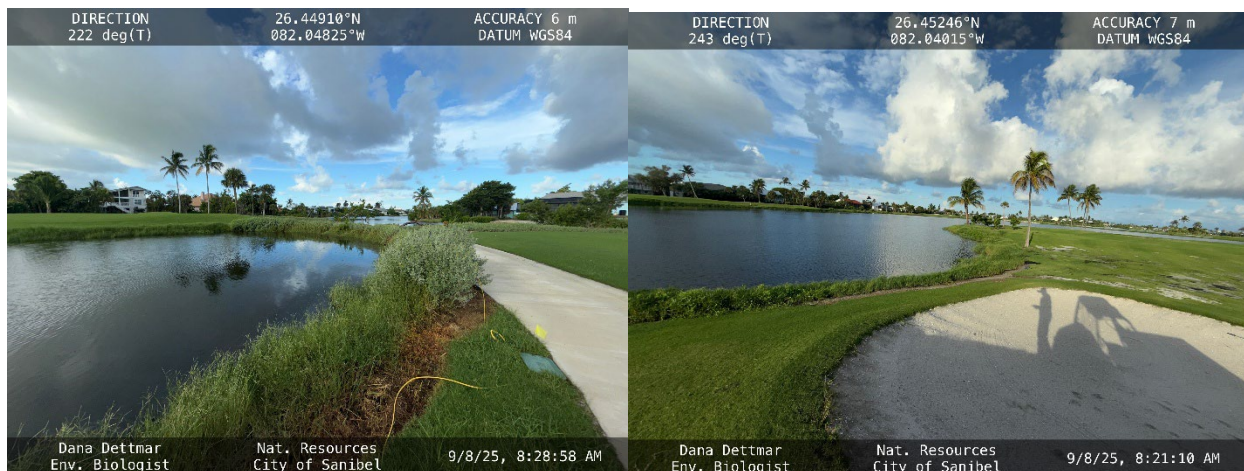
Shoreline buffers

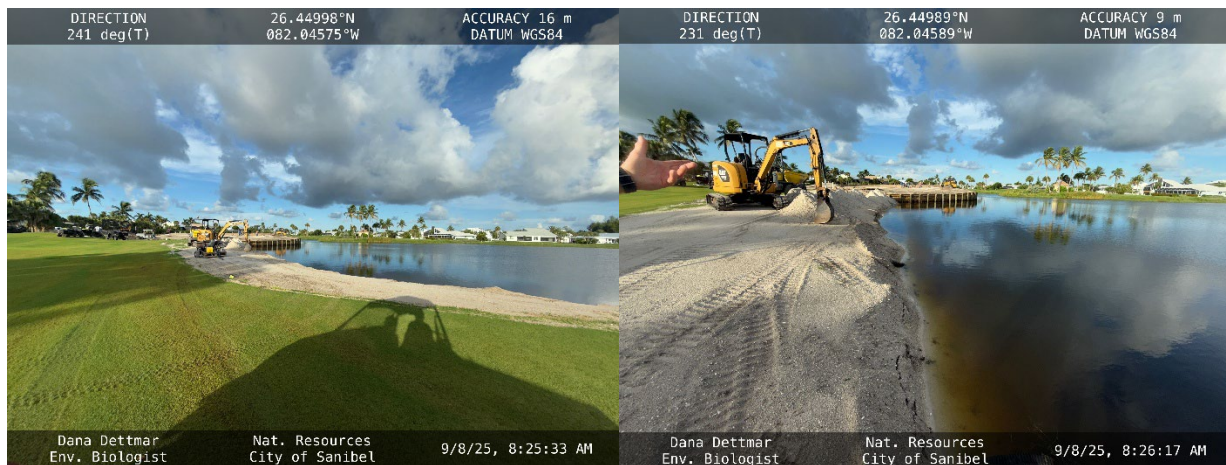
- As a result of recent storm events, The Dunes experienced multiple lake bank washouts. The Dunes is in the process of reducing the amount bulkhead around the course and recontouring the shorelines, which provides opportunity for future shoreline plantings.
- Dunes staff are working on long-term plans for failing cart paths, bulkheads, and lake berms.

Bulkhead removal and recontouring of shoreline

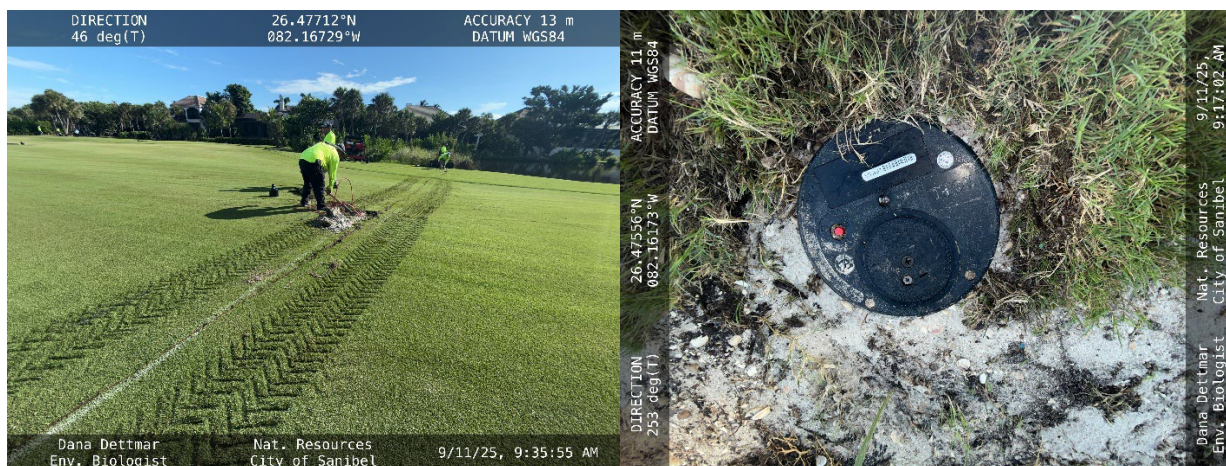
- The Sanctuary is in the process of replacing the entire irrigation system with state of the art technology. The new system is wireless and can be manipulated through an app, which runs a daily diagnostic test to identify any issues. The system is hurricane proof since all receivers can be unplugged and brought in when storms are approaching.

Irrigation replacement

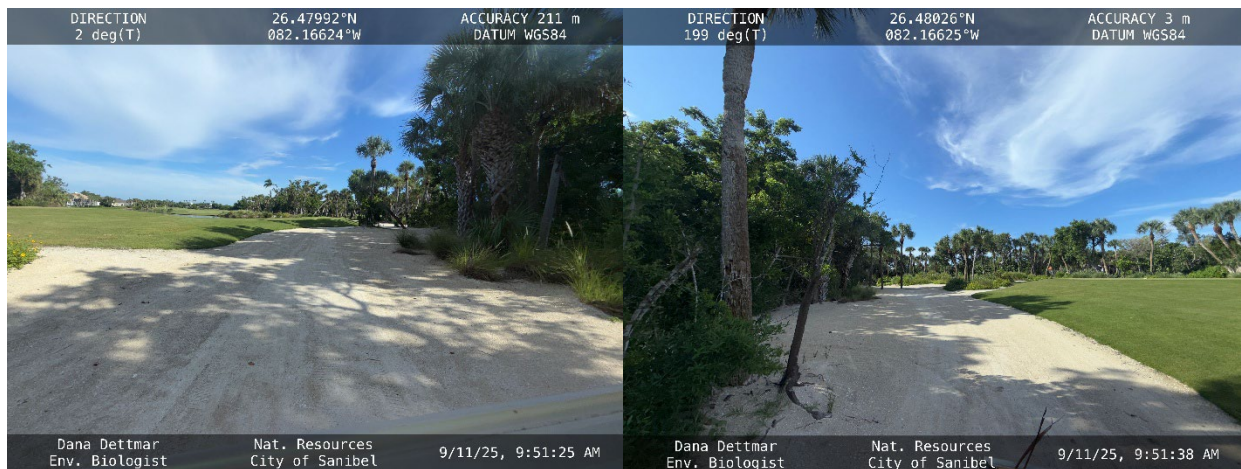
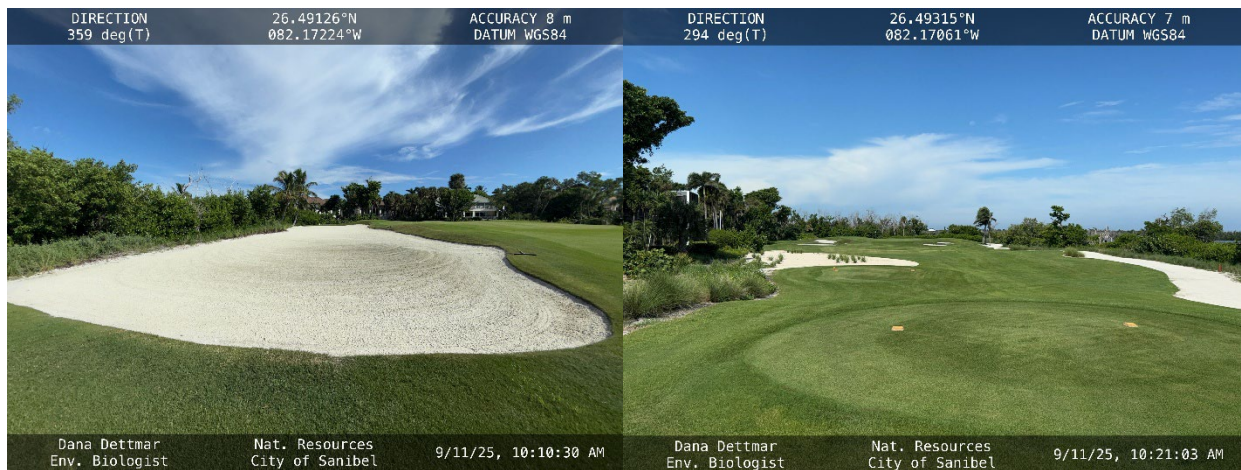
- The Sanctuary has removed turf grass on multiple holes throughout the course that have been difficult to manage following the storm events, including 2,000 sqft on Hole 1, 12,000 sqft on Hole 3, and 6,000 sqft on Hole 4. These areas were replaced with bunkers or waste areas with native plantings. This will reduce the amount of fertilizer applied to the course.
- Soil tests found high salt content in areas where storm surge sat for an extended period of time and have required the use of gypsum to reduce salt levels.

Turf removal areas

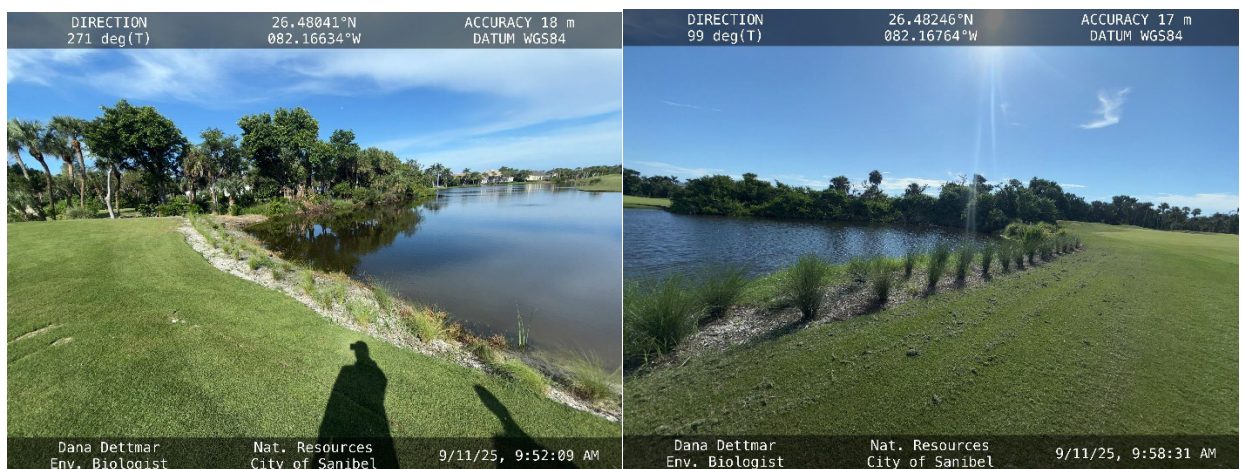
- Two small-scale algae blooms were reported on Lake 1 in March 2025 and Lake 4 in February 2025.
- Last year, water quality sampling as part of the SCCW program revealed a Chl-a concentration of 38.3 ug/L and 74.4 ug/L in lakes 4 and 7, respectively. Recent sampling revealed an average Chl-a concentration of 41.0 ug/L and 34.7 ug/L in lakes 4 and 7, respectively.
- Lake salinity remains elevated at 10.7 PSU and 8.3 PSU in lakes 4 and 7, respectively.
- The Sanctuary's aeration system is fully back online. The purchase of the new system was a cost-share between the golf course and HOA.
- The lakes experienced washouts along some portions of the bank in addition to shoreline and littoral vegetation loss. Course staff has restored the eroded banks and has installed approximately 5,000 native plants.
- No fish kills were reported.

New shoreline plantings

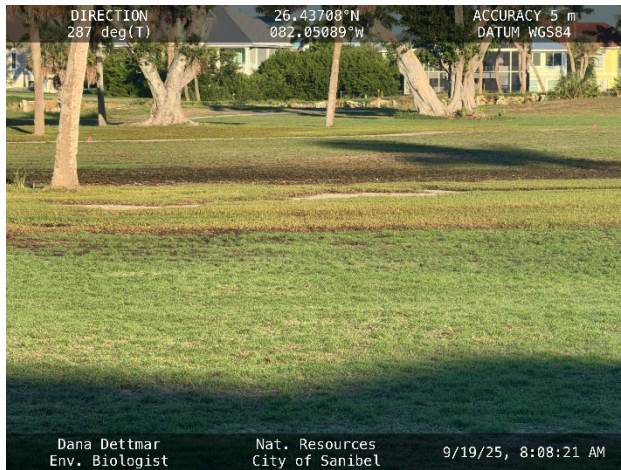
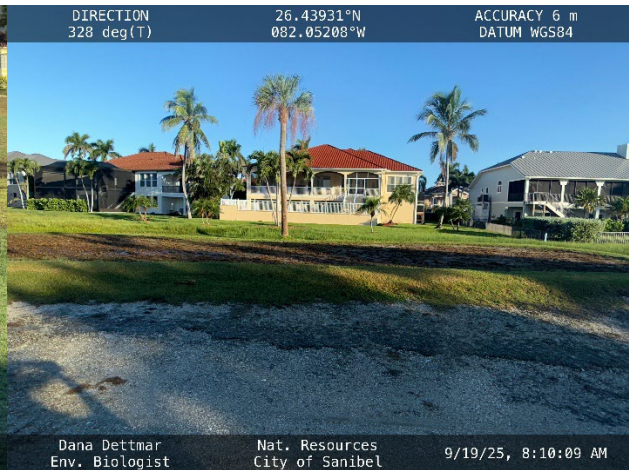
- Sanibel Island Golf Club (SIGC) uses paspalum turf; however, there are a significant number of low-lying areas on the course that held saltwater storm surge for weeks to months following Hurricane Ian, but also more recently with Debby, Helene, and Milton. The course experienced significant turf losses in these areas and continues to struggle to restore them. The course is currently undergoing a large-scale renovation that includes resodding tees and greens and resprigging the fairways with paspalum.
- Due to budget constraints, minimal fertilization is occurring on the course. Course staff is administering less expensive soil microbial blends and humates to offset fertility deficits.

Paspalum resprigging areas

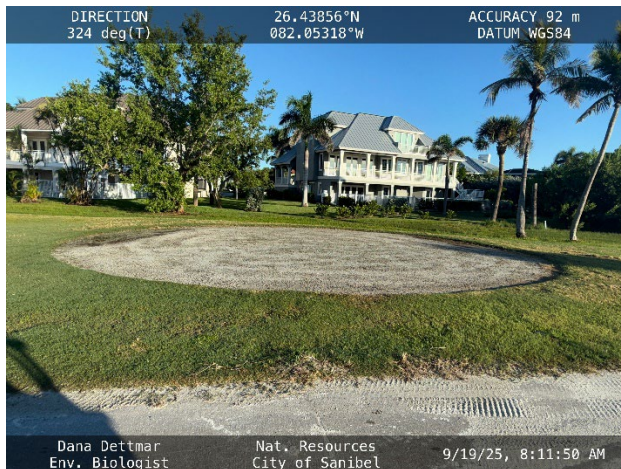
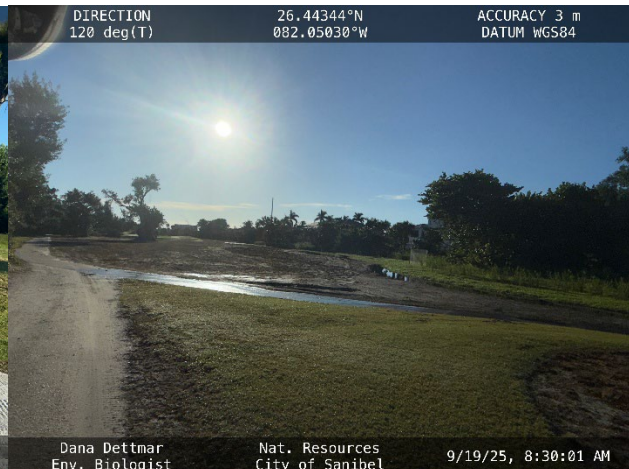
Paspalum replacement areas
